DEPARTMENT OF TRANSPORTATION

Contract #: 04-0120F4Cty: SF/ALA Rte: 80 PM: 13.2/13.9File #: 69.28**WELDING INSPECTION REPORT****Resident Engineer:** Pursell, Gary**Address:** 333 Burma Road**City:** Oakland, CA 94607**Report No:** WIR-007280**Date Inspected:** 03-Jun-2009**Project Name:** SAS Superstructure**OSM Arrival Time:** 700**Prime Contractor:** American Bridge/Fluor Enterprises, a JV**OSM Departure Time:** 1900**Contractor:** Zhenhua Port Machinery Company, Ltd (ZPMC), Changxing Island **Location:** Shanghai, China**CWI Name:** Shi Lin**CWI Present:** Yes No**Inspected CWI report:** Yes No N/A**Rod Oven in Use:** Yes No N/A**Electrode to specification:** Yes No N/A**Weld Procedures Followed:** Yes No N/A**Qualified Welders:** Yes No N/A**Verified Joint Fit-up:** Yes No N/A**Approved Drawings:** Yes No N/A**Approved WPS:** Yes No N/A**Delayed / Cancelled:** Yes No N/A**Bridge No:** 34-0006**Component:** OBG trial assembly**Summary of Items Observed:**

OBG superstructure trial assembly east line

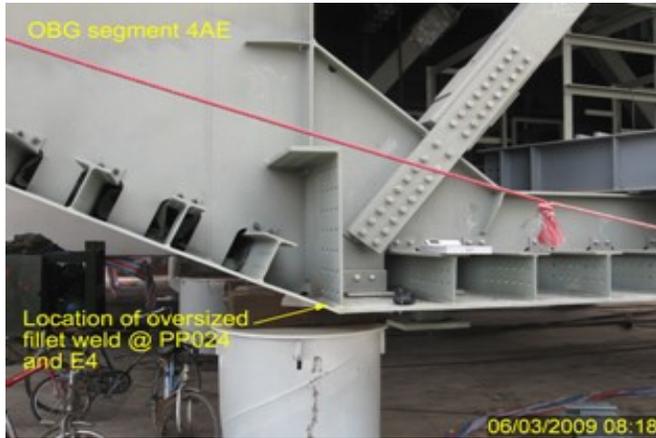
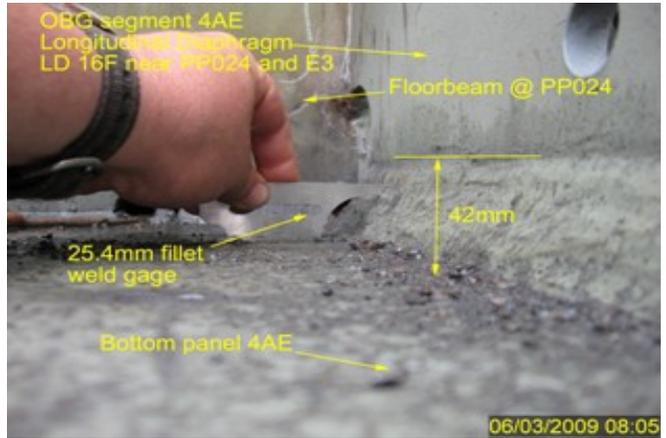
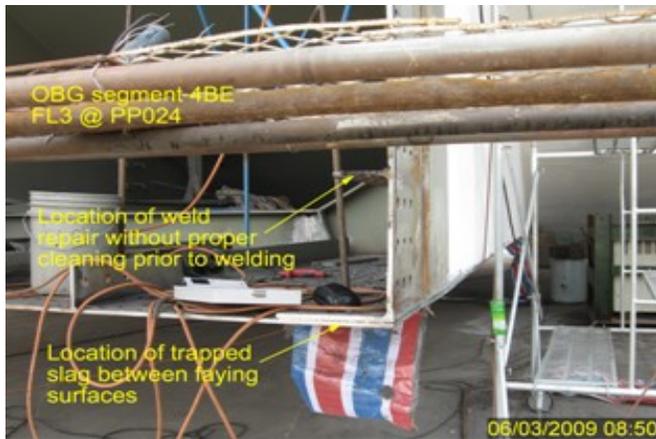
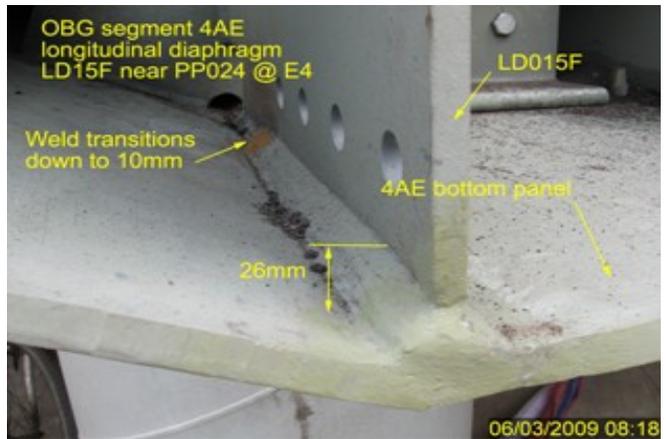
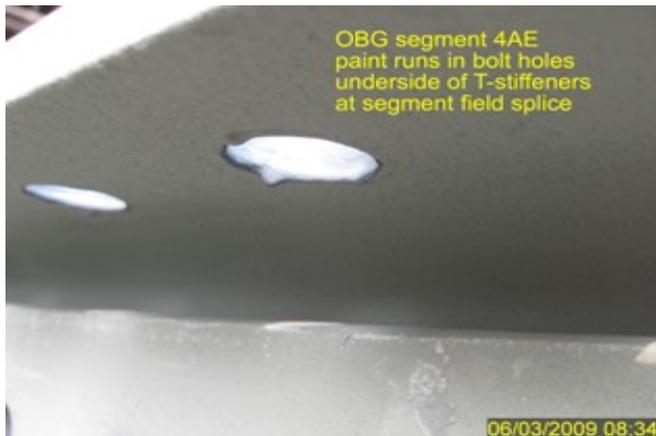
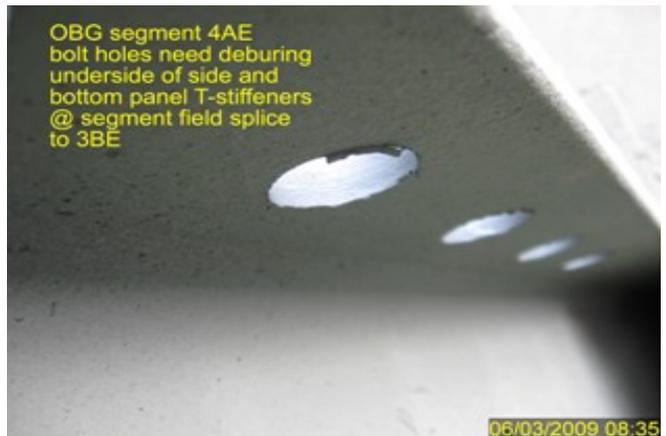
During random visual inspection of segment 4AE/4BE this QA observed the following: fillet welds joining longitudinal diaphragm LD16F and LD15F to the bottom panel of segment 4AE are over the specified size of 8mm and 6mm respectively. The weld sizes are 42mm at LD16F and 26mm at LD15F. See attached photos. Side and bottom panel T-stiffener bolt holes @ 3BE connection need to be deburred, paint runs on underside of side and bottom panel stiffeners @ 5AE connection, slag trapped between the faying surfaces of FL3 bottom flange and bolt on bottom plate @ PP026 on segment 4BE.

This QA observed that the contractor appears to have performed base metal edge weld repair without cleaning and removing slag prior to welding. The part is identified as X82V. The part is located on FL3 floorbeam identified as FB018A @ PP026 on OBG segment 4BE. AWS D1.5 2002 section 3.7.1 states..."The surface shall be thoroughly cleaned before welding." This QA informed ZPMC QC inspector identified as Mr. Zhang Hai Jun and ABF QA inspector identified as Mr. Li Jing Bo that an incident report would be generated for this issue.

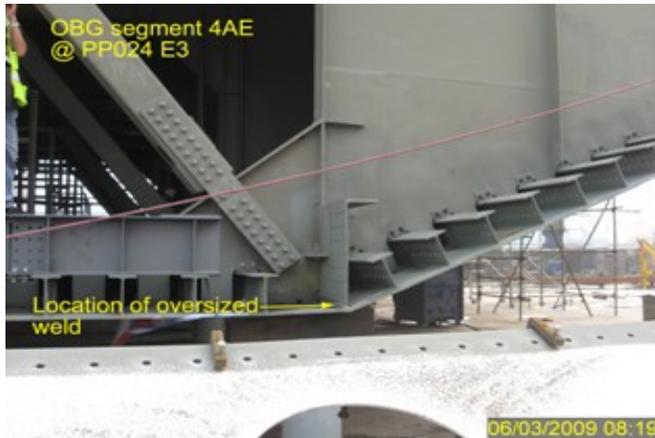
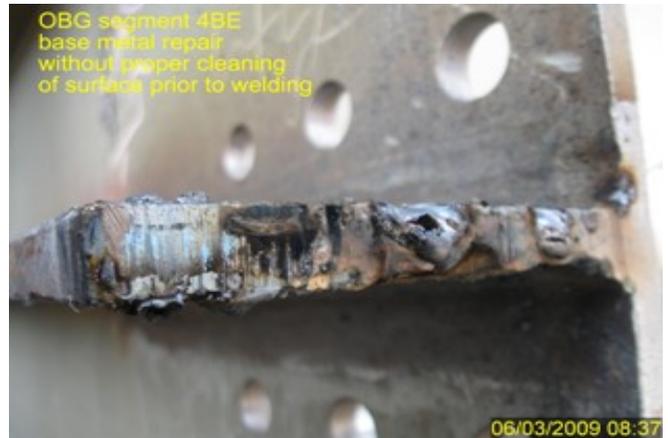
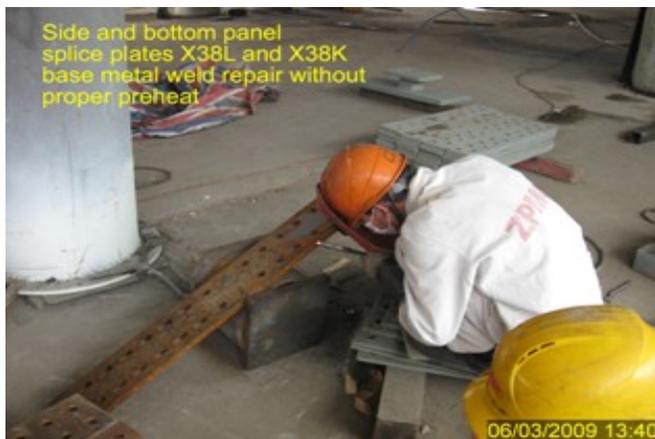
This Quality Assurance (QA) inspector observed the contractors welding personnel perform base metal edge weld repair without preheating. The parts are identified as X38L and X38K. It appears the contractor has repaired approximately 35 of these parts. Approved Weld Procedure Specification # WPS-345-FCAW-1G (1F)-Repair specifies 60 deg. minimum preheat for material equal to or less than 20mm thick. This QA informed ZPMC QC identified as Mr. Shi Lin (CWI) and ABF QA inspector identified as Mr. Kevin Chen that an incident report would be generated for this issue.
