DEPARTMENT OF TRANSPORTATION

Quality Assurance and Source Inspection

Contract #: 04-0120F4Cty: SF/ALA Rte: 80 PM: 13.2/13.9File #: 69.28**WELDING INSPECTION REPORT****Resident Engineer:** Pursell, Gary**Address:** 333 Burma Road**City:** Oakland, CA 94607**Report No:** WIR-007318**Date Inspected:** 16-May-2009**Project Name:** SAS Superstructure**OSM Arrival Time:** 700**Prime Contractor:** American Bridge/Fluor Enterprises, a JV**OSM Departure Time:** 1900**Contractor:** Zhenhua Port Machinery Company, Ltd (ZPMC), Changxing Island **Location:** Shanghai, China**CWI Name:** Sun Wei / Sun Bo**CWI Present:** Yes No**Inspected CWI report:** Yes No N/A**Rod Oven in Use:** Yes No N/A**Electrode to specification:** Yes No N/A**Weld Procedures Followed:** Yes No N/A**Qualified Welders:** Yes No N/A**Verified Joint Fit-up:** Yes No N/A**Approved Drawings:** Yes No N/A**Approved WPS:** Yes No N/A**Delayed / Cancelled:** Yes No N/A**Bridge No:** 34-0006**Component:** TOWER**Summary of Items Observed:**

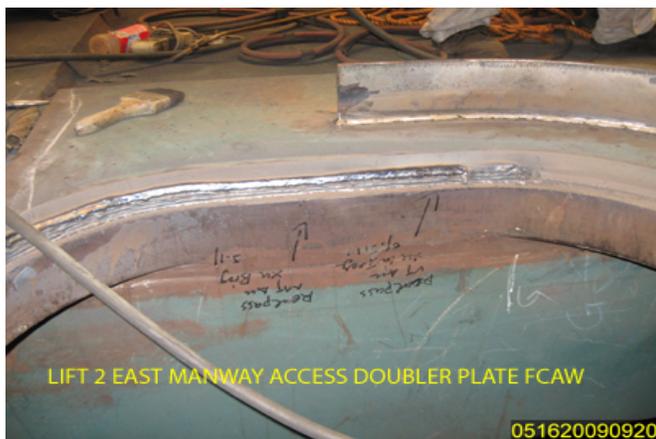
The QA Inspector randomly observed ZPMC welders Yang Gui Long ID 068919, utilizing the FCAW Process with ZPMC WPS WPS-B-T-2332-TC-P4-F in the 2G/2F (Horizontal Groove/ Horizontal Fillet) Positions, to weld the manway doubler plate Lift 2 East Tower Skin A at WJ's ESD1-SA300B/F-11. The QA Inspector randomly

observed ZPMC QC monitoring weld parameters. Weld parameters appeared to comply with contract requirements. The attached photograph provides additional detail.

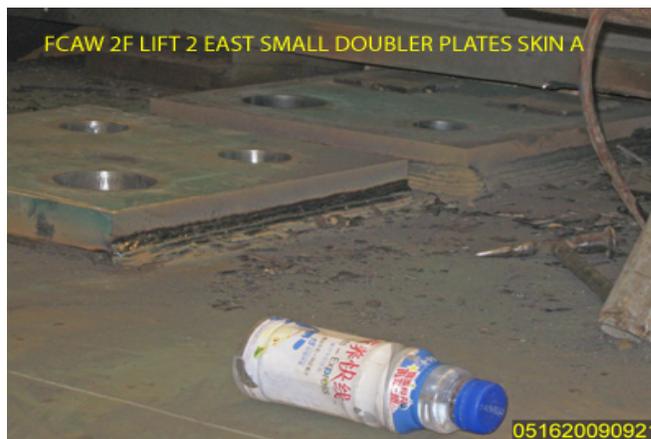
The QA Inspector randomly observed ZPMC welder Wang Ru Jia ID 066882, utilizing the Flux Cored Arc Welding (FCAW) Process with ZPMC Weld Procedure Specification (WPS) WPS-B-T-2332-TC-P4-F in the 2F (Horizontal Fillet) Positions, to weld the small doubler plates Lift 2 East Tower Skin A at WJ's ESD1-SA300B/F-7 and 10. The QA Inspector randomly observed ZPMC QC monitoring weld parameters. Weld parameters appeared to comply with contract requirements. The attached photograph provides additional detail.
