DEPARTMENT OF TRANSPORTATION

Quality Assurance and Source Inspection

Contract #: 04-0120F4Cty: SF/ALA Rte: 80 PM: 13.2/13.9File #: 69.28**WELDING INSPECTION REPORT****Resident Engineer:** Pursell, Gary**Address:** 333 Burma Road**City:** Oakland, CA 94607**Report No:** WIR-007326**Date Inspected:** 18-May-2009**Project Name:** SAS Superstructure**OSM Arrival Time:** 700**Prime Contractor:** American Bridge/Fluor Enterprises, a JV**OSM Departure Time:** 1900**Contractor:** Zhenhua Port Machinery Company, Ltd (ZPMC), Changxing Island **Location:** Shanghai, China**CWI Name:** Sun Wei / Sun Bo**CWI Present:** Yes No**Inspected CWI report:** Yes No N/A**Rod Oven in Use:** Yes No N/A**Electrode to specification:** Yes No N/A**Weld Procedures Followed:** Yes No N/A**Qualified Welders:** Yes No N/A**Verified Joint Fit-up:** Yes No N/A**Approved Drawings:** Yes No N/A**Approved WPS:** Yes No N/A**Delayed / Cancelled:** Yes No N/A**Bridge No:** 34-0006**Component:** TOWER**Summary of Items Observed:**

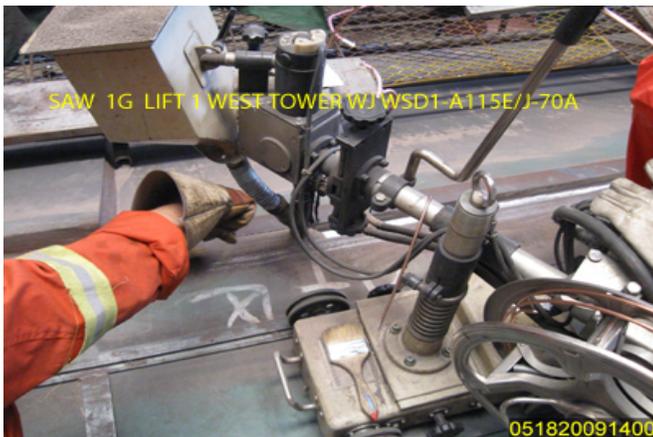
(Flat Groove) Position, to weld the fill pass in the long seam between Skin Plate B and Skin Plate C in Lift 1 West Tower at WJ WSD1-A115E/J-90A. The QA Inspector randomly observed ZPMC QC monitoring weld parameters.

The QA Inspector also randomly monitored weld parameters and recorded them as follows: 679 amps, 30.6 volts with a travel speed of 580 millimeters (mm) per minute. Weld parameters appeared to comply with contract requirements.
