DEPARTMENT OF TRANSPORTATION

Contract #: 04-0120F4Cty: SF/ALA Rte: 80 PM: 13.2/13.9File #: 69.28**WELDING INSPECTION REPORT****Resident Engineer:** Pursell, Gary**Address:** 333 Burma Road**City:** Oakland, CA 94607**Report No:** WIR-007329**Date Inspected:** 03-Jun-2009**Project Name:** SAS Superstructure**OSM Arrival Time:** 700**Prime Contractor:** American Bridge/Fluor Enterprises, a JV**OSM Departure Time:** 1900**Contractor:** Zhenhua Port Machinery Company, Ltd (ZPMC), Changxing Island **Location:** Shanghai, China**CWI Name:** Xu Le Feng**CWI Present:** Yes No**Inspected CWI report:** Yes No N/A**Rod Oven in Use:** Yes No N/A**Electrode to specification:** Yes No N/A**Weld Procedures Followed:** Yes No N/A**Qualified Welders:** Yes No N/A**Verified Joint Fit-up:** Yes No N/A**Approved Drawings:** Yes No N/A**Approved WPS:** Yes No N/A**Delayed / Cancelled:** Yes No N/A**Bridge No:** 34-0006**Component:** TOWER**Summary of Items Observed:**

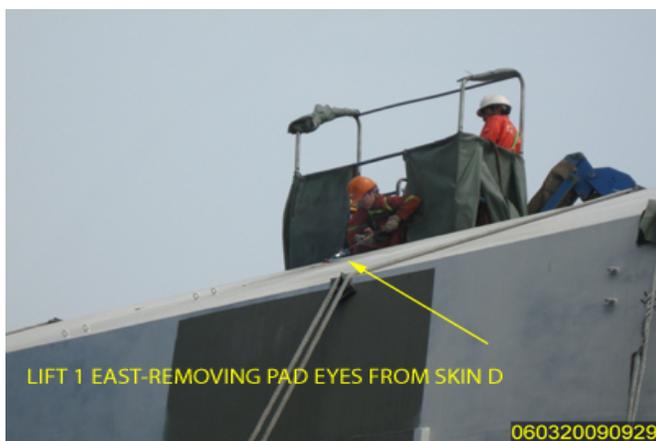
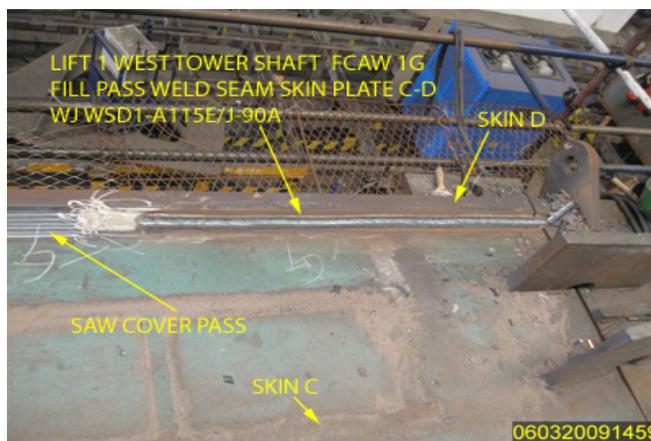
The QA Inspector randomly observed 1 ZPMC helper utilizing a hand held torch to remove pad eyes from 2 areas on Skin D on Lift 1 East Tower Shaft. The attached photograph provides additional detail.
