DEPARTMENT OF TRANSPORTATION

Contract #: 04-0120F4Cty: SF/ALA Rte: 80 PM: 13.2/13.9File #: 69.28**WELDING INSPECTION REPORT****Resident Engineer:** Pursell, Gary**Address:** 333 Burma Road**City:** Oakland, CA 94607**Report No:** WIR-007332**Date Inspected:** 07-Jun-2009**Project Name:** SAS Superstructure**OSM Arrival Time:** 700**Prime Contractor:** American Bridge/Fluor Enterprises, a JV**OSM Departure Time:** 1900**Contractor:** Zhenhua Port Machinery Company, Ltd (ZPMC), Changxing Island **Location:** Shanghai, China**CWI Name:** Xu Le Feng, Liu Yang**CWI Present:** Yes No**Inspected CWI report:** Yes No N/A**Rod Oven in Use:** Yes No N/A**Electrode to specification:** Yes No N/A**Weld Procedures Followed:** Yes No N/A**Qualified Welders:** Yes No N/A**Verified Joint Fit-up:** Yes No N/A**Approved Drawings:** Yes No N/A**Approved WPS:** Yes No N/A**Delayed / Cancelled:** Yes No N/A**Bridge No:** 34-0006**Component:** TOWER**Summary of Items Observed:**

WELDING INSPECTION REPORT

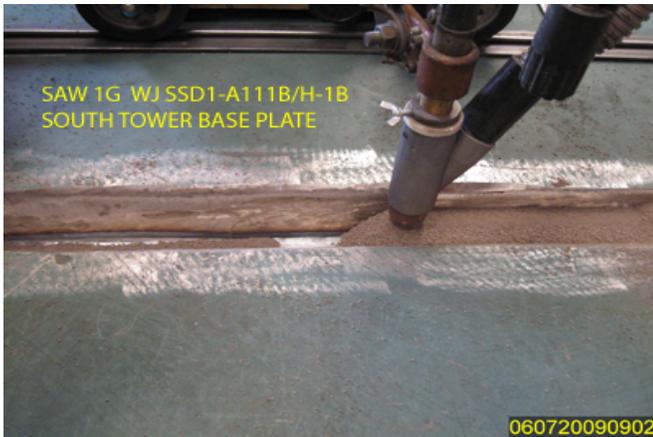
The QA Inspector randomly observed ZPMC welder Xia Yong ID 040625, utilizing the Submerged Arc Welding (SAW) Process in the 1G (Flat Groove) Position with ZPMC Weld Procedure Specification (WPS) WPS-B-T-2221-B-U3c-S-2 to weld the butt seam at Weld Joint (WJ) SSD1-A111B/H-1B. The QA Inspector randomly observed ZPMC QC monitoring weld parameters. The QA Inspector also randomly monitored weld parameters and recorded them as follows: 658 amps, 31.7 volts with a travel speed of 600 millimeters (mm) per

minute. Weld parameters appeared to comply with contract requirements. The attached photograph provides additional detail.
