DEPARTMENT OF TRANSPORTATION

Quality Assurance and Source Inspection

Contract #: 04-0120F4Cty: SF/ALA Rte: 80 PM: 13.2/13.9File #: 69.28**WELDING INSPECTION REPORT****Resident Engineer:** Pursell, Gary**Address:** 333 Burma Road**City:** Oakland, CA 94607**Report No:** WIR-007333**Date Inspected:** 10-Jun-2009**Project Name:** SAS Superstructure**OSM Arrival Time:** 700**Prime Contractor:** American Bridge/Fluor Enterprises, a JV**OSM Departure Time:** 1900**Contractor:** Zhenhua Port Machinery Company, Ltd (ZPMC), Changxing Island **Location:** Shanghai, China**CWI Name:** Xu Le Feng, Liu Yang**CWI Present:** Yes No**Inspected CWI report:** Yes No N/A**Rod Oven in Use:** Yes No N/A**Electrode to specification:** Yes No N/A**Weld Procedures Followed:** Yes No N/A**Qualified Welders:** Yes No N/A**Verified Joint Fit-up:** Yes No N/A**Approved Drawings:** Yes No N/A**Approved WPS:** Yes No N/A**Delayed / Cancelled:** Yes No N/A**Bridge No:** 34-0006**Component:** TOWER**Summary of Items Observed:**

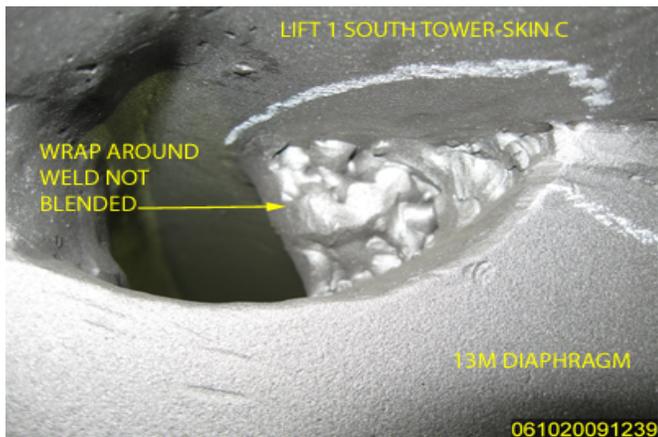
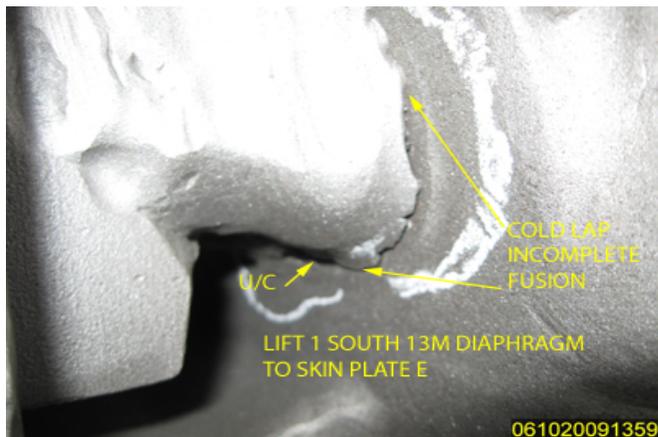
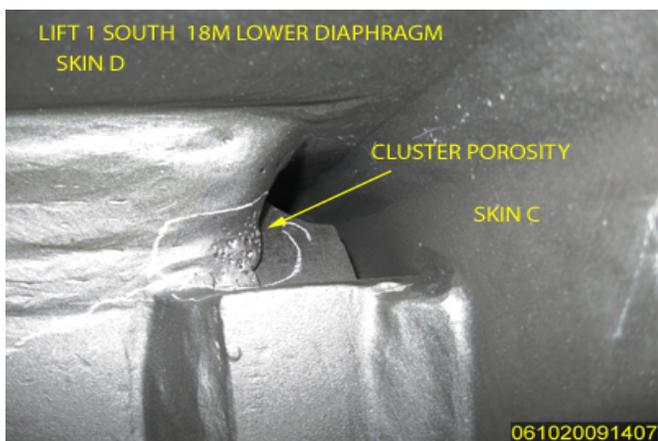
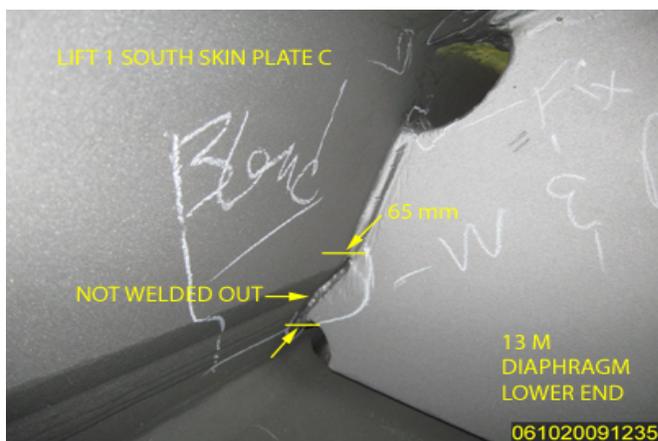
The QA Inspector performed an after blast VT Inspection in interior of Lift 1 East Tower Shaft on Skin Plates A, B, C, D and E from the base to 18M Lower Diaphragm after lighting had been restored. The QA Inspector observed several areas which require a minimum of grinding and several other areas which will require weld repair in addition to grinding. The QA Inspector randomly observed ZPMC production personnel utilizing angle and pencil grinders to re-work areas as they were being marked up. The QA Inspector recorded areas requiring welding on a separate tracking sheet for the generation of a punch list. The attached photographs provide additional detail.
