Contract #: 04-0120F4Cty: SF/ALA Rte: 80 PM: 13.2/13.9File #: 13.28**WELDING INSPECTION REPORT****Resident Engineer:** Pursell, Gary**Address:** 333 Burma Road**City:** Oakland, CA 94607**Report No:** WIR-007406**Date Inspected:** 22-Jun-2009**Project Name:** SAS Superstructure**OSM Arrival Time:** 1400**Prime Contractor:** American Bridge/Fluor Enterprises, a JV**OSM Departure Time:** 2230**Contractor:** Oregon Iron Works Clackamas, Or.**Location:** Clackamas, OR

Bridge No: 34-0006**Component:** Hinge-K Components**Summary of Items Observed:**

Summary of Items Observed: On this date, Caltrans Quality Assurance Inspector (QA) Clete Henke was present at Oregon Iron Works, Inc. (OIW) in Clackamas, OR for observation of fabrication of the Hinge K Pipe Beams and related activities including in process welding and OIW Quality Control (QC) visual and nondestructive testing. The following observations were recorded:

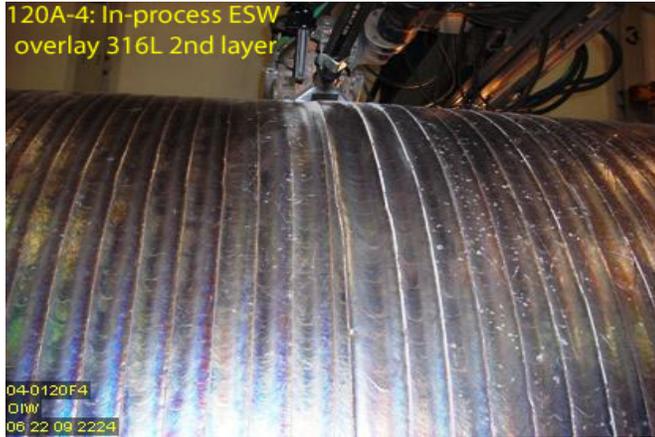
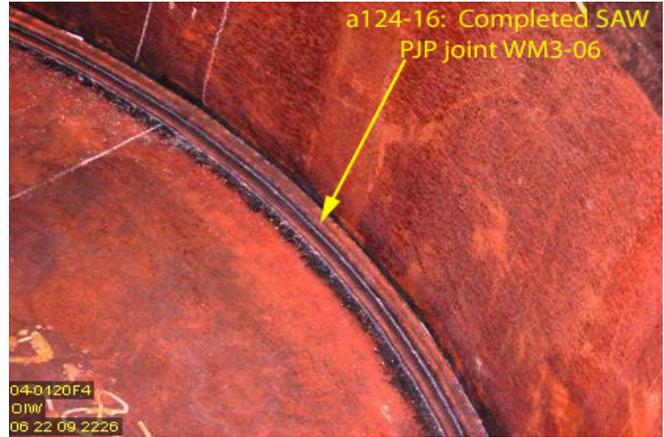
The QA Inspector intermittently monitored OIW welder Yuriy Bannikov (WID B61) during in progress Submerged Arc Welding (SAW) at weld joint WM3-06 joining a125 stiffener ring to a124-16 Fuse Section. Welder B61 deposited SAW fill and cover passes in the flat (1G) position in accordance with approved welding procedure 4020 at the location referenced above. The QA Inspector noted the OIW welder was maintaining continuous preheat utilizing two torches. An OIW helper was observed assisting welder B61 during SAW process.

The QA Inspector intermittently monitored OIW welder Bui Liem (WID B10) during in progress Submerged Arc Welding (SAW) at weld joints W1-126 & W1-149. The referenced connections join e108 and d108 stiffeners to a111-4 forging. The QA Inspector observed as OIW QC Inspector Steve Barnett performed Magnetic particle Testing (MT) and Visual Inspection (VT) of completed root pass at weld joints W1-126 & W1-149. Mr. Barnett stated that he had located no rejectable indications. The QA Inspector subsequently performed 100% VT & 50% MT verification at the locations noted above finding the root passes to be in general compliance with contract documents. Please reference TL-6028 report for this date for details. The QA Inspector intermittently observed as welder B10 continued to deposit SAW fill and cover passes in the flat (1G) position in accordance with approved welding procedures 4016. The QA Inspector noted the OIW welder was maintaining continuous preheat utilizing a torch. The QA Inspector observed OIW QC Inspector Steve Barnett regularly monitoring and recording the in process SAW parameters. The QA Inspector also intermittently observed in process welding parameters and determined that the SAW parameters and minimum preheat/interpass temperature appeared to be in general compliance with the contract requirements -- (W1-149 - Fill: 35 volts, 585 amperes, 432mm/min travel speed).

The QA Inspector intermittently observed OIW qualified welder Bounheune Savanh (WID S74) during in-process welding of Soudotape 316L stainless steel overlay to hinge k pipe beam fuse sub-assembly 120A-4. The weld joint is identified as 316L 2nd layer. Mr. Savanh was observed welding in the flat position utilizing automatic electro slag welding (ESW) overlay process with a .5mm x 60mm Soudotape 316L stainless electrode, filler metal brand Soudotape class EQ316L automatic. An OIW helper was observed assisting welder V7 during ESW activity.
