**DEPARTMENT OF TRANSPORTATION**

Contract #: 04-0120F4Cty: SF/ALA Rte: 80 PM: 13.2/13.9File #: 69.28**WELDING INSPECTION REPORT****Resident Engineer:** Pursell, Gary**Address:** 333 Burma Road**City:** Oakland, CA 94607**Report No:** WIR-007418**Date Inspected:** 10-Jun-2009**Project Name:** SAS Superstructure**OSM Arrival Time:** 1900**Prime Contractor:** American Bridge/Fluor Enterprises, a JV**OSM Departure Time:** 700**Contractor:** Zhenhua Port Machinery Company, Ltd (ZPMC), Changxing Island **Location:** Shanghai, China**CWI Name:** See Below**CWI Present:** Yes No**Inspected CWI report:** Yes No N/A**Rod Oven in Use:** Yes No N/A**Electrode to specification:** Yes No N/A**Weld Procedures Followed:** Yes No N/A**Qualified Welders:** Yes No N/A**Verified Joint Fit-up:** Yes No N/A**Approved Drawings:** Yes No N/A**Approved WPS:** Yes No N/A**Delayed / Cancelled:** Yes No N/A**Bridge No:** 34-0006**Component:** OBG and Tower Fabrication**Summary of Items Observed:**

**OBG Bay 13**

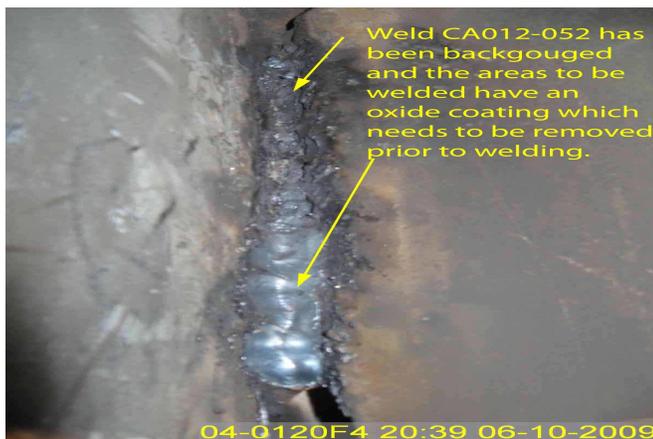
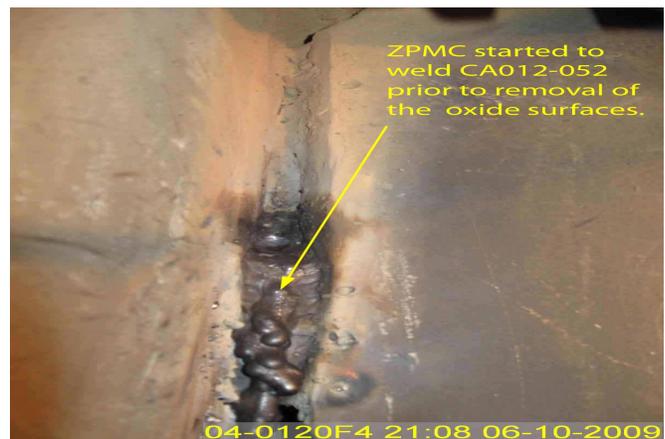
This QA Inspector observed ZPMC welder Mr. Xue Yian, stencil 040634 is working on weld SEG012-052 in segment 4BE near panel point PP27. The QA Inspector observed ZPMC has removed this weld to permit an adjacent bolted connection to be properly seated prior to installation of high strength bolts. The QA inspector observed Mr Yian has completed weld SEG012-050 on one side of this plate and the top of the weld has a weave width of approximately 35 mm which is in excess of the 25 mm maximum allowed by AWS. Weld SEG012-052 has not been rewelded and the weld joint appears to have been air carbon arc gouged and the areas to be welded have not been ground. The QA Inspector informed ZPMC QC Inspector Mr. Wang Wi Liang and CWI Mr. Kua Wenshang that the air carbon arc oxide material will need to be ground to a bright metal condition prior to welding.

Around ten minutes later the QA Inspector observed ZPMC welder Mr. Xue Yian starting to weld SEG012-052. The QA Inspector observed this weld joint has not been ground to a bright metal condition and the QA Inspector informed CWI Mr. Kua Wenshang and ZPMC QC Representative Mr. Wang Lu (Mr. Testino) that welding on this oxide surface is a violation of AWS D1.5 and that an incident report is going to be issued. See the photographs below for additional information.
