Quality Assurance and Source Inspection

Contract #: 04-0120F4Cty: SF/ALA Rte: 80 PM: 13.2/13.9File #: 69.28**WELDING INSPECTION REPORT****Resident Engineer:** Pursell, Gary**Address:** 333 Burma Road**City:** Oakland, CA 94607**Report No:** WIR-007556**Date Inspected:** 01-Jul-2009**Project Name:** SAS Superstructure**OSM Arrival Time:** 700**Prime Contractor:** American Bridge/Fluor Enterprises, a JV**OSM Departure Time:** 1900**Contractor:** Zhenhua Port Machinery Company, Ltd (ZPMC), Changxing Island **Location:** Shanghai, China**CWI Name:** Xu Le Feng, Yu Dong Ping**CWI Present:** Yes No**Inspected CWI report:** Yes No N/A**Rod Oven in Use:** Yes No N/A**Electrode to specification:** Yes No N/A**Weld Procedures Followed:** Yes No N/A**Qualified Welders:** Yes No N/A**Verified Joint Fit-up:** Yes No N/A**Approved Drawings:** Yes No N/A**Approved WPS:** Yes No N/A**Delayed / Cancelled:** Yes No N/A**Bridge No:** 34-0006**Component:** TOWER**Summary of Items Observed:**

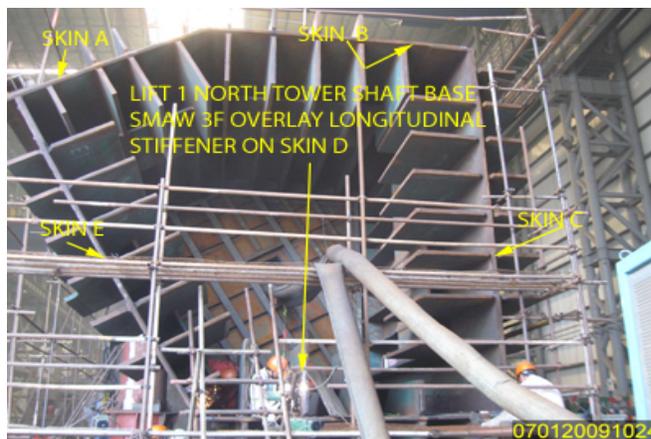
The QA Inspector randomly observed ZPMC welder Fan Chun Lei ID 040491, utilizing the Shielded Metal Arc Welding (SMAW) Process in the 3F (Vertical Fillet) Position with ZPMC Weld Procedure Specification (WPS) WPS-345-SMAW-3G (3F) to weld overlay on the external stiffeners after removal of backing on Lift 1 North Tower. The QA Inspector randomly observed ZPMC QC monitoring weld parameters. Weld parameters appeared to comply with contract requirements. The attached photograph provides additional detail.
