**DEPARTMENT OF TRANSPORTATION**

Contract #: 04-0120F4Cty: SF/ALA Rte: 80 PM: 13.2/13.9File #: 69.28**WELDING INSPECTION REPORT****Resident Engineer:** Pursell, Gary**Address:** 333 Burma Road**City:** Oakland, CA 94607**Report No:** WIR-007643**Date Inspected:** 05-Jul-2009**Project Name:** SAS Superstructure**OSM Arrival Time:** 700**Prime Contractor:** American Bridge/Fluor Enterprises, a JV**OSM Departure Time:** 1900**Contractor:** Zhenhua Port Machinery Company, Ltd (ZPMC), Changxing Island **Location:** Shanghai, China**CWI Name:** Zhoa Chen Sun**CWI Present:** Yes No**Inspected CWI report:** Yes No N/A**Rod Oven in Use:** Yes No N/A**Electrode to specification:** Yes No N/A**Weld Procedures Followed:** Yes No N/A**Qualified Welders:** Yes No N/A**Verified Joint Fit-up:** Yes No N/A**Approved Drawings:** Yes No N/A**Approved WPS:** Yes No N/A**Delayed / Cancelled:** Yes No N/A**Bridge No:** 34-0006**Component:** various subassemblies and deck panel PMT**Summary of Items Observed:**

**OBG bay 6**

**OBG bay 9**

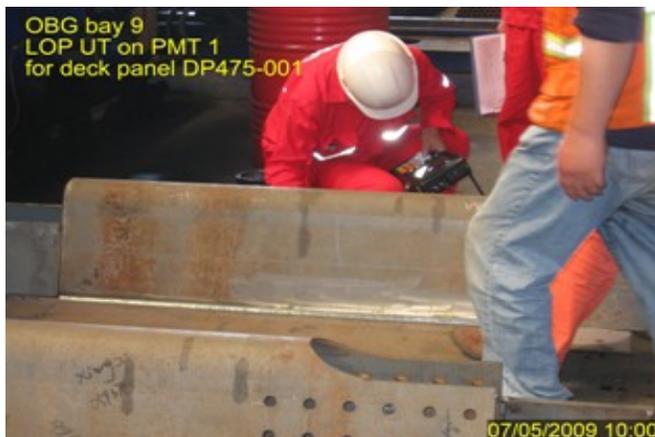
Submerged Arc Weld (SAW) 3 Rib PMT# 1 for deck panel DP-475-001 on gantry #1. ZPMC welding personnel commenced welding PMT #1 for gantry #1 at 0845 hrs for the above mentioned deck panel. QA observed ZPMC QC CWI identified as Mr. Sun Bo and American Bridge Fluor (ABF) QA inspector identified as Mr. Huang Wen Guang perform and accept the Visual Test (VT) of 500mm on each of the completed welds. This QA concurred that the welds appeared to comply with the latest revision of the PMT acceptance criteria. QA completed a U-Ribs PMT inspection report for this date and gantry. The report is on file in the Caltrans QA office. QA observed ZPMC QC UT technician perform and accept the UT inspection for Depth Of Penetration (DOP) on 500mm of each weld. Caltrans QA waived the right to perform DOP UT verification on this PMT. QA laid-out, match marked and stenciled 5 macro-etch samples on each PMT rib for a total of 15 samples. The welding parameters and welder ID's for Gantry 1 PMT #1 are as follows:

ZPMC QA identified as Mr. wang Lu contacted this QA to examine the 15 macro-etch samples cut from the above mentioned PMT panel at 15:00 hrs. All of the macro-etch samples examined appeared to meet the requirements of the contract documents. QA logged the results in on the Team China Server.
