DEPARTMENT OF TRANSPORTATION

Contract #: 04-0120F4Cty: SF/ALA Rte: 80 PM: 13.2/13.9File #: 13.28**WELDING INSPECTION REPORT****Resident Engineer:** Pursell, Gary**Address:** 333 Burma Road**City:** Oakland, CA 94607**Report No:** WIR-008396**Date Inspected:** 06-Aug-2009**Project Name:** SAS Superstructure**OSM Arrival Time:** 700**Prime Contractor:** American Bridge/Fluor Enterprises, a JV**OSM Departure Time:** 1530**Contractor:** Oregon Iron Works Clackamas, Or.**Location:** Clackamas, OR**CWI Name:** Mike Gregson, Jose Salazar**CWI Present:** Yes No**Inspected CWI report:** Yes No N/A**Rod Oven in Use:** Yes No N/A**Electrode to specification:** Yes No N/A**Weld Procedures Followed:** Yes No N/A**Qualified Welders:** Yes No N/A**Verified Joint Fit-up:** Yes No N/A**Approved Drawings:** Yes No N/A**Approved WPS:** Yes No N/A**Delayed / Cancelled:** Yes No N/A**Bridge No:** 34-0006**Component:** Hinge K Pipe Beams**Summary of Items Observed:**

Hinge-K Pipe Beam Assembly 102A-1: 8/6/09

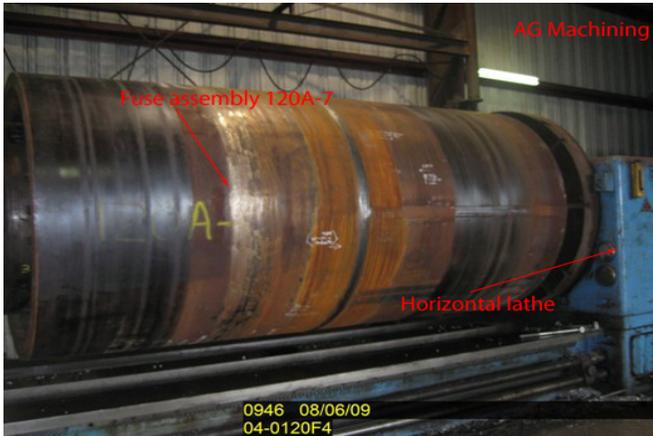
QA Inspector noticed welder #J6, Mr. Craig Jacobsen had previously completed the flux core arc welding (FCAW) on the critical weld repair (CWR #2244-006), a111-3 forging to a110-3 base plate, designated as weld joint #W2-13 and 100% preliminary ultrasonic weld inspection had been performed by OIW QC Inspector Rob Walters. QA Inspector spoke with QC Inspector Rob Walters and Mr. Walters explained that the inspection was performed utilizing a 60/70 degree transducer from face "A" and a 60 degree transducer from face "B" and no rejectable indications were found.

Mr. Walters also explained that final ultrasonic weld inspection will be performed after the required 72hrs. cooling time, per AWS D1.5 and contract requirements. See attached picture below.

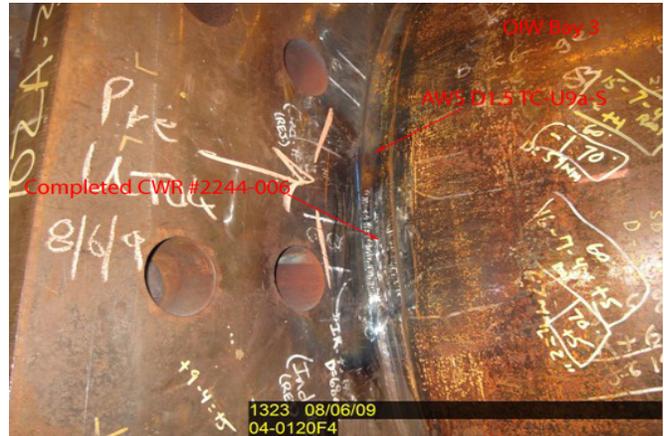
Note: QA Inspector spoke with AG machinist and AG explained that the "trial" machining on the previous fuse assembly 120A-3 had been completed to a outside diameter of 1921.5mm and OIW had picked up this fuse assembly 120A-3 and transferred back to OIW, on this date. QA Inspector noted that OIW QC Inspectors will then perform preliminary inspections on the ESW weld passes, on the fuse assembly 120A-3 and perform any

necessary welding/grinding repairs on the overlay. Once accepted by OIW, this fuse assembly 120A-3 will be eventually transferred back to AG Machining and AG will machine a final outside diameter of 1920mm (+/- 1mm), per contract requirements and OIW approved drawings. See attached picture below.
