DEPARTMENT OF TRANSPORTATION

Quality Assurance and Source Inspection

Contract #: 04-0120F4Cty: SF/ALA Rte: 80 PM: 13.2/13.9File #: 13.28**WELDING INSPECTION REPORT****Resident Engineer:** Pursell, Gary**Address:** 333 Burma Road**City:** Oakland, CA 94607**Report No:** WIR-008400**Date Inspected:** 07-Aug-2009**Project Name:** SAS Superstructure**OSM Arrival Time:** 700**Prime Contractor:** American Bridge/Fluor Enterprises, a JV**OSM Departure Time:** 1530**Contractor:** Oregon Iron Works Clackamas, Or.**Location:** Clackamas, OR**CWI Name:** Mike Gregson, Jose Salazar**CWI Present:** Yes No**Inspected CWI report:** Yes No N/A**Rod Oven in Use:** Yes No N/A**Electrode to specification:** Yes No N/A**Weld Procedures Followed:** Yes No N/A**Qualified Welders:** Yes No N/A**Verified Joint Fit-up:** Yes No N/A**Approved Drawings:** Yes No N/A**Approved WPS:** Yes No N/A**Delayed / Cancelled:** Yes No N/A**Bridge No:** 34-0006**Component:** Hinge K Pipe Beams**Summary of Items Observed:**

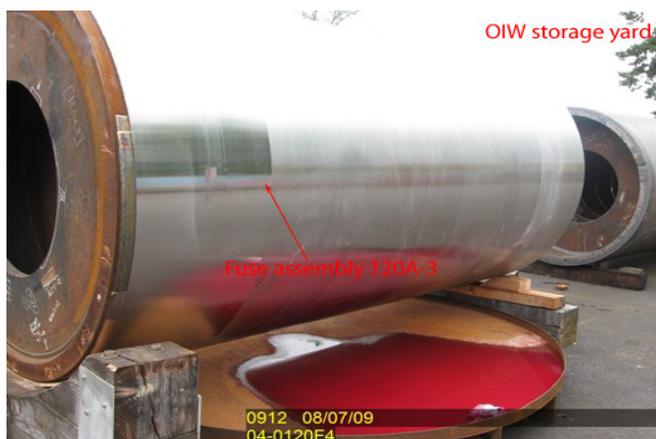
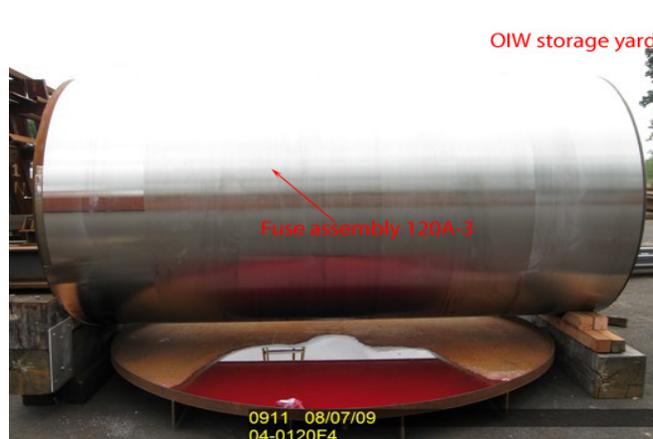
QA Inspector noted that the final "trial" machining on fuse assembly 120A-3 had been completed, by AG Machining, to a outside diameter of 1921.5mm and OIW had previously picked up this fuse assembly 120A-3 and this assembly was idle. QA Inspector spoke with lead QC Inspector Mike Gregson and Mr. Gregson explained that random "preliminary" penetrant testing had been performed on the finished ESW overlay, after final "trial" machining. Mr. Gregson explained that 6ea. 2' x 2' (610mm x 610mm) random grid locations were tested and no rejectable indications were found.

Note: Fuse assembly 120A-3 will be eventually transferred back to AG Machining and AG will machine a final outside diameter of 1920mm (+/- 1mm), per contract requirements and OIW approved drawings. See attached pictures below.
