**DEPARTMENT OF TRANSPORTATION**

Contract #: 04-0120F4Cty: SF/ALA Rte: 80 PM: 13.2/13.9File #: 13.28**WELDING INSPECTION REPORT****Resident Engineer:** Pursell, Gary**Address:** 333 Burma Road**City:** Oakland, CA 94607**Report No:** WIR-008405**Date Inspected:** 11-Aug-2009**Project Name:** SAS Superstructure**OSM Arrival Time:** 700**Prime Contractor:** American Bridge/Fluor Enterprises, a JV**OSM Departure Time:** 1530**Contractor:** Oregon Iron Works Clackamas, Or.**Location:** Clackamas, OR**CWI Name:** Mike Gregson, Rob Walters**CWI Present:** Yes No**Inspected CWI report:** Yes No N/A**Rod Oven in Use:** Yes No N/A**Electrode to specification:** Yes No N/A**Weld Procedures Followed:** Yes No N/A**Qualified Welders:** Yes No N/A**Verified Joint Fit-up:** Yes No N/A**Approved Drawings:** Yes No N/A**Approved WPS:** Yes No N/A**Delayed / Cancelled:** Yes No N/A**Bridge No:** 34-0006**Component:** Hinge K Pipe Beams**Summary of Items Observed:**

## WELDING INSPECTION REPORT

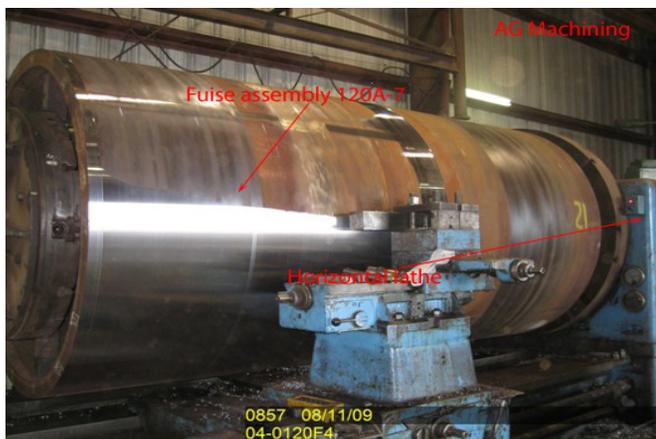
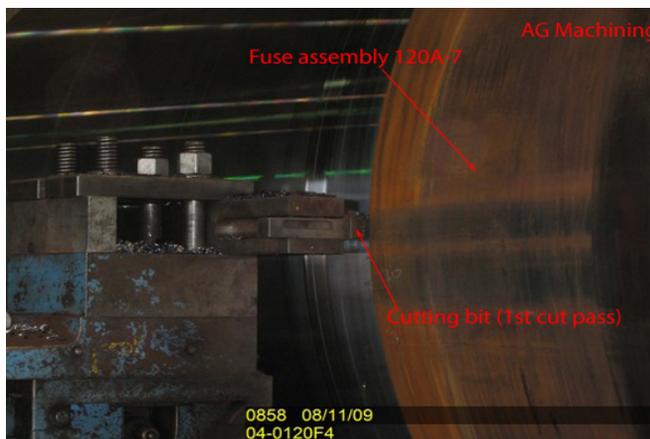
QA Inspector arrived at AG Machining, on this date and noticed that AG Machining had previously placed this fuse assembly 120A-7 in a horizontal lathe and was in-process of performing rough machining. QA Inspector spoke with AG Machinist and AG explained that OIW had previously released this fuse assembly to AG and the first machining cut pass was in-progress, at approximately .160" (4mm) deep and was approximately 50% complete. AG explained that 2 more cut passes will be necessary, at approximately .160" (4mm) deep, to achieve a final outside diameter measurement of approximately 1903mm. QA Inspector noted that contract requirements require a finished rough machining outside diameter of 1900mm (+- 3mm) and AG Machining appeared to be in compliance with contract requirements. QA Inspector noted that once AG completes the rough machining, on this fuse assembly 120A-7, OIW will transfer back to OIW fabrication shop and QC Inspectors will perform 100% magnetic particle testing on the finished machined surface, per contract requirements. See attached pictures below.
