Contract #: 04-0120F4Cty: SF/ALA Rte: 80 PM: 13.2/13.9File #: 69.28**WELDING INSPECTION REPORT****Resident Engineer:** Pursell, Gary**Address:** 333 Burma Road**City:** Oakland, CA 94607**Report No:** WIR-008571**Date Inspected:** 14-Aug-2009**Project Name:** SAS Superstructure**OSM Arrival Time:** 1900**Prime Contractor:** American Bridge/Fluor Enterprises, a JV**OSM Departure Time:** 700**Contractor:** Zhenhua Port Machinery Company, Ltd (ZPMC), Changxing Island **Location:** Shanghai, China**CWI Name:** Xu Yumin, Wang Chuangng**CWI Present:** Yes No**Inspected CWI report:** Yes No N/A**Rod Oven in Use:** Yes No N/A**Electrode to specification:** Yes No N/A**Weld Procedures Followed:** Yes No N/A**Qualified Welders:** Yes No N/A**Verified Joint Fit-up:** Yes No N/A**Approved Drawings:** Yes No N/A**Approved WPS:** Yes No N/A**Delayed / Cancelled:** Yes No N/A**Bridge No:** 34-0006**Component:** OBG & Tower**Summary of Items Observed:**

WELDING INSPECTION REPORT

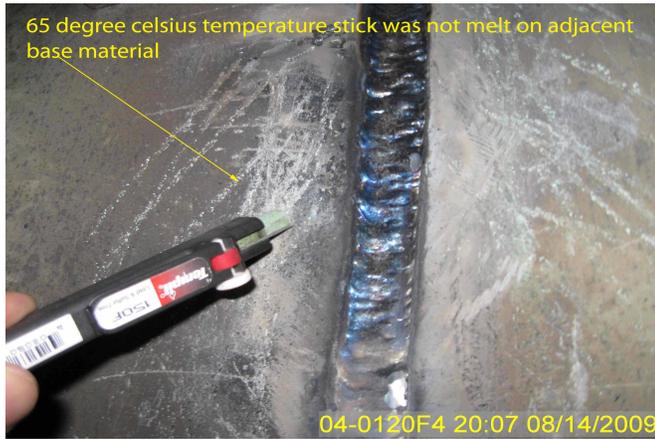
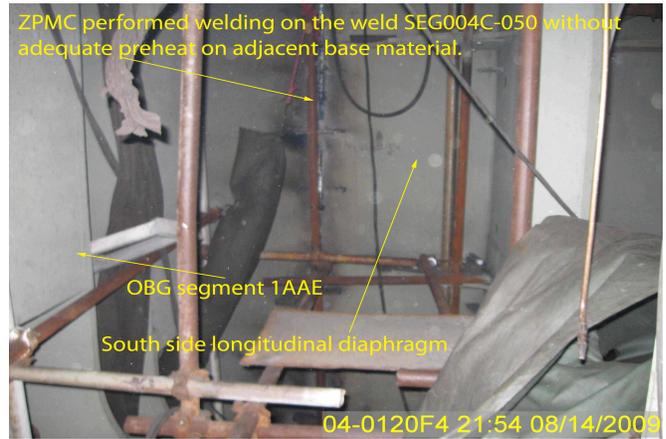
During the random visual inspection this Caltrans Quality Assurance Inspector (QA) observed ZPMC performed welding on the weld SEG004C-050, south side longitudinal diaphragm splice weld joint between OBG segment 1AAE and 1AE, without adequate preheating of the adjacent base material. This QA Inspector observed a 65 degree Celsius Tempstick did not melt when applied to the adjacent base material. For additional information see attached photos. Incident report was send to task leader and other supervisor.
