DEPARTMENT OF TRANSPORTATION

Quality Assurance and Source Inspection

Contract #: 04-0120F4Cty: SF/ALA Rte: 80 PM: 13.2/13.9File #: 13.28**WELDING INSPECTION REPORT****Resident Engineer:** Pursell, Gary**Address:** 333 Burma Road**City:** Oakland, CA 94607**Report No:** WIR-008590**Date Inspected:** 19-Aug-2009**Project Name:** SAS Superstructure**OSM Arrival Time:** 700**Prime Contractor:** American Bridge/Fluor Enterprises, a JV**OSM Departure Time:** 1530**Contractor:** Oregon Iron Works Clackamas, Or.**Location:** Clackamas, OR**CWI Name:** Mike Gregson, Jose Salazar**CWI Present:** Yes No**Inspected CWI report:** Yes No N/A**Rod Oven in Use:** Yes No N/A**Electrode to specification:** Yes No N/A**Weld Procedures Followed:** Yes No N/A**Qualified Welders:** Yes No N/A**Verified Joint Fit-up:** Yes No N/A**Approved Drawings:** Yes No N/A**Approved WPS:** Yes No N/A**Delayed / Cancelled:** Yes No N/A**Bridge No:** 34-0006**Component:** Hinge K Pipe Beams**Summary of Items Observed:**

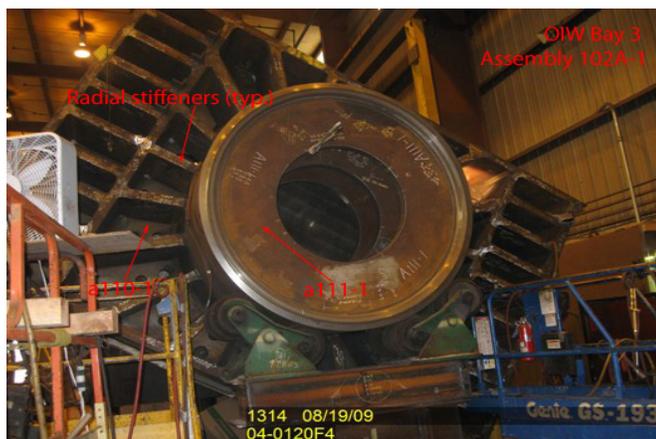
Hinge-K Pipe Beam Assembly 102A-1: 8/19/09

a111-1 Forging to a110-1 Base Plate

QA Inspector noticed this assembly 102A-1 had been previously placed in position and welder #J6, Mr. Craig Jacobson, was in process of performing submerged arc welding, on the c106 stiffener plate to a107 stiffener plate, designated as weld joint # W1-56, in the flat position. QA Inspector noted that this weld joint was designated as a multi-pass 25mm fillet weld and verified Mr. Jacobson was currently qualified for this process/position. QA Inspector noted that Mr. Jacobson was utilizing OIW approved welding procedure specification (WPS 4020) and randomly recorded pre-heat temperatures of approximately 350 degrees Fahrenheit. QA Inspector noticed QC Inspector Jose Salazar was present to monitor in-process welding parameters (amps/volts) and noted that Mr. Salazar had previously recorded in-process welding parameters of 430 amps and 30 volts, which appears to be in compliance with the applicable welding procedure specification and contract requirements. See attached picture below.

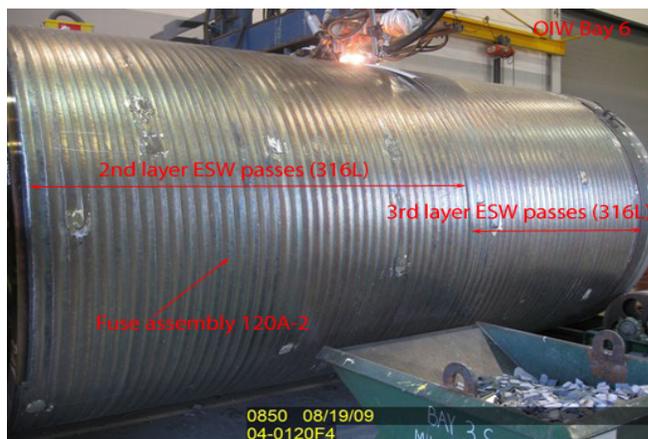
Hinge-K Pipe Beam Fuse Assembly 120A-2: 8/19/09

a124-3 Half Fuse to a124-11 Half Fuse

QA Inspector noticed that the ESW stainless steel overlay passes were in-process, on this fuse assembly 120A-2. QA Inspector witnessed welder #F17, Mr. Igor Frolov performing electro slag welding (ESW) on the third and final layer welding passes, (approximately 40% complete), in the flat position, utilizing Soudokay brand Soudotape 316L stainless steel consumable strip. QA Inspector noted the first layer passes were previously completed utilizing the 309L consumable strip and second layers utilizing the 316L consumable strip, per contract requirements. QA Inspector randomly noticed QC Inspector's Mike Gregson and Jose Salazar were present, to verify in-process welding parameters (amps/volts) and monitor in-process continuous pre-heat temperatures. QA Inspector spoke with QC Inspector Jose Salazar and Mr. Salazar explained that welding amps were recorded as 1200 amps/25.2 volts, travel speed at 241mm/min. and a pre-heat temperature recorded at 70 degrees Fahrenheit (20 C). QA Inspector verified Mr. Igor Frolov was currently qualified for this welding process/position and randomly recorded pre-heat temperatures of approximately 70 degrees Fahrenheit. QA Inspector noted that Mr. Igor Frolov appeared to be in compliance with the applicable approved welding procedure specification (WPS 7003). See attached picture below.
