Contract #: 04-0120F4Cty: SF/ALA Rte: 80 PM: 13.2/13.9File #: 69.28**WELDING INSPECTION REPORT****Resident Engineer:** Pursell, Gary**Address:** 333 Burma Road**City:** Oakland, CA 94607**Report No:** WIR-008613**Date Inspected:** 25-Jul-2009**Project Name:** SAS Superstructure**OSM Arrival Time:** 1900**Prime Contractor:** American Bridge/Fluor Enterprises, a JV**OSM Departure Time:** 700**Contractor:** Zhenhua Port Machinery Company, Ltd (ZPMC), Changxing Island **Location:** Shanghai, China**CWI Name:** Li Jia, Du Zhi Gun**CWI Present:** Yes No**Inspected CWI report:** Yes No N/A**Rod Oven in Use:** Yes No N/A**Electrode to specification:** Yes No N/A**Weld Procedures Followed:** Yes No N/A**Qualified Welders:** Yes No N/A**Verified Joint Fit-up:** Yes No N/A**Approved Drawings:** Yes No N/A**Approved WPS:** Yes No N/A**Delayed / Cancelled:** Yes No N/A**Bridge No:** 34-0006**Component:** Tower & OBG**Summary of Items Observed:**

WELDING INSPECTION REPORT

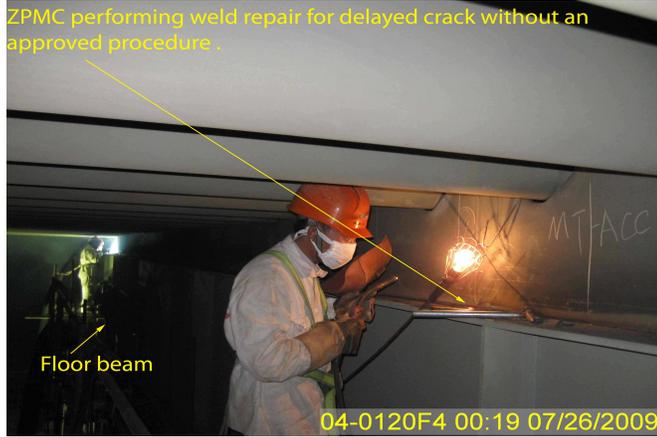
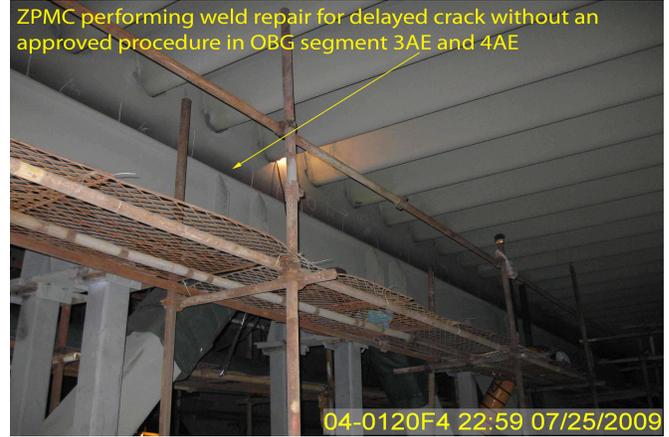
This Caltrans Quality Assurance Inspector (QA) observed that the Contractor is in the process of performing weld repairs without an approved procedure. The weld joints in question are being repaired due to what appears to be delayed transverse cracks discovered using Magnetic particle Testing (MT) at the trial assembly stage. These welds were previously tested and accepted using the MT method. This condition exists on OBG segment 3AE at PP21, PP22 and OBG segment 4AE at PP24, PP25, The weld joints are identified as SSD18-PP22-004, 005; SSD17A-PP21-004, 005; SSD20-PP25-004, 005; SSD19-PP24-005, 004. See the photos below for more information. For this issue incident report was issued.
