Quality Assurance and Source Inspection

Contract #: 04-0120F4Cty: SF/ALA Rte: 80 PM: 13.2/13.9File #: 13.28**WELDING INSPECTION REPORT****Resident Engineer:** Pursell, Gary**Address:** 333 Burma Road**City:** Oakland, CA 94607**Report No:** WIR-008624**Date Inspected:** 20-Aug-2009**Project Name:** SAS Superstructure**OSM Arrival Time:** 700**Prime Contractor:** American Bridge/Fluor Enterprises, a JV**OSM Departure Time:** 1530**Contractor:** Oregon Iron Works Clackamas, Or.**Location:** Clackamas, OR**CWI Name:** Mike Gregson, Jose Salazar**CWI Present:** Yes No**Inspected CWI report:** Yes No N/A**Rod Oven in Use:** Yes No N/A**Electrode to specification:** Yes No N/A**Weld Procedures Followed:** Yes No N/A**Qualified Welders:** Yes No N/A**Verified Joint Fit-up:** Yes No N/A**Approved Drawings:** Yes No N/A**Approved WPS:** Yes No N/A**Delayed / Cancelled:** Yes No N/A**Bridge No:** 34-0006**Component:** Hinge K Pipe Beams**Summary of Items Observed:**

WELDING INSPECTION REPORT

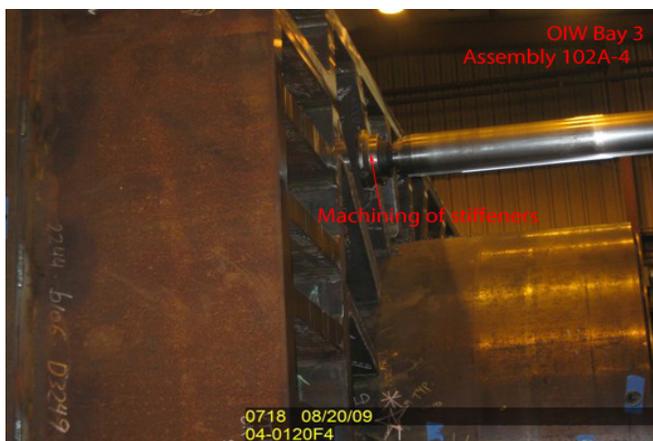
Hinge-K Pipe Beam Assembly 102A-4: 8/20/09

QA Inspector noticed that OIW had previously placed this forging assembly 102A-4 in position and was in-process of machining the completed stiffeners, utilizing a mechanical machining bit, as shown in attached picture below. QA Inspector had previously measured the stiffener heights to be approximately 662mm and noted that approximately 12mm of material (485W) was in process of being removed, to achieve a desired result of 650mm (+3mm/-10mm), which is in accordance to contract requirements. QA Inspector spoke with OIW machinist and OIW explained that the mechanical machining bit was set to remove approximately 1/32" (.8mm) of material (485W), per each cutting pass. QA Inspector noted that once the machining process is complete, OIW will perform dimensional measurements utilizing a laser tracker, prior to fitting the a109 (Post Tension Cap) plates.
