Contract #: 04-0120F4Cty: SF/ALA Rte: 80 PM: 13.2/13.9File #: 13.28**WELDING INSPECTION REPORT****Resident Engineer:** Pursell, Gary**Address:** 333 Burma Road**City:** Oakland, CA 94607**Report No:** WIR-008646**Date Inspected:** 25-Aug-2009**Project Name:** SAS Superstructure**OSM Arrival Time:** 1400**Prime Contractor:** American Bridge/Fluor Enterprises, a JV**OSM Departure Time:** 2230**Contractor:** Oregon Iron Works Clackamas, Or.**Location:** Clackamas, OR

Bridge No: 34-0006**Component:** Hinge-K Components**Summary of Items Observed:**

Hinge-K Pipe Beam Base Assembly 102A-2:

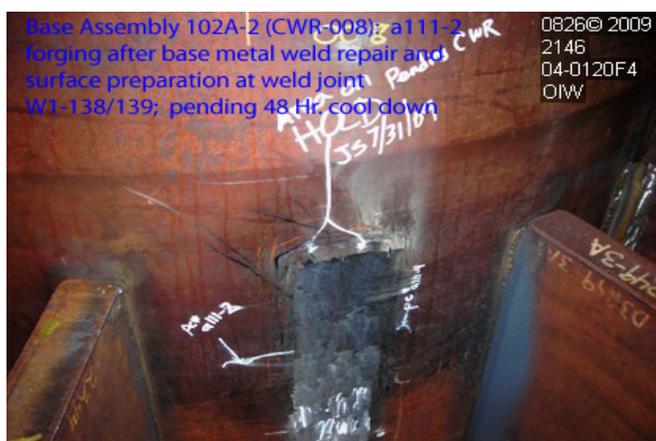
The QA Inspector was notified upon arrival by day shift QA Inspector Sean Vance that OIW personnel had initiated base metal repair at two locations on a111-2 forging identified in Critical weld Repair report 8 (CWR-008). CWR-008 consists of two areas (weld joints W1-147 & W1-138/139) on the forging where broken tacks were identified and removed and subsequently found to contain linear indications in the base metal. The areas had been previously excavated and prepared for repair welding in accordance with the approved CWR report.

MT had been performed by QC and QA at the excavated and prepared locations and found to be free of relevant indications (ref. TL-6028-8/19/09). Mr. Vance indicated that the work was underway at shift turnover and in fact repair at weld joint W1-147 was substantially complete. The QA Inspector subsequently randomly observed as OIW welder Phuong Huynh (WID H4) performed Flux Core Arc Welding (FCAW) at excavation located at weld joint W1-138/139. Mr. Huynh was observed welding in the vertical (3G) position in accordance with approved OIW Welding Procedure Specification (WPS) 3048. Continuous preheat was maintained utilizing a torch. The QA Inspector observed OIW QC Inspector Bill Buck regularly monitoring and recording the in process FCAW parameters. Post-weld heat treatment (PWHT) was subsequently applied at affected area at temperatures between

230° C and 315° C for two hours per approved CWR report. The QA Inspector intermittently monitored post-heat utilizing the appropriate temp-stick. CWR-008 appeared to be completed in general compliance with relevant contract documents.

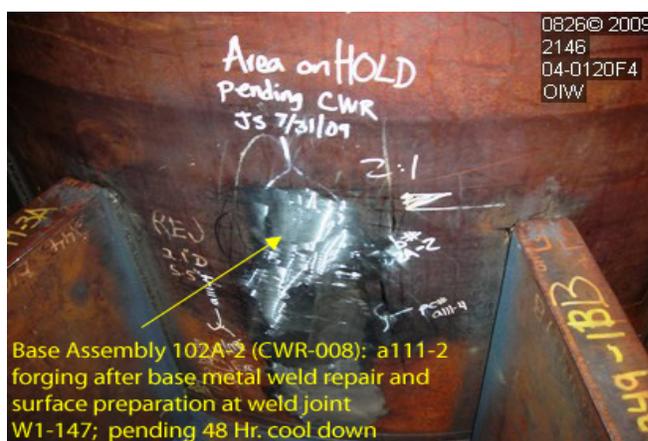
The QA Inspector intermittently monitored OIW welder Phuong Huynh (WID H4) as he engaged in grinding at interior weld terminations in an attempt to achieve a 2:1 transition at these locations. Welder H4 was engaged in this activity for the remainder of the shift after completion of CWR-008.

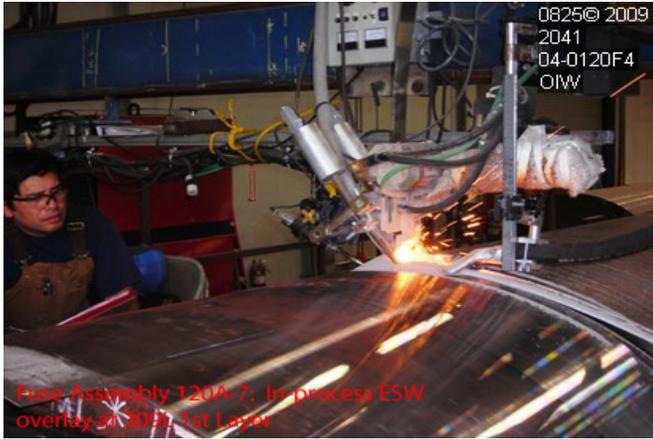
The QA Inspector intermittently observed OIW qualified welder Vincent Vu (WID V7) during in-process welding of Soudotape 309L stainless steel overlay to hinge k pipe beam fuse sub-assembly 120A-7. The weld joint is identified as 309L 1st Layer. Mr. Savanh was observed welding in the flat position utilizing automatic electro slag welding (ESW) overlay process with a .5mm x 60mm Soudotape 309L stainless electrode, filler metal brand Soudotape class EQ309L automatic. An OIW helper was observed assisting welder V7 during ESW activity. The QA Inspector observed OIW QC Inspector Bill Buck regularly monitoring and recording the in process ESW parameters. The QA Inspector also intermittently observed in process welding parameters and determined that the ESW parameters (1200 amps, 25.7 volts, 267mm/min travel speed) and minimum preheat temperature of 225° F appeared to be in general compliance with the contract requirements and approved OIW Welding Procedure Specification (WPS) 7003.
