Contract #: 04-0120F4Cty: SF/ALA Rte: 80 PM: 13.2/13.9File #: 13.28**WELDING INSPECTION REPORT****Resident Engineer:** Pursell, Gary**Address:** 333 Burma Road**City:** Oakland, CA 94607**Report No:** WIR-008683**Date Inspected:** 27-Aug-2009**Project Name:** SAS Superstructure**OSM Arrival Time:** 700**Prime Contractor:** American Bridge/Fluor Enterprises, a JV**OSM Departure Time:** 1530**Contractor:** Oregon Iron Works Clackamas, Or.**Location:** Clackamas, OR**CWI Name:** Mike Gregson, Jose Salazar**CWI Present:** Yes No**Inspected CWI report:** Yes No N/A**Rod Oven in Use:** Yes No N/A**Electrode to specification:** Yes No N/A**Weld Procedures Followed:** Yes No N/A**Qualified Welders:** Yes No N/A**Verified Joint Fit-up:** Yes No N/A**Approved Drawings:** Yes No N/A**Approved WPS:** Yes No N/A**Delayed / Cancelled:** Yes No N/A**Bridge No:** 34-0006**Component:** Hinge K Pipe Beams**Summary of Items Observed:**

## WELDING INSPECTION REPORT

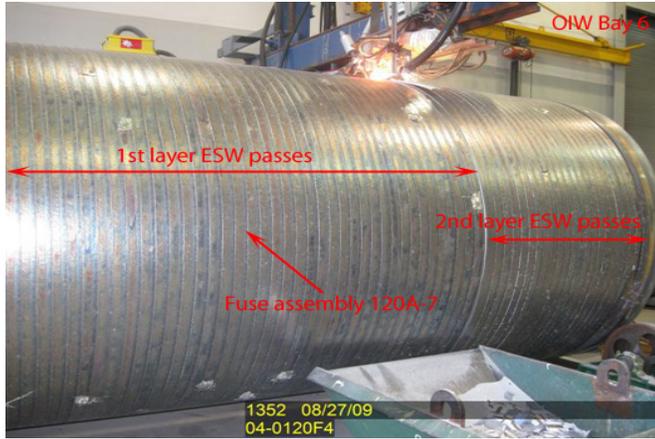
QA Inspector noticed that the first ESW stainless steel overlay passes complete and the second layer ESW passes were in-process, on this fuse assembly 120A-7. QA Inspector noted that the first electro slag welding (ESW) passes were completed in the flat position, utilizing Soudokay brand Soudotape 309L stainless steel consumable strip and the second layer electro slag welding (ESW) in-process passes, utilizing Soudokay brand Soudotape 316L stainless steel consumable strip, per contract requirements. QA Inspector randomly noticed QC Inspector’s Mike Gregson and Jose Salazar were present, to verify in-process welding parameters (amps/volts) and monitor in-process continuous pre-heat temperatures. QA Inspector spoke with QC Inspector Jose Salazar and Mr. Salazar explained that welding amps were recorded as 1200 amps/25.2 volts, travel speed at 248mm/min. and a pre-heat temperature recorded at 225 Fahrenheit (100 C). QA Inspector verified Mr. Igor Frolov was currently qualified for this welding process/position, verified amps/volts (1200/25.2) and randomly recorded pre-heat temperatures of approximately 225 Fahrenheit. QA Inspector noted that Mr. Igor Frolov appeared to be in compliance with the applicable approved welding procedure specification (WPS 7003). See attached picture below.
