Quality Assurance and Source Inspection

Contract #: 04-0120F4Cty: SF/ALA Rte: 80 PM: 13.2/13.9File #: 69.28**WELDING INSPECTION REPORT****Resident Engineer:** Pursell, Gary**Address:** 333 Burma Road**City:** Oakland, CA 94607**Report No:** WIR-008690**Date Inspected:** 26-Aug-2009**Project Name:** SAS Superstructure**OSM Arrival Time:** 700**Prime Contractor:** American Bridge/Fluor Enterprises, a JV**OSM Departure Time:** 1900**Contractor:** Zhenhua Port Machinery Company, Ltd (ZPMC), Changxing Island **Location:** Shanghai, China**CWI Name:** Lv Li Qing / Shen Fu You**CWI Present:** Yes No**Inspected CWI report:** Yes No N/A**Rod Oven in Use:** Yes No N/A**Electrode to specification:** Yes No N/A**Weld Procedures Followed:** Yes No N/A**Qualified Welders:** Yes No N/A**Verified Joint Fit-up:** Yes No N/A**Approved Drawings:** Yes No N/A**Approved WPS:** Yes No N/A**Delayed / Cancelled:** Yes No N/A**Bridge No:** 34-0006**Component:** OBG Assembly**Summary of Items Observed:**

OBG Assembly Bay 14

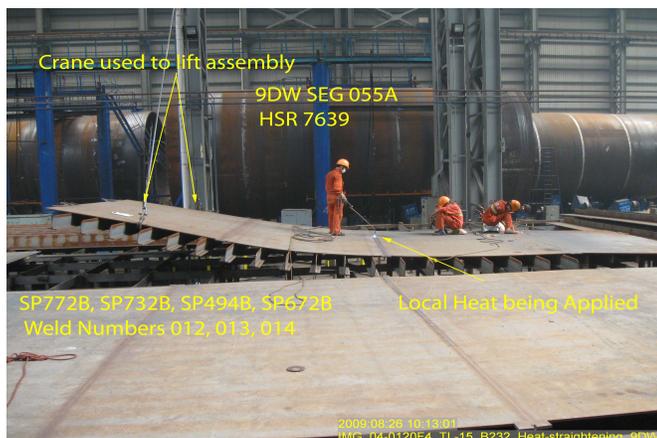
This Quality Assurance Inspector (QA) observed that the contractor is deviating from the AWS D1.5 Code requirements for heat straightening. The contractor is using an overhead crane to lift one end of a side panel while local heat is being applied. ZPMC Heat Straightening Report (HSR) number is 7639. The side panel super assembly is going in assembly 9DW SEG 055A the Side Panels are SP772B, SP732B, SP494B, SP672B the weld in the photograph that heat is being applied to is Weld Number 013. An incident report will be written on this issue. See photograph for additional information.
