Contract #: 04-0120F4Cty: SF/ALA Rte: 80 PM: 13.2/13.9File #: 13.28**WELDING INSPECTION REPORT****Resident Engineer:** Pursell, Gary**Address:** 333 Burma Road**City:** Oakland, CA 94607**Report No:** WIR-008695**Date Inspected:** 28-Aug-2009**Project Name:** SAS Superstructure**OSM Arrival Time:** 1400**Prime Contractor:** American Bridge/Fluor Enterprises, a JV**OSM Departure Time:** 2230**Contractor:** Oregon Iron Works Clackamas, Or.**Location:** Clackamas, OR**CWI Name:** Mike Gregson, Jose Salazar**CWI Present:** Yes No**Inspected CWI report:** Yes No N/A**Rod Oven in Use:** Yes No N/A**Electrode to specification:** Yes No N/A**Weld Procedures Followed:** Yes No N/A**Qualified Welders:** Yes No N/A**Verified Joint Fit-up:** Yes No N/A**Approved Drawings:** Yes No N/A**Approved WPS:** Yes No N/A**Delayed / Cancelled:** Yes No N/A**Bridge No:** 34-0006**Component:** Hinge K Pipe Beams**Summary of Items Observed:**

Hinge-K Pipe Beam Assembly 102A-1: 8/28/09

Hinge-K Pipe Beam Fuse Assembly 120A-7: 8/28/09

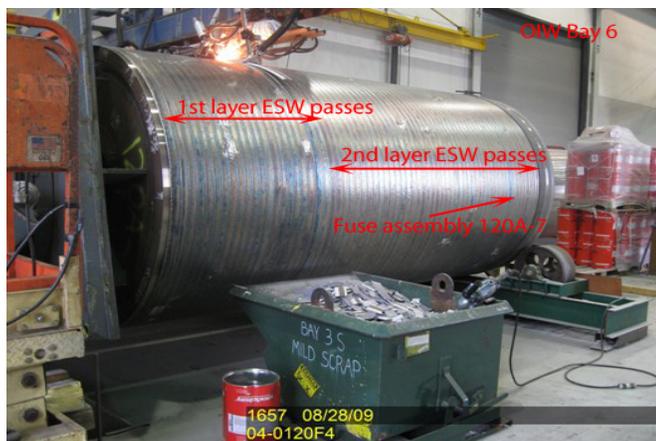
QA Inspector noticed that the second ESW stainless steel overlay passes were in-process, on this fuse assembly 120A-7. QA Inspector witnessed welder #V7, Mr. Vincent Vue performing electro slag welding (ESW) on the second layer welding passes, (approximately 75% complete), in the flat position, utilizing Soudokay brand Soudotape 316L stainless steel consumable strip. QA Inspector noted the first layer passes were completed utilizing the 309L consumable strip and the remaining second (in-process) & third layer passes would be completed utilizing Soudokay brand Soudotape 316L stainless steel consumable strip, per contract requirements. QA Inspector randomly noticed QC Inspector William Buck was present, to verify in-process welding parameters (amps/volts) and monitor in-process continuous pre-heat temperatures. QA Inspector spoke with QC Inspector William Buck and Mr. Buck explained that welding amps were recorded as 1200 amps/25.2 volts, travel speed at 241mm/min. and a pre-heat temperature recorded at 70 Fahrenheit (21 C). QA Inspector verified Mr. Vincent Vue was currently qualified for this welding process/position and randomly recorded pre-heat temperatures of approximately 70 Fahrenheit (21 C). QA Inspector noted that Mr. Vincent Vue appeared to be in compliance with the applicable approved welding procedure specification (WPS 7003). See attached picture below.
