Contract #: 04-0120F4Cty: SF/ALA Rte: 80 PM: 13.2/13.9File #: 13.28**WELDING INSPECTION REPORT****Resident Engineer:** Pursell, Gary**Address:** 333 Burma Road**City:** Oakland, CA 94607**Report No:** WIR-008760**Date Inspected:** 31-Aug-2009**Project Name:** SAS Superstructure**OSM Arrival Time:** 700**Prime Contractor:** American Bridge/Fluor Enterprises, a JV**OSM Departure Time:** 1530**Contractor:** Oregon Iron Works Clackamas, Or.**Location:** Clackamas, OR**CWI Name:** Mike Gregson, Jose Salazar**CWI Present:** Yes No**Inspected CWI report:** Yes No N/A**Rod Oven in Use:** Yes No N/A**Electrode to specification:** Yes No N/A**Weld Procedures Followed:** Yes No N/A**Qualified Welders:** Yes No N/A**Verified Joint Fit-up:** Yes No N/A**Approved Drawings:** Yes No N/A**Approved WPS:** Yes No N/A**Delayed / Cancelled:** Yes No N/A**Bridge No:** 34-0006**Component:** Hinge K Pipe Beams**Summary of Items Observed:**

Hinge-K Pipe Beam Assembly 102A-1: 8/31/09

Hinge-K Pipe Beam Assembly 102A-4: 8/31/09

Hinge-K Pipe Beam Fuse Assembly 120A-7: 8/31/09

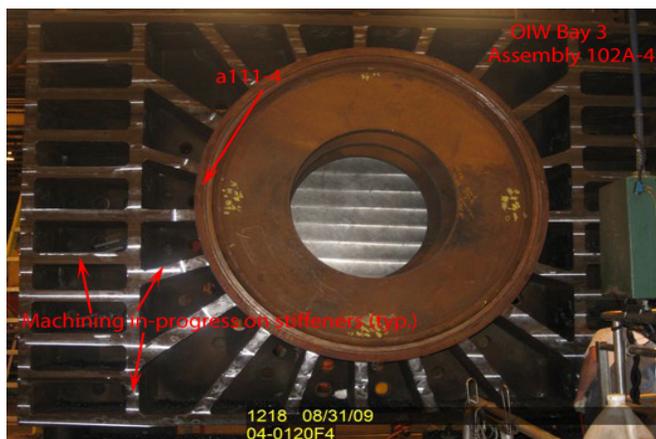
QA Inspector noticed that OIW production personell were grinding and performing weld clean-up, on the PJP and fillet welds stiffeners to a111-1 forging and a107/b106 stiffeners. QA Inspector spoke with lead QC Inspector Mike Gregson and Mr. Gregson explained that OIW production personell continuing to blend the weld start/stops, removing weld spatter and repairing undersize welds in specific areas, which were previously marked by QC Inspector Jose Salazar. Mr. Gregson also explained that the completed fillet and PJP welds on the radial stiffeners, which were found to be visually acceptable per AWS D1.5 and contract requirements, were in process of 100% magnetic particle inspection by QC Inspector Jose Salazar. QA Inspector noted that the in-process visual and magnetic particle testing by OIW QC Inspectors appeared to be in compliance with AWS D1.5 and contract requirements. See attached picture below.

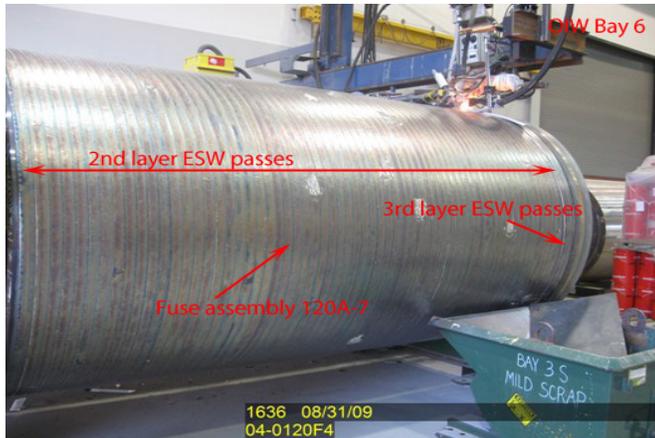
QA Inspector noticed that the first/second ESW stainless steel overlay passes were complete and welder #F17, Mr. Igor Frolov, was in-process of performing the third layer ESW passes, on this fuse assembly 120A-7. QA Inspector noted that the first electro slag welding (ESW) passes were completed in the flat position, utilizing Soudokay brand Soudotape 309L stainless steel consumable strip and the second/third layer (in-process) electro slag welding (ESW) passes, utilizing Soudokay brand Soudotape 316L stainless steel consumable strip, per contract requirements. QA Inspector randomly noticed QC Inspector's Mike Gregson and Jose Salazar were present, to verify in-process welding parameters (amps/volts) and monitor in-process continuous pre-heat temperatures. QA Inspector spoke with QC Inspector Jose Salazar and Mr. Salazar explained that welding amps were recorded as 1150 amps/25.2 volts, travel speed at 241mm/min. and a pre-heat temperature recorded at 70 Fahrenheit (21 C). QA Inspector verified Mr. Igor Frolov was currently qualified for this welding process/position, verified amps/volts (1150/25.2) and randomly recorded pre-heat temperatures of approximately 70 Fahrenheit (21C). QA Inspector noted that Mr. Igor Frolov appeared to be in compliance with the applicable approved welding procedure specification (WPS 7003). See attached picture below.
