Contract #: 04-0120F4Cty: SF/ALA Rte: 80 PM: 13.2/13.9File #: 69.28**WELDING INSPECTION REPORT****Resident Engineer:** Pursell, Gary**Address:** 333 Burma Road**City:** Oakland, CA 94607**Report No:** WIR-008781**Date Inspected:** 06-Sep-2009**Project Name:** SAS Superstructure**OSM Arrival Time:** 700**Prime Contractor:** American Bridge/Fluor Enterprises, a JV**OSM Departure Time:** 1900**Contractor:** Zhenhua Port Machinery Company, Ltd (ZPMC), Changxing Island **Location:** Shanghai, China

Bridge No: 34-0006**Component:** Crossbeams**Summary of Items Observed:**

WELDING INSPECTION REPORT

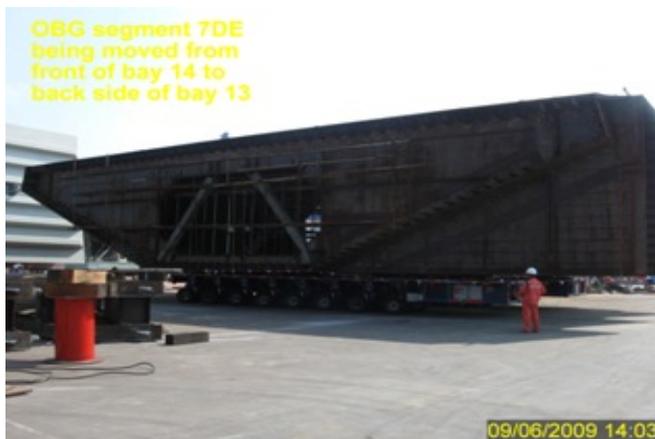
This QA observed ZPMC personnel moving this segment from the front of bay 14 to the backside of bay 13. No other significant work was observed on this segment during the time QA was present.
