DEPARTMENT OF TRANSPORTATION

Contract #: 04-0120F4Cty: SF/ALA Rte: 80 PM: 13.2/13.9File #: 13.28**WELDING INSPECTION REPORT****Resident Engineer:** Pursell, Gary**Address:** 333 Burma Road**City:** Oakland, CA 94607**Report No:** WIR-008904**Date Inspected:** 14-Sep-2009**Project Name:** SAS Superstructure**OSM Arrival Time:** 1300**Prime Contractor:** American Bridge/Fluor Enterprises, a JV**OSM Departure Time:** 2130**Contractor:** Oregon Iron Works Clackamas, Or.**Location:** Clackamas, OR**CWI Name:** Mike Gregson, Jose Salazar**CWI Present:** Yes No**Inspected CWI report:** Yes No N/A**Rod Oven in Use:** Yes No N/A**Electrode to specification:** Yes No N/A**Weld Procedures Followed:** Yes No N/A**Qualified Welders:** Yes No N/A**Verified Joint Fit-up:** Yes No N/A**Approved Drawings:** Yes No N/A**Approved WPS:** Yes No N/A**Delayed / Cancelled:** Yes No N/A**Bridge No:** 34-0006**Component:** Hinge K Pipe Beams**Summary of Items Observed:**

Hinge-K Pipe Beam Assembly 102A-1: 9/14/09

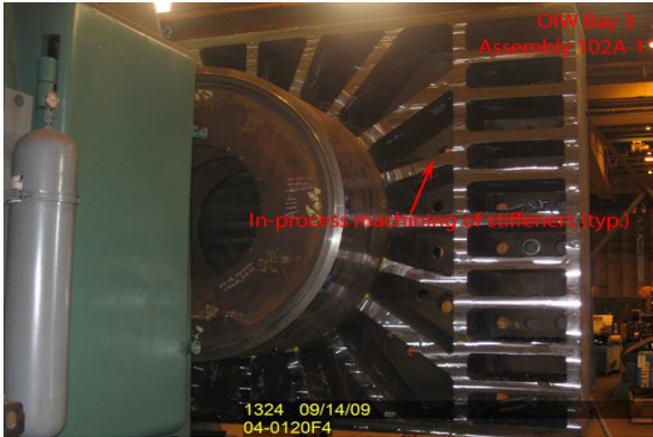
QA Inspector noticed that OIW had previously placed this forging assembly 102A-1 in position and was in-process of machining the completed stiffeners, utilizing a mechanical machining bit. QA Inspector had previously measured the stiffener heights to be approximately 662mm and noted that approximately 12mm of material (485W) was in process of being removed, to achieve a desired result of 650mm (+3mm/-10mm), which is in accordance to contract requirements. QA Inspector had previously spoken with OIW machinist and OIW explained that the mechanical machining bit was set to remove approximately 1/32" (.8mm) of material (485W), per each cutting pass. QA Inspector noted that once the machining process is complete, OIW will perform dimensional measurements utilizing a laser tracker, prior to fitting the a109 (Post Tension Cap) plates. See attached picture below.
