Contract #: 04-0120F4Cty: SF/ALA Rte: 80 PM: 13.2/13.9File #: 69.28**WELDING INSPECTION REPORT****Resident Engineer:** Pursell, Gary**Address:** 333 Burma Road**City:** Oakland, CA 94607**Report No:** WIR-008972**Date Inspected:** 09-Sep-2009**Project Name:** SAS Superstructure**OSM Arrival Time:** 1845**Prime Contractor:** American Bridge/Fluor Enterprises, a JV**OSM Departure Time:** 645**Contractor:** Zhenhua Port Machinery Company, Ltd (ZPMC), Changxing Island **Location:** Shanghai, China**CWI Name:** Wan Wen Zhong**CWI Present:** Yes No**Inspected CWI report:** Yes No N/A**Rod Oven in Use:** Yes No N/A**Electrode to specification:** Yes No N/A**Weld Procedures Followed:** Yes No N/A**Qualified Welders:** Yes No N/A**Verified Joint Fit-up:** Yes No N/A**Approved Drawings:** Yes No N/A**Approved WPS:** Yes No N/A**Delayed / Cancelled:** Yes No N/A**Bridge No:** 34-0006**Component:** OBG and Tower**Summary of Items Observed:**

WELDING INSPECTION REPORT

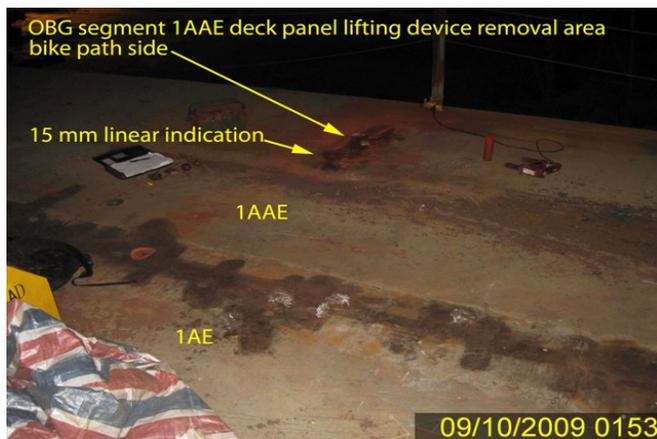
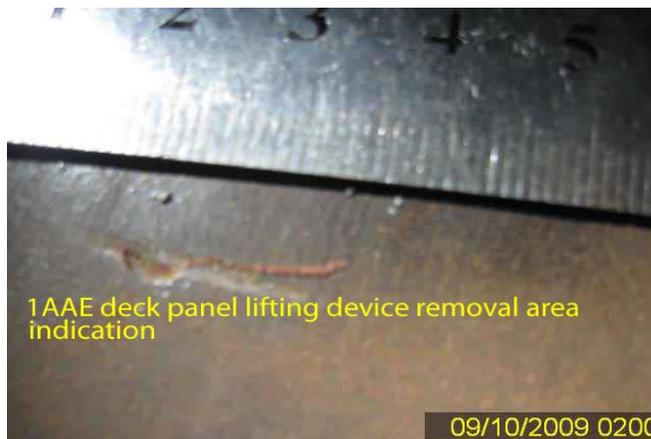
During Magnetic Particle Testing (MT) verification, this Quality Control Inspector discovered a linear indication measuring approximately 15 mm in length in the base material of OBG Segment 1AAE deck panel lifting device weld removal area. The indication was located 8770 mm from the edge plate to deck panel weld on the bike path side. The base material at the lifting device removal area had been previously tested and accepted by ZPMC Quality Control (QC). Caltrans QA submitted an incident report this date for the above mentioned MT indication. Please see the attached photos.
