**DEPARTMENT OF TRANSPORTATION**

Contract #: 04-0120F4Cty: SF/ALA Rte: 80 PM: 13.2/13.9File #: 13.28**WELDING INSPECTION REPORT****Resident Engineer:** Pursell, Gary**Address:** 333 Burma Road**City:** Oakland, CA 94607**Report No:** WIR-008991**Date Inspected:** 15-Sep-2009**Project Name:** SAS Superstructure**OSM Arrival Time:** 1300**Prime Contractor:** American Bridge/Fluor Enterprises, a JV**OSM Departure Time:** 2130**Contractor:** Oregon Iron Works Clackamas, Or.**Location:** Clackamas, OR

Hinge-K Pipe Beam Assembly 102A-1: 9/15/09

OIW Fabrication Shop-Bay 6 (ESW Overlay Process)

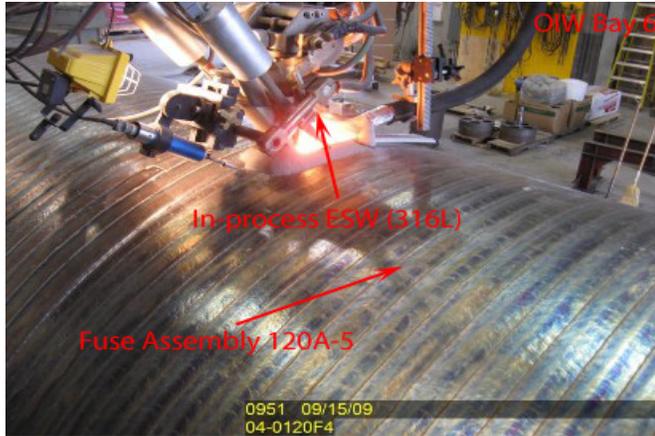
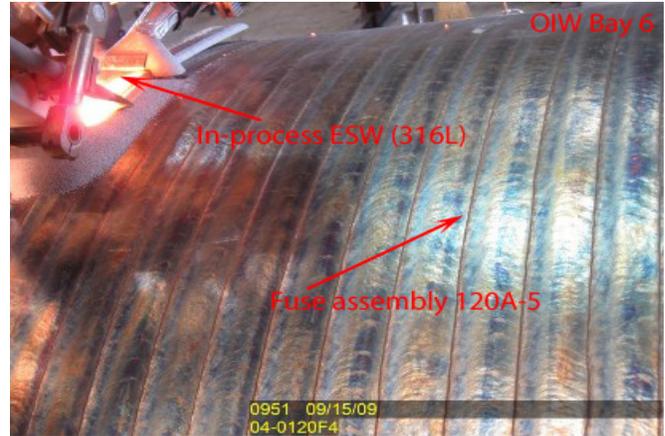
QA Inspector noticed that the second ESW stainless steel overlay passes were in-process, on this fuse assembly 120A-5. QA Inspector witnessed welder #F17, Mr. Igor Frolov performing electro slag welding (ESW) on the second layer welding passes, (approximately 75% complete), in the flat position, utilizing Soudokay brand Soudotape 316L stainless steel consumable strip. QA Inspector noted the first layer passes were completed utilizing the 309L consumable strip and the remaining second (in-process) & third layer passes would be completed utilizing Soudokay brand Soudotape 316L stainless steel consumable strip, per contract requirements. QA Inspector randomly noticed QC Inspector's Mike Gregson and Jose Salazar were present, to verify in-process welding parameters (amps/volts) and monitor in-process continuous pre-heat temperatures. QA Inspector spoke with QC Inspector Jose Salazar and Mr. Salazar explained that welding amps were recorded as 1200 amps/25.2 volts, travel speed at 269mm/min. and a pre-heat temperature recorded at 225 Fahrenheit (107 C). QA Inspector verified in-process welding parameters of 1200 amps/25.2 volts and recorded pre-heat temperatures of approximately 225 Fahrenheit (107 C) QA Inspector verified Mr. Igor Frolov was currently qualified for this welding process/position and randomly recorded pre-heat temperatures of approximately 225 Fahrenheit. QA Inspector noted that Mr. Igor Frolov appeared to be in compliance with the applicable approved welding procedure specification (WPS 7003). See attached picture below.
