Quality Assurance and Source Inspection

Contract #: 04-0120F4Cty: SF/ALA Rte: 80 PM: 13.2/13.9File #: 13.28**WELDING INSPECTION REPORT****Resident Engineer:** Pursell, Gary**Address:** 333 Burma Road**City:** Oakland, CA 94607**Report No:** WIR-009197**Date Inspected:** 23-Sep-2009**Project Name:** SAS Superstructure**OSM Arrival Time:** 700**Prime Contractor:** American Bridge/Fluor Enterprises, a JV**OSM Departure Time:** 1530**Contractor:** Oregon Iron Works Clackamas, Or.**Location:** Clackamas, OR**CWI Name:** Mike Gregson, Jose Salazar**CWI Present:** Yes No**Inspected CWI report:** Yes No N/A**Rod Oven in Use:** Yes No N/A**Electrode to specification:** Yes No N/A**Weld Procedures Followed:** Yes No N/A**Qualified Welders:** Yes No N/A**Verified Joint Fit-up:** Yes No N/A**Approved Drawings:** Yes No N/A**Approved WPS:** Yes No N/A**Delayed / Cancelled:** Yes No N/A**Bridge No:** 34-0006**Component:** Hinge K Pipe Beams**Summary of Items Observed:**

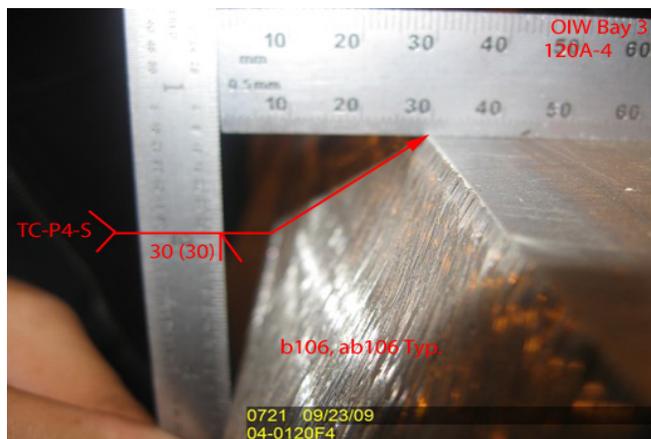
QA Inspector noticed that Mr. Troy Smith had completed the grinding (utilizing a mechanical grinder), the bevel prep, on the b106/ab106 stiffener plates, in preparation for fitting the a109 Post Tension Cap plate. QA Inspector previously reviewed the applicable OIW approved drawings and noted that this was a partial joint penetration (PJP AWS D1.5 TC-P4-S), 60 degree bevel prep angle, zero root opening, with a 30mm weld size. QA Inspector randomly measured the completed bevel prep angle on the b106 stiffener plate, utilizing a bridge cam gauge and noted the angle to be 60 degrees, with a 30mm weld size, which appears to be in compliance with AWS D1.5 and contract requirements. See attached pictures below.
