DEPARTMENT OF TRANSPORTATION

Quality Assurance and Source Inspection

Contract #: 04-0120F4Cty: SF/ALA Rte: 80 PM: 13.2/13.9File #: 13.28**WELDING INSPECTION REPORT****Resident Engineer:** Pursell, Gary**Address:** 333 Burma Road**City:** Oakland, CA 94607**Report No:** WIR-009219**Date Inspected:** 24-Sep-2009**Project Name:** SAS Superstructure**OSM Arrival Time:** 700**Prime Contractor:** American Bridge/Fluor Enterprises, a JV**OSM Departure Time:** 1530**Contractor:** Oregon Iron Works Clackamas, Or.**Location:** Clackamas, OR**CWI Name:** Mike Gregson, Jose Salazar**CWI Present:** Yes No**Inspected CWI report:** Yes No N/A**Rod Oven in Use:** Yes No N/A**Electrode to specification:** Yes No N/A**Weld Procedures Followed:** Yes No N/A**Qualified Welders:** Yes No N/A**Verified Joint Fit-up:** Yes No N/A**Approved Drawings:** Yes No N/A**Approved WPS:** Yes No N/A**Delayed / Cancelled:** Yes No N/A**Bridge No:** 34-0006**Component:** Hinge K Pipe Beams**Summary of Items Observed:**

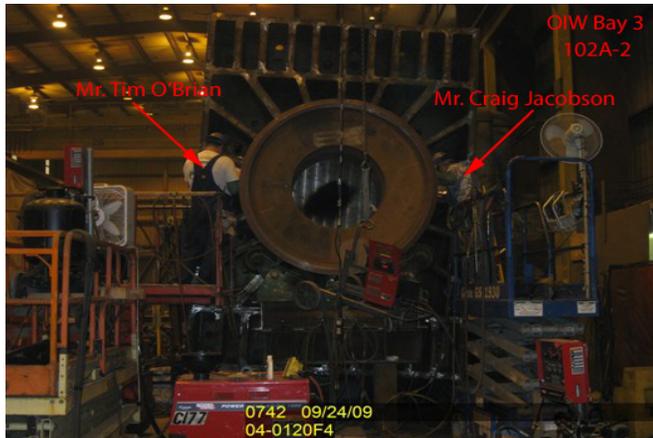
Hinge-K Pipe Beam Assembly 102A-2: 9/24/09

a111-2 Forging to a110-2 Base Plate

QA Inspector noticed that welder #O6, Mr. Tim O'Brian and #J6, Mr. Craig Jacobson, were in-process of grinding and performing weld clean-up, on the PJP and fillet welds stiffeners to a111-2 forging and a107/b106/ab106 stiffeners. QA Inspector spoke with lead QC Inspector Mike Gregson and Mr. Gregson explained that the blending and weld clean-up was being performed on the weld transitions and weld spatter/undersize welds were being repaired, which were previously marked by QC Inspector Jose Salazar. Mr. Gregson also explained that the completed fillet and PJP welds on the radial stiffeners, which were found to be visually acceptable per AWS D1.5 and contract requirements, were in process of 100% magnetic particle inspection by QC Inspector Jose Salazar. QA Inspector noted that the in-process visual and magnetic particle testing by OIW QC Inspectors appeared to be in compliance with AWS D1.5 and contract requirements. See attached picture below.

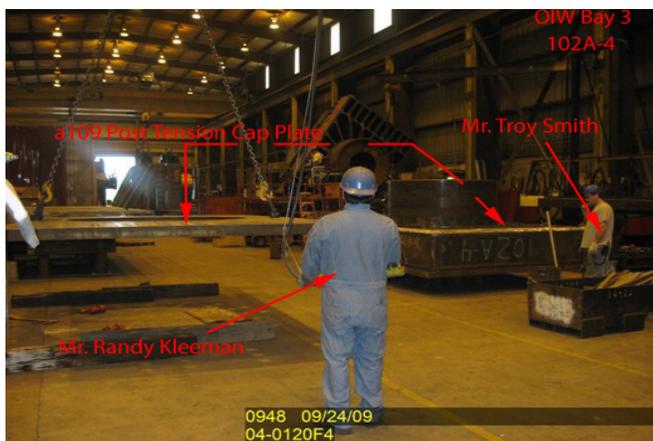
Hinge-K Pipe Beam Assembly 102A-4: 9/24/09

a111-4 Forging to a110-4 Base Plate

QA Inspector randomly witnessed OIW Lead, Mr. Troy Smith and Mr. Randy Kleeman were in-process of fitting

the a109 Post Tension Cap plate into position. Mr. Troy Smith explained to QA Inspector that once the a109 Cap plate was in-position and fit, a series of threaded bolts would be placed in the existing bolt holes and tightened, to eliminate the possibility of warping and distortion of the a109 Cap plate, during the FCAW tacking. See attached pictures below.

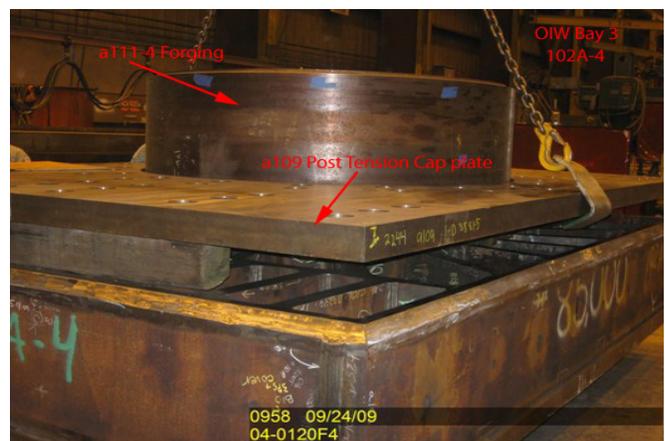
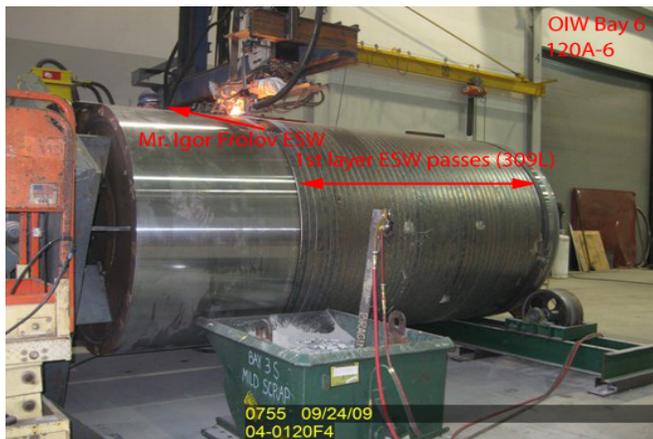
Hinge-K Pipe Beam Fuse Assembly 120A-6: 9/24/09

a124-14 Half Fuse to a124-2 Half Fuse

QA Inspector noticed that the first ESW stainless steel overlay passes were in-process, on this fuse assembly 120A-6. QA Inspector witnessed welder #F17, Mr. Igor Frolov performing electro slag welding (ESW) on the first layer welding passes, (approximately 75% complete), in the flat position, utilizing Soudokay brand Soudotape 309L stainless steel consumable strip. QA Inspector noted the first layer passes would be completed utilizing the 309L consumable strip and the remaining second & third layer passes would be completed utilizing Soudokay brand Soudotape 316L stainless steel consumable strip, per contract requirements. QA Inspector randomly noticed QC Inspector's Mike Gregson and Jose Salazar were present, to verify in-process welding parameters (amps/volts) and monitor in-process continuous pre-heat temperatures. QA Inspector spoke with QC Inspector Jose Salazar and Mr. Salazar explained that welding amps were recorded as 1200 amps/25.2 volts, travel speed at 269mm/min. and a pre-heat temperature recorded at 225 Fahrenheit (107 C). QA Inspector verified in-process welding parameters of 1200 amps/25.2 volts and recorded pre-heat temperatures of approximately 225 Fahrenheit (107 C) QA Inspector verified Mr. Igor Frolov was currently qualified for this welding process/position and randomly recorded pre-heat temperatures of approximately 225 degrees Fahrenheit (107 C). QA Inspector noted that Mr. Igor Frolov appeared to be in compliance with the applicable approved welding procedure specification (WPS 7003). See attached picture below.
