**DEPARTMENT OF TRANSPORTATION**

Contract #: 04-0120F4Cty: SF/ALA Rte: 80 PM: 13.2/13.9File #: 13.28**WELDING INSPECTION REPORT****Resident Engineer:** Pursell, Gary**Address:** 333 Burma Road**City:** Oakland, CA 94607**Report No:** WIR-009245**Date Inspected:** 28-Sep-2009**Project Name:** SAS Superstructure**OSM Arrival Time:** 700**Prime Contractor:** American Bridge/Fluor Enterprises, a JV**OSM Departure Time:** 1530**Contractor:** Oregon Iron Works Clackamas, Or.**Location:** Clackamas, OR**CWI Name:** Mike Gregson, Jose Salazar**CWI Present:** Yes No**Inspected CWI report:** Yes No N/A**Rod Oven in Use:** Yes No N/A**Electrode to specification:** Yes No N/A**Weld Procedures Followed:** Yes No N/A**Qualified Welders:** Yes No N/A**Verified Joint Fit-up:** Yes No N/A**Approved Drawings:** Yes No N/A**Approved WPS:** Yes No N/A**Delayed / Cancelled:** Yes No N/A**Bridge No:** 34-0006**Component:** Hinge K Pipe Beams**Summary of Items Observed:**

Hinge-K Pipe Beam Assembly 102A-2: 9/28/09

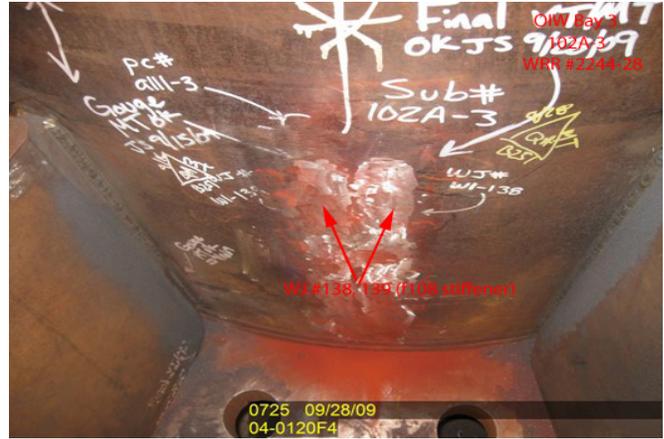
QA Inspector noticed that welder #O6, Mr. Tim O'Brian and #J6, Mr. Craig Jacobson, were in-process of grinding and performing weld clean-up, on the PJP and fillet welds stiffeners to a111-2 forging and a107/b106/ab106 stiffeners. QA Inspector spoke with lead QC Inspector Mike Gregson and Mr. Gregson explained that the blending and weld clean-up was being performed on the weld transitions and weld spatter/undersize welds were being repaired, which were previously marked by QC Inspector Jose Salazar. Mr. Gregson also explained that the completed fillet and PJP welds on the radial stiffeners, which were found to be visually acceptable per AWS D1.5 and contract requirements, were in process of 100% magnetic particle inspection by QC Inspector Jose Salazar. QA Inspector noted that the in-process visual and magnetic particle testing by OIW QC Inspectors appeared to be in compliance with AWS D1.5 and contract requirements. See attached picture below.

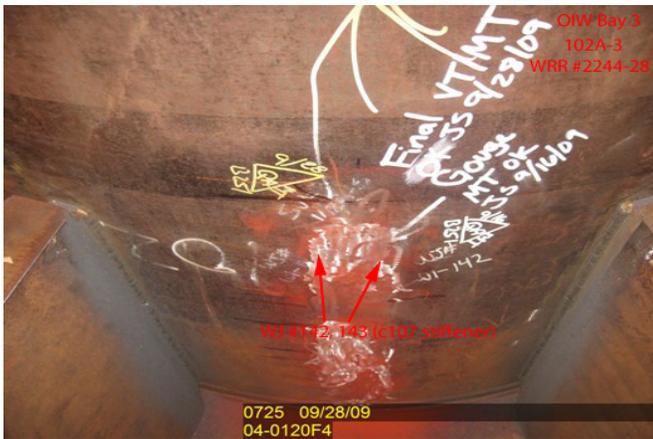
QA Inspector witnessed OIW QC Inspector Jose Salazar performing 100% visual and magnetic particle testing on

the completed weld repair (WRR #2244-28). QA Inspector later spoke with QC Inspector Jose Salazar and Mr. Salazar explained that no rejectable indications were found, per AWS D1.5 and the applicable welding procedure specification (WPS 3048). QA Inspector noted that the magnetic particle testing had been performed after the minimum 48hrs. cooling time. QA Inspector performed 100% visual and magnetic particle testing on the completed weld repair (WRR #2244-28), and found no rejectable indications, per AWS D1.5 and the applicable welding procedure specification (WPS 3048). QA Inspector notified Lead QC Inspector Mike Gregson of the testing results and completed the applicable magnetic testing report (TL6028). See attached pictures below. Note: QA Inspector previously noted that this non-critical weld repair was submitted by OIW after QC Inspector Jose Salazar had found multiple linear indications, utilizing magnetic particle testing, on the full length FCAW tacks and into the a111-3 forging base metal, on the following stiffeners: e108 (WJ #126, 127), f108 (WJ #138, 139), c107 (WJ #142, 143), e108 (WJ #146, 147) and d108 (WJ #148, 149). QA Inspector previously spoke with QC Inspector Jose Salazar and Mr. Salazar explained that the FCAW on weld joints, on the above mentioned weld joints, had been completed by OIW welder #J6, Mr. Craig Jacobson, post heat had previously been applied to the completed weld repair areas, with a recorded temperature of approximately 450 degrees Fahrenheit (232 C) and the welds were previously ground flush.
