DEPARTMENT OF TRANSPORTATION

Contract #: 04-0120F4Cty: SF/ALA Rte: 80 PM: 13.2/13.9File #: 13.28**WELDING INSPECTION REPORT****Resident Engineer:** Pursell, Gary**Address:** 333 Burma Road**City:** Oakland, CA 94607**Report No:** WIR-009274**Date Inspected:** 29-Sep-2009**Project Name:** SAS Superstructure**OSM Arrival Time:** 700**Prime Contractor:** American Bridge/Fluor Enterprises, a JV**OSM Departure Time:** 1530**Contractor:** Oregon Iron Works Clackamas, Or.**Location:** Clackamas, OR**CWI Name:** Mike Gregson, Jose Salazar**CWI Present:** Yes No**Inspected CWI report:** Yes No N/A**Rod Oven in Use:** Yes No N/A**Electrode to specification:** Yes No N/A**Weld Procedures Followed:** Yes No N/A**Qualified Welders:** Yes No N/A**Verified Joint Fit-up:** Yes No N/A**Approved Drawings:** Yes No N/A**Approved WPS:** Yes No N/A**Delayed / Cancelled:** Yes No N/A**Bridge No:** 34-0006**Component:** Hinge K Pipe Beams**Summary of Items Observed:**

WELDING INSPECTION REPORT

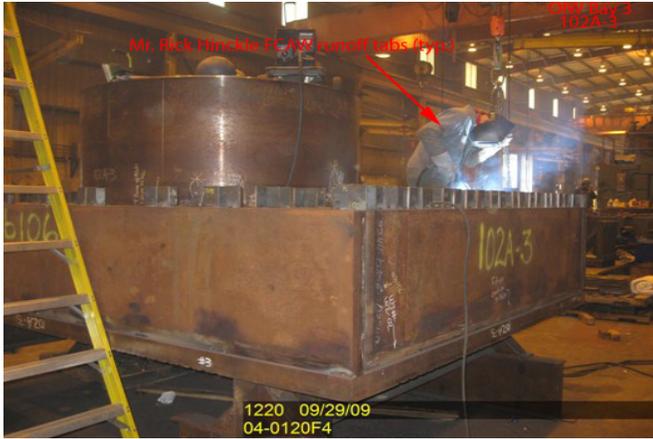
Note: QA Inspector noted that Mr. Rick Hinkle had completed the FCAW tacking of the above mentioned weld joints, later in the shift and had initiated the FCAW tacking on the weld run-off tabs, for the radial stiffeners, as shown in picture below. QA Inspector noted that the run-off tabs were probably be completed by end of shift and this assembly 102A-3 would eventually be placed in position for the SAW root passes on the radial stiffeners.

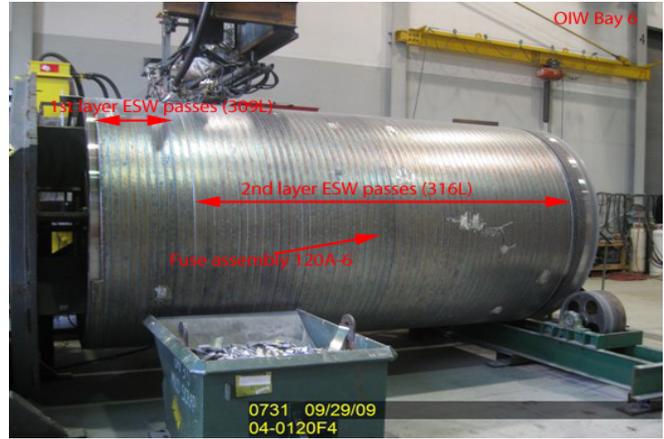
QA Inspector noticed that the second ESW stainless steel overlay passes were in-process, on this fuse assembly 120A-6. QA Inspector witnessed welder #F17, Mr. Igor Frolov performing electro slag welding (ESW) on the second layer welding passes, (approximately 90% complete), in the flat position, utilizing Soudokay brand Soudotape 316L stainless steel consumable strip. QA Inspector noted the first layer passes had previously been completed utilizing the 309L consumable strip and the remaining second (in-process) & third layer passes would be completed utilizing Soudokay brand Soudotape 316L stainless steel consumable strip, per contract requirements. QA Inspector randomly noticed QC Inspector's Mike Gregson and Jose Salazar were present, to verify in-process welding parameters (amps/volts) and monitor in-process continuous pre-heat temperatures. QA Inspector spoke with QC Inspector Jose Salazar and Mr. Salazar explained that welding amps were recorded as 1200 amps/25.2 volts, travel speed at 269mm/min. and a pre-heat temperature recorded at 70 degrees Fahrenheit (21 C). QA Inspector verified in-process welding parameters of 1200 amps/25.2 volts and recorded pre-heat temperatures of approximately 70 degrees Fahrenheit (21 C). QA Inspector verified Mr. Igor Frolov was currently qualified for this welding process/position and noted that Mr. Igor Frolov appeared to be in compliance with the applicable approved welding procedure specification (WPS 7003). See attached picture below.
