**DEPARTMENT OF TRANSPORTATION**

Quality Assurance and Source Inspection

Contract #: 04-0120F4Cty: SF/ALA Rte: 80 PM: 13.2/13.9File #: 69.28**WELDING INSPECTION REPORT****Resident Engineer:** Pursell, Gary**Address:** 333 Burma Road**City:** Oakland, CA 94607**Report No:** WIR-009295**Date Inspected:** 12-Sep-2009**Project Name:** SAS Superstructure**OSM Arrival Time:** 645**Prime Contractor:** American Bridge/Fluor Enterprises, a JV**OSM Departure Time:** 1845**Contractor:** Zhenhua Port Machinery Company, Ltd (ZPMC), Changxing Island **Location:** Shanghai, China**CWI Name:** Yu Dong Ping.**CWI Present:** Yes No**Inspected CWI report:** Yes No N/A**Rod Oven in Use:** Yes No N/A**Electrode to specification:** Yes No N/A**Weld Procedures Followed:** Yes No N/A**Qualified Welders:** Yes No N/A**Verified Joint Fit-up:** Yes No N/A**Approved Drawings:** Yes No N/A**Approved WPS:** Yes No N/A**Delayed / Cancelled:** Yes No N/A**Bridge No:** 34-0006**Component:** Tower Components**Summary of Items Observed:**

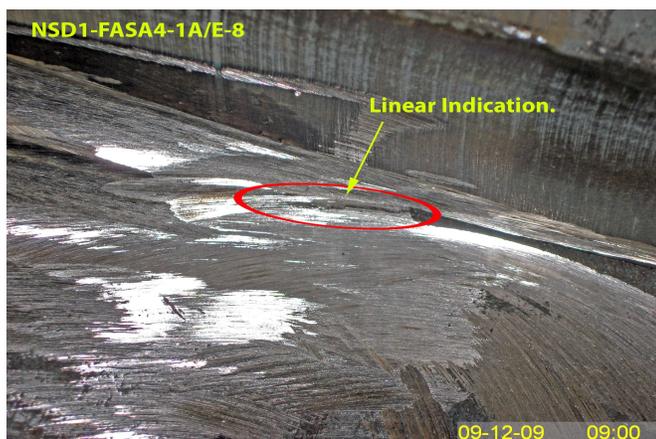
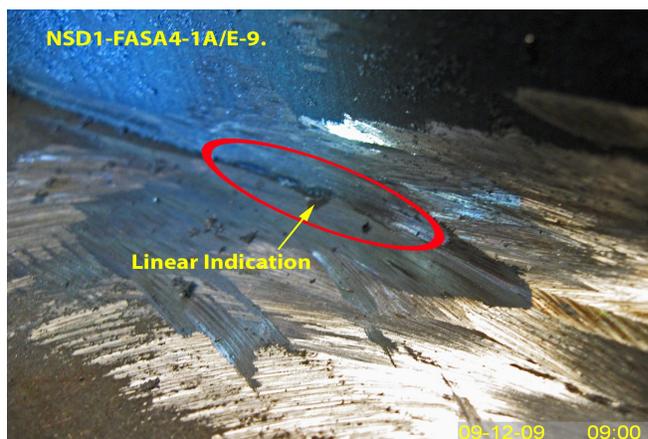
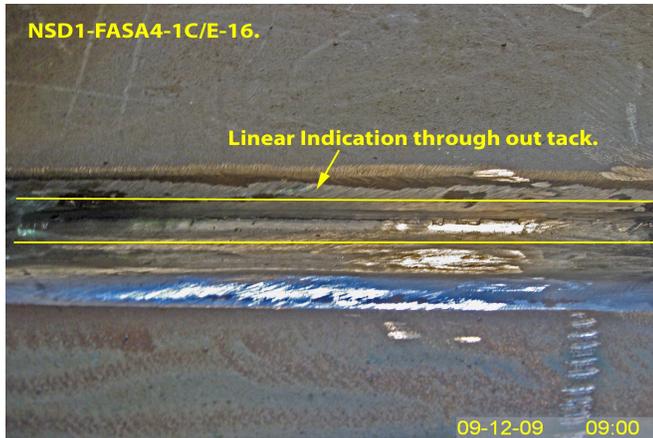
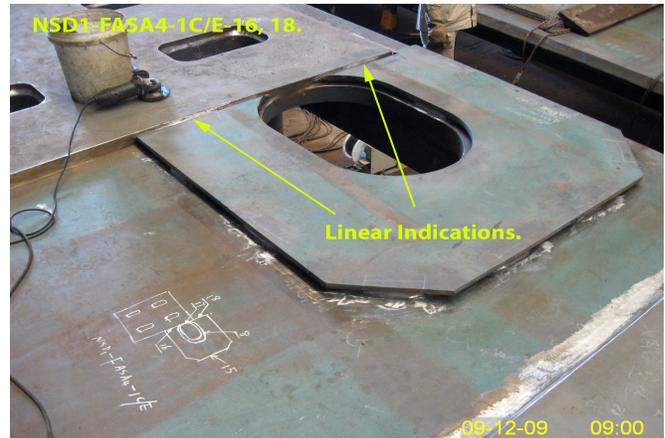
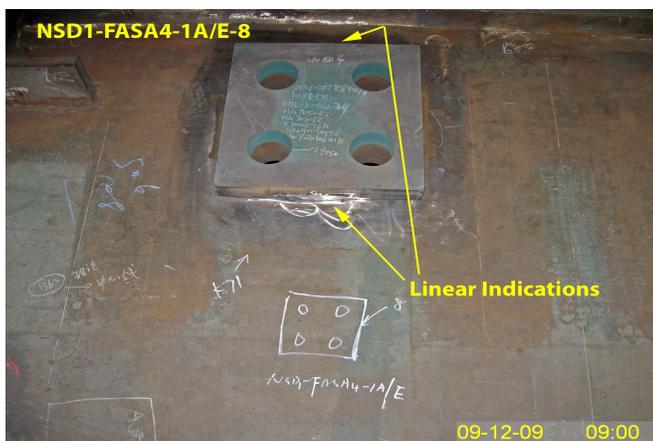
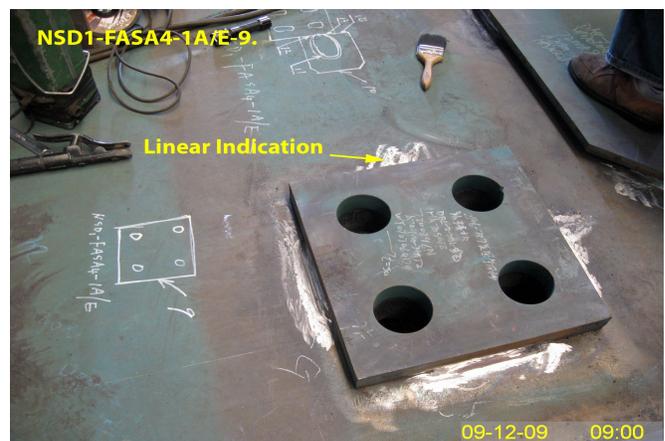
Bay 11, North Tower, Lift 4, Skin A.

During inprogress Visual Inspection this QA Inspector observed Cracke like Indications on Tack Welds on the Doubler Plates to Skin Plate Weld joints. ZPMC QA Ken has been informed about this. Since ZPMC have not carried out any inspection on the above mentioned part untill Caltrans QA found above mentioned Indications; so NO Incident report has been written about this. The attached photographs provide additional detail.
