DEPARTMENT OF TRANSPORTATION

Quality Assurance and Source Inspection

Contract #: 04-0120F4Cty: SF/ALA Rte: 80 PM: 13.2/13.9File #: 69.28**WELDING INSPECTION REPORT****Resident Engineer:** Pursell, Gary**Address:** 333 Burma Road**City:** Oakland, CA 94607**Report No:** WIR-009340**Date Inspected:** 28-Sep-2009**Project Name:** SAS Superstructure**OSM Arrival Time:** 645**Prime Contractor:** American Bridge/Fluor Enterprises, a JV**OSM Departure Time:** 1900**Contractor:** Zhenhua Port Machinery Company, Ltd (ZPMC), Changxing Island **Location:** Shanghai, China**CWI Name:** Chen fu you**CWI Present:** Yes No**Inspected CWI report:** Yes No N/A**Rod Oven in Use:** Yes No N/A**Electrode to specification:** Yes No N/A**Weld Procedures Followed:** Yes No N/A**Qualified Welders:** Yes No N/A**Verified Joint Fit-up:** Yes No N/A**Approved Drawings:** Yes No N/A**Approved WPS:** Yes No N/A**Delayed / Cancelled:** Yes No N/A**Bridge No:** 34-0006**Component:** OBG Components**Summary of Items Observed:**

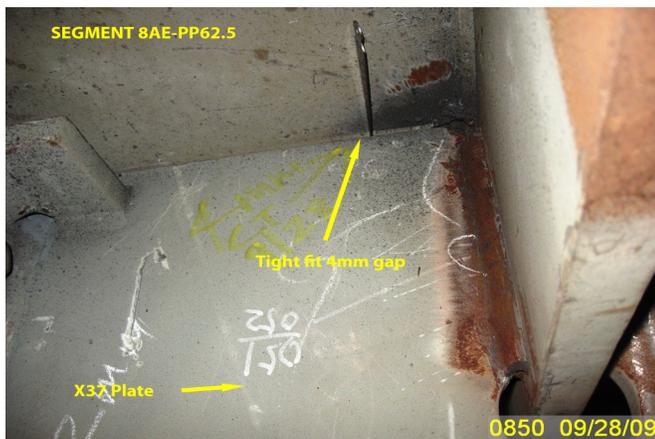
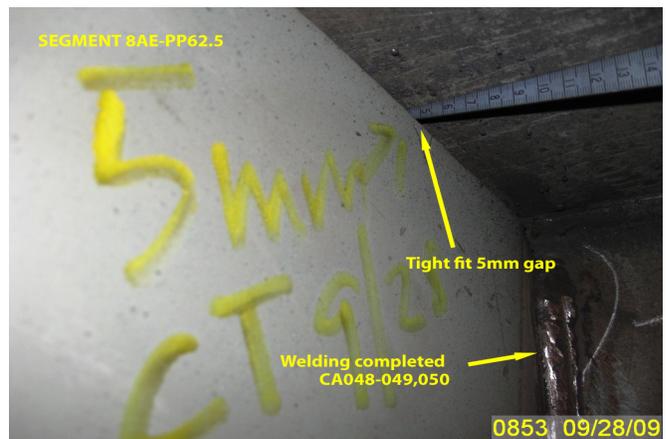
During visual inspection it is found that in Segment 8AE Corner assembly X37 plate the weld no Identified as CA048-049,050,051,052,053,054 , it needs Tight fit but in actual the gap between Deck plate and X37 is 4mm and 5mm. this is informed to ABF QA-Mr.Tang youqing. ZPMC QC-Mr.Wang xian pin.
