Contract #: 04-0120F4Cty: SF/ALA Rte: 80 PM: 13.2/13.9File #: 13.28**WELDING INSPECTION REPORT****Resident Engineer:** Pursell, Gary**Address:** 333 Burma Road**City:** Oakland, CA 94607**Report No:** WIR-009387**Date Inspected:** 01-Oct-2009**Project Name:** SAS Superstructure**OSM Arrival Time:** 700**Prime Contractor:** American Bridge/Fluor Enterprises, a JV**OSM Departure Time:** 1530**Contractor:** Oregon Iron Works Clackamas, Or.**Location:** Clackamas, OR**CWI Name:** Mike Gregson, Jose Salazar**CWI Present:** Yes No**Inspected CWI report:** Yes No N/A**Rod Oven in Use:** Yes No N/A**Electrode to specification:** Yes No N/A**Weld Procedures Followed:** Yes No N/A**Qualified Welders:** Yes No N/A**Verified Joint Fit-up:** Yes No N/A**Approved Drawings:** Yes No N/A**Approved WPS:** Yes No N/A**Delayed / Cancelled:** Yes No N/A**Bridge No:** 34-0006**Component:** Hinge K Pipe Beams**Summary of Items Observed:**

WELDING INSPECTION REPORT

Hinge-K Pipe Beam Fuse Assembly 120A-6: 10/1/09

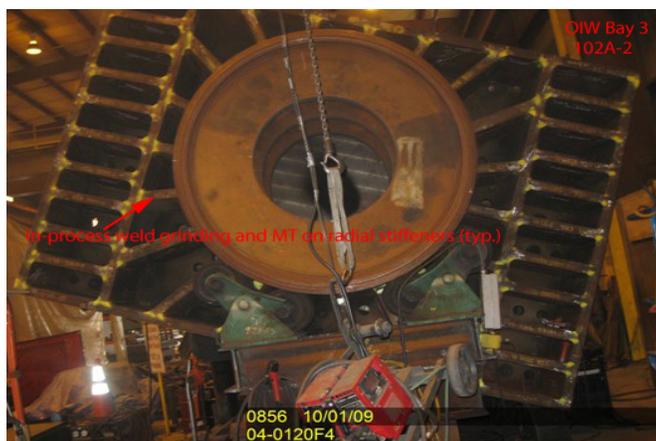
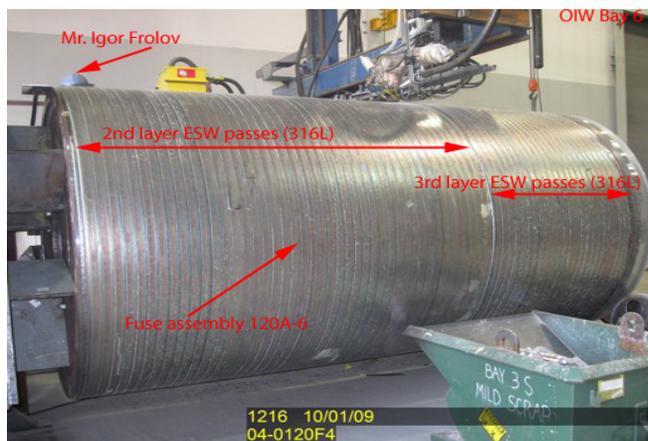
QA Inspector noticed that the third and final ESW stainless steel overlay passes were in-process, on this fuse assembly 120A-6. QA Inspector witnessed welder #F17, Mr. Igor Frolov performing electro slag welding (ESW) on the third layer welding passes (approximately 30% complete), in the flat position, utilizing Soudokay brand Soudotape 316L stainless steel consumable strip. QA Inspector noted the first layer passes had previously been completed utilizing the 309L consumable strip and the remaining second & third layer (in-process) passes would be completed utilizing Soudokay brand Soudotape 316L stainless steel consumable strip, per contract requirements.

QA Inspector randomly noticed QC Inspector's Mike Gregson and Jose Salazar were present, to verify in-process welding parameters (amps/volts) and monitor in-process continuous pre-heat temperatures. QA Inspector spoke with QC Inspector Jose Salazar and Mr. Salazar explained that welding amps were recorded as 1200 amps/25.2 volts, travel speed at 269mm/min. and a pre-heat temperature recorded at 70 degrees Fahrenheit (21 C). QA Inspector verified in-process welding parameters of 1200 amps/25.2 volts and recorded pre-heat temperatures of approximately 70 degrees Fahrenheit (21 C). QA Inspector verified Mr. Igor Frolov was currently qualified for this welding process/position and noted that Mr. Igor Frolov appeared to be in compliance with the applicable approved welding procedure specification (WPS 7003). See attached picture below.
