Contract #: 04-0120F4Cty: SF/ALA Rte: 80 PM: 13.2/13.9File #: 69.28**WELDING INSPECTION REPORT****Resident Engineer:** Pursell, Gary**Address:** 333 Burma Road**City:** Oakland, CA 94607**Report No:** WIR-009390**Date Inspected:** 06-Oct-2009**Project Name:** SAS Superstructure**OSM Arrival Time:** 1900**Prime Contractor:** American Bridge/Fluor Enterprises, a JV**OSM Departure Time:** 700**Contractor:** Zhenhua Port Machinery Company, Ltd (ZPMC), Changxing Island **Location:** Shanghai, China**CWI Name:** Tu Jun, Xi Yumin**CWI Present:** Yes No**Inspected CWI report:** Yes No N/A**Rod Oven in Use:** Yes No N/A**Electrode to specification:** Yes No N/A**Weld Procedures Followed:** Yes No N/A**Qualified Welders:** Yes No N/A**Verified Joint Fit-up:** Yes No N/A**Approved Drawings:** Yes No N/A**Approved WPS:** Yes No N/A**Delayed / Cancelled:** Yes No N/A**Bridge No:** 34-0006**Component:** Tower/OBG**Summary of Items Observed:**

WELDING INSPECTION REPORT

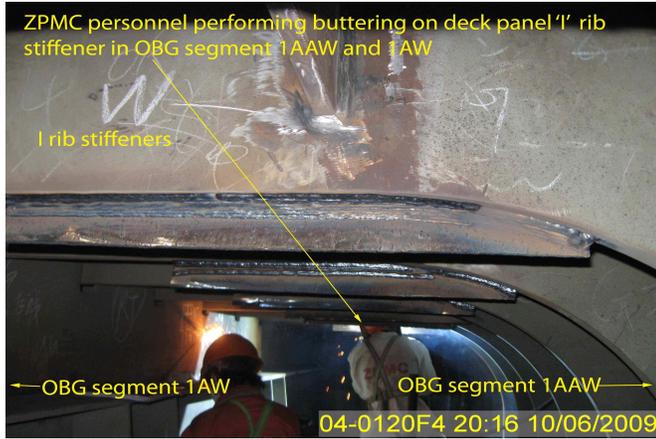
This Quality assurance (QA) Inspector observed ZPMC welders 220063 and 220067 performing buttering with the help of FCAW process on deck panel 'I' rib stiffener of OBG segment 1AAW and 1AW. ZPMC QC (CWI) is identified as Xu Yumin. The welding variables recorded by QC appeared to comply with WPS -345-FCAW-4G (4F) Repair. The critical weld report identified as B-CWR778. For additional information see attached photo.
