**DEPARTMENT OF TRANSPORTATION**

Contract #: 04-0120F4Cty: SF/ALA Rte: 80 PM: 13.2/13.9File #: 69.28**WELDING INSPECTION REPORT****Resident Engineer:** Pursell, Gary**Address:** 333 Burma Road**City:** Oakland, CA 94607**Report No:** WIR-009403**Date Inspected:** 13-Sep-2009**Project Name:** SAS Superstructure**OSM Arrival Time:** 645**Prime Contractor:** American Bridge/Fluor Enterprises, a JV**OSM Departure Time:** 1845**Contractor:** Zhenhua Port Machinery Company, Ltd (ZPMC), Changxing Island **Location:** Shanghai, China**CWI Name:** Lv Liaing**CWI Present:** Yes No**Inspected CWI report:** Yes No N/A**Rod Oven in Use:** Yes No N/A**Electrode to specification:** Yes No N/A**Weld Procedures Followed:** Yes No N/A**Qualified Welders:** Yes No N/A**Verified Joint Fit-up:** Yes No N/A**Approved Drawings:** Yes No N/A**Approved WPS:** Yes No N/A**Delayed / Cancelled:** Yes No N/A**Bridge No:** 34-0006**Component:** OBG Components**Summary of Items Observed:**

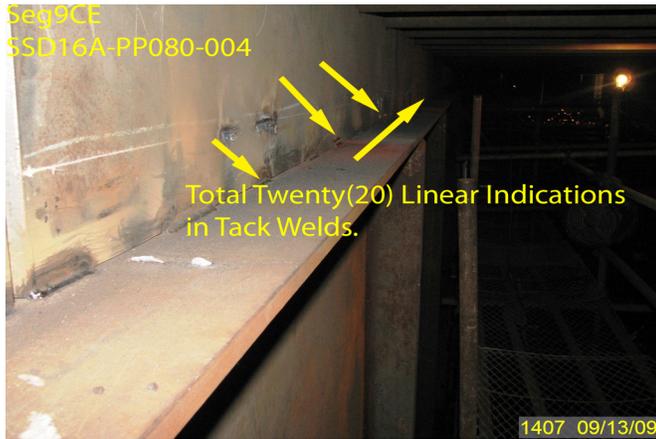
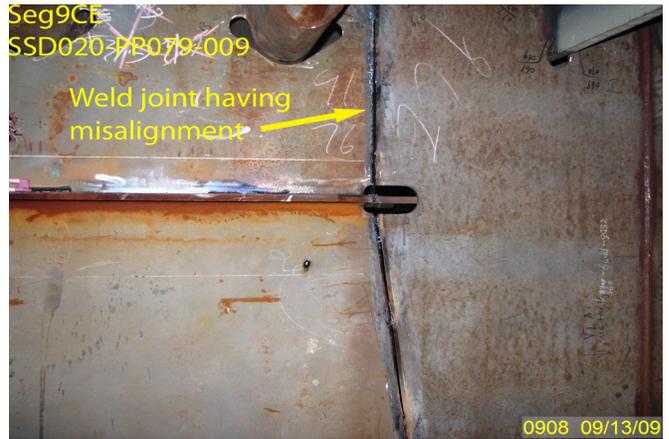
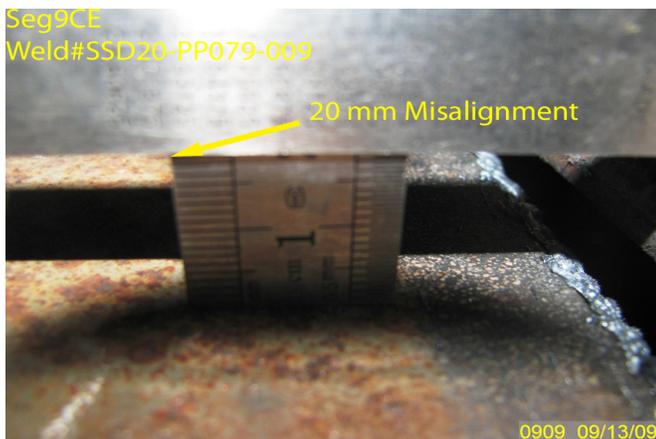
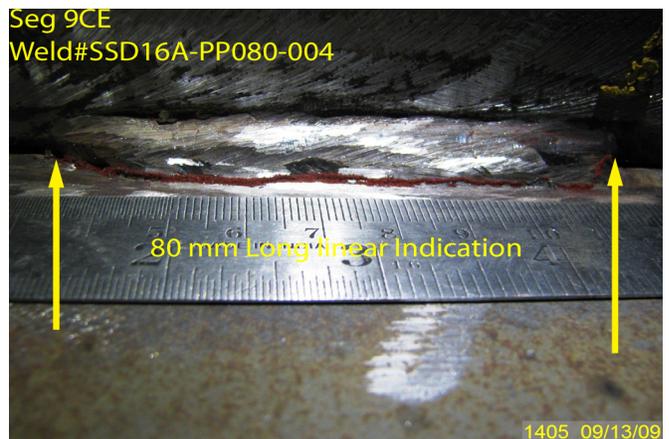
During random visual inspection, This QA inspector found a total of twenty (20) linear indications in the tack welds on segment 9CE. The weld number is identified as SSD16A-PP080-004. ZPMC QC ground the tack welds out and confirmed its removal by Magnetic Particle Testing prior to welding. For further information, please see attached pictures.

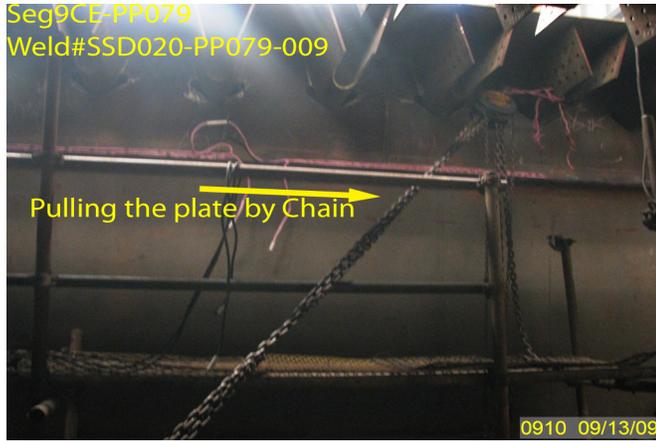
During random visual inspection of Segment 9CE, This QA inspector found 20mm misalignment on weld joint number SSD020-PP079-009. ZPMC personal were observed using a Chain Hoist to pull that plate and minimize the misalignment. For further information, please see attached pictures.
