Contract #: 04-0120F4Cty: SF/ALA Rte: 80 PM: 13.2/13.9File #: 69.28**WELDING INSPECTION REPORT****Resident Engineer:** Pursell, Gary**Address:** 333 Burma Road**City:** Oakland, CA 94607**Report No:** WIR-009643**Date Inspected:** 18-Oct-2009**Project Name:** SAS Superstructure**OSM Arrival Time:** 700**Prime Contractor:** American Bridge/Fluor Enterprises, a JV**OSM Departure Time:** 1900**Contractor:** Zhenhua Port Machinery Company, Ltd (ZPMC), Changxing Island **Location:** Shanghai, China**CWI Name:** Li Ming, Feng Guo.**CWI Present:** Yes No**Inspected CWI report:** Yes No N/A**Rod Oven in Use:** Yes No N/A**Electrode to specification:** Yes No N/A**Weld Procedures Followed:** Yes No N/A**Qualified Welders:** Yes No N/A**Verified Joint Fit-up:** Yes No N/A**Approved Drawings:** Yes No N/A**Approved WPS:** Yes No N/A**Delayed / Cancelled:** Yes No N/A**Bridge No:** 34-0006**Component:** Tower**Summary of Items Observed:**

Bay 11 West Tower Lift 3, 85.25M diaphragm to skin A, B, E and fit lugs

WELDING INSPECTION REPORT

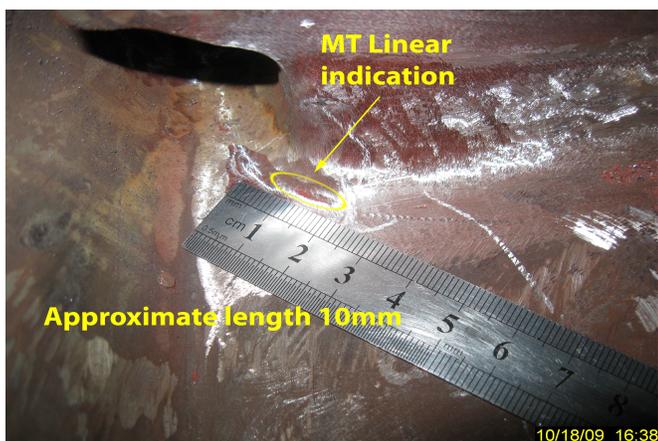
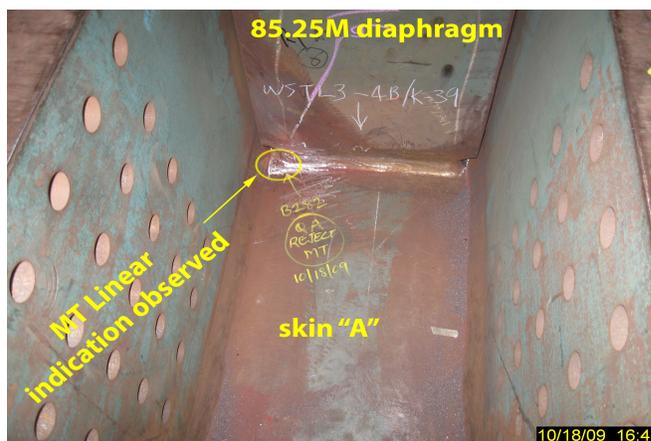
WSTL3-4B/K-39 (MT Linear Indication observed, Incident Report)

During random verification Magnetic Particle Testing (MT) of West tower lift 3, 85.25M diaphragm to skin A, weld WSTL3-4B/K-39 located in the Tower Bay No. 11, Caltrans Quality Assurance (QA) Inspector discovered a linear indication of approximately 10mm in length. This area had been previously tested and accepted by ZPMC NDT personnel. (NDT Inspection Notification sheet # 004423) The attached photographs provide additional detail.
