DEPARTMENT OF TRANSPORTATION

Contract #: 04-0120F4Cty: SF/ALA Rte: 80 PM: 13.2/13.9File #: 69.28**WELDING INSPECTION REPORT****Resident Engineer:** Pursell, Gary**Address:** 333 Burma Road**City:** Oakland, CA 94607**Report No:** WIR-009681**Date Inspected:** 10-Oct-2009**Project Name:** SAS Superstructure**OSM Arrival Time:** 700**Prime Contractor:** American Bridge/Fluor Enterprises, a JV**OSM Departure Time:** 1900**Contractor:** Zhenhua Port Machinery Company, Ltd (ZPMC), Changxing Island **Location:** Shanghai, China**CWI Name:** ZPMC and ABF**CWI Present:** Yes No**Inspected CWI report:** Yes No N/A**Rod Oven in Use:** Yes No N/A**Electrode to specification:** Yes No N/A**Weld Procedures Followed:** Yes No N/A**Qualified Welders:** Yes No N/A**Verified Joint Fit-up:** Yes No N/A**Approved Drawings:** Yes No N/A**Approved WPS:** Yes No N/A**Delayed / Cancelled:** Yes No N/A**Bridge No:** 34-0006**Component:** OBG**Summary of Items Observed:**

WELDING INSPECTION REPORT

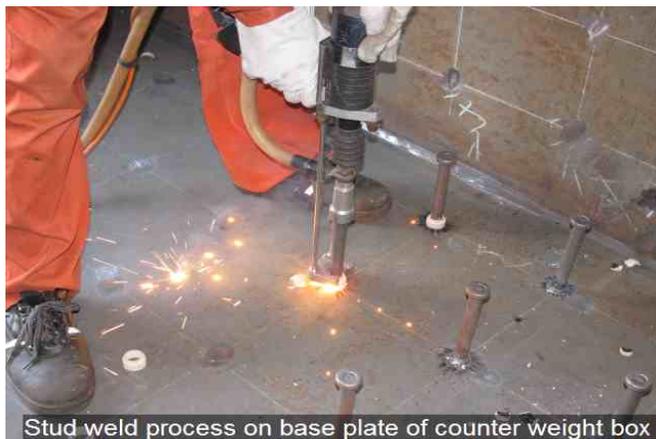
Counter weight box: - Caltrans QA inspector observed two ZPMC welding operators performed an electric arc stud weld process on the interior surface of base plate for counter weight box #CW50. The stud size is 19mm diameter x150mm length. A stud and ceramic ferrule are loaded into the gun, and the gun properly positioned against the base plate on the assigned location with down hand welding position. The stud welding has been completed approximately two hours on one side of base plate. The counter weight box need rotate to another side for stud welding. The stud welding process was monitored and recorded by ZPMC and ABF QC inspector. Based on Caltrans QA Inspector observations, no discrepancies were noted.

Stud weld process on base plate of counter weight box

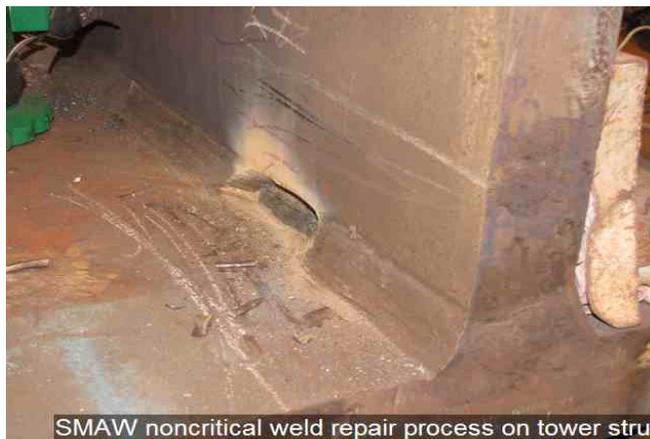
Tower strut: - Caltrans QA Inspector observed a welder performed two spots SMAW noncritical weld repair process on tower strut. The tower struts ID was WD1-A305-53M-1. All of FCAW noncritical repair weld located at web to flange of tower strut which have been rejected by ZPMC UT testing. The weld repair report number is T-CWR292 and the weld repair areas are 65mm length x 25mm wide x 30mm depth and 55mm length x 20mm wide x 35mm depth. The SMAW noncritical weld repair is monitored and recorded by ZPMC and ABF QC inspector. Based on Caltrans QA inspector observations, no discrepancies were noted.

SMAW noncritical weld repair process on tower strut
