**DEPARTMENT OF TRANSPORTATION**

Contract #: 04-0120F4Cty: SF/ALA Rte: 80 PM: 13.2/13.9File #: 13.28**WELDING INSPECTION REPORT****Resident Engineer:** Pursell, Gary**Address:** 333 Burma Road**City:** Oakland, CA 94607**Report No:** WIR-009686**Date Inspected:** 13-Oct-2009**Project Name:** SAS Superstructure**OSM Arrival Time:** 700**Prime Contractor:** American Bridge/Fluor Enterprises, a JV**OSM Departure Time:** 1530**Contractor:** Oregon Iron Works Clackamas, Or.**Location:** Clackamas, OR**CWI Name:** Mike Gregson, Bill Buck**CWI Present:** Yes No**Inspected CWI report:** Yes No N/A**Rod Oven in Use:** Yes No N/A**Electrode to specification:** Yes No N/A**Weld Procedures Followed:** Yes No N/A**Qualified Welders:** Yes No N/A**Verified Joint Fit-up:** Yes No N/A**Approved Drawings:** Yes No N/A**Approved WPS:** Yes No N/A**Delayed / Cancelled:** Yes No N/A**Bridge No:** 34-0006**Component:** Hinge K Pipe Beams**Summary of Items Observed:**

## WELDING INSPECTION REPORT

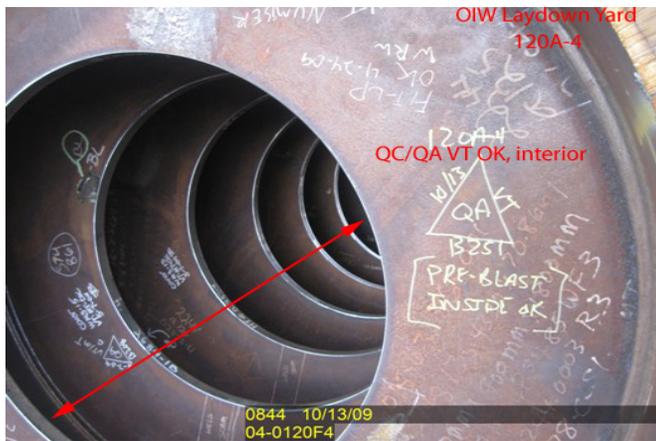
QA Inspector noted that welder #F17, Mr. Igor Frolov, was currently in-process, of performing the weld clean-up and grinding, on the previously marked interior of fuse assemblies 120A-4 and 120A-5. QA Inspector noted that QC Inspector Jose Salazar had previously marked up the above mentioned fuse assemblies, for additional weld clean-up, on the interior base metal/ring stiffeners, prior to transfer to OIW Vancouver painting facility, to meet the criteria of AWS D1.5 and contract requirements. Mr. Salazar had previously explained to QA Inspector that the interior areas that were marked up, included weld blending, excessive weld spatter, sharp edges and various minor base metal gauges, to be blended and transitioned on the fuse assembly base material and interior stiffener rings. See attached pictures below.

Note:QA Inspector was later notified by Mr.Frolov that the weld-clean up on the previously marked areas on these fuse assembly 120A-4/120A-5, was complete. QA Inspector verified that the previously marked up areas by Mr. Salazar had been completed and noted additional interior weld spatter, to be removed. QA Inspector informed Mr. Frolov of the additional weld spatter that needed to be removed and QA Inspector witnessed Mr. Frolov performing this.

QA Inspector noted that the above mentioned fuse assemblies, would be transferred to OIW Vancouver, WA. painting facility and the interior blasted at a later date and QA Inspector will then perform an after blast visual inspection, per AWS D1.5 and contract requirements, prior to OIW applying inorganic zinc primer coat. See attached pictures below.
