**DEPARTMENT OF TRANSPORTATION**

Contract #: 04-0120F4Cty: SF/ALA Rte: 80 PM: 13.2/13.9File #: 13.28**WELDING INSPECTION REPORT****Resident Engineer:** Pursell, Gary**Address:** 333 Burma Road**City:** Oakland, CA 94607**Report No:** WIR-009715**Date Inspected:** 20-Oct-2009**Project Name:** SAS Superstructure**OSM Arrival Time:** 700**Prime Contractor:** American Bridge/Fluor Enterprises, a JV**OSM Departure Time:** 1530**Contractor:** Oregon Iron Works Clackamas, Or.**Location:** Clackamas, OR

**Bridge No:** 34-0006**Component:** Hinge K Pipe Beams**Summary of Items Observed:**

Hinge-K Pipe Beam Assembly 102A-3: 10/20/09

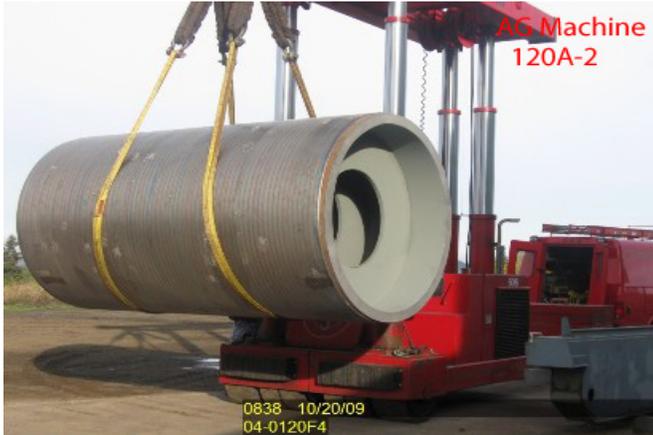
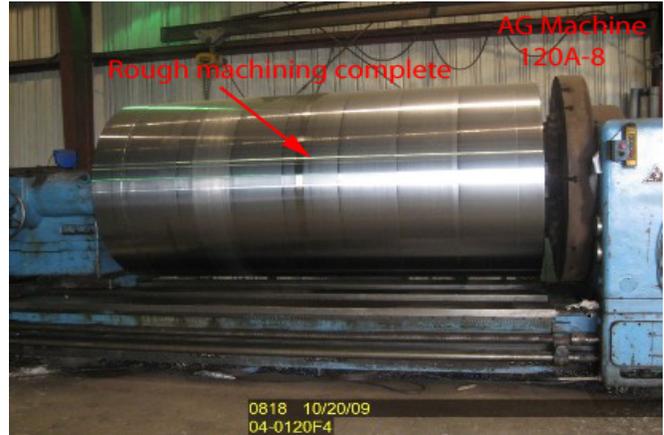
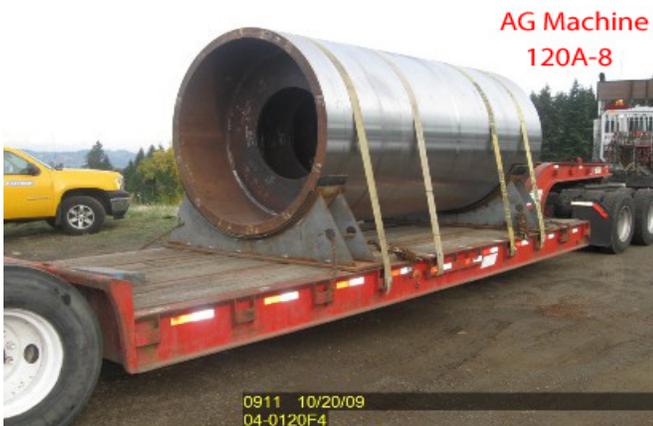
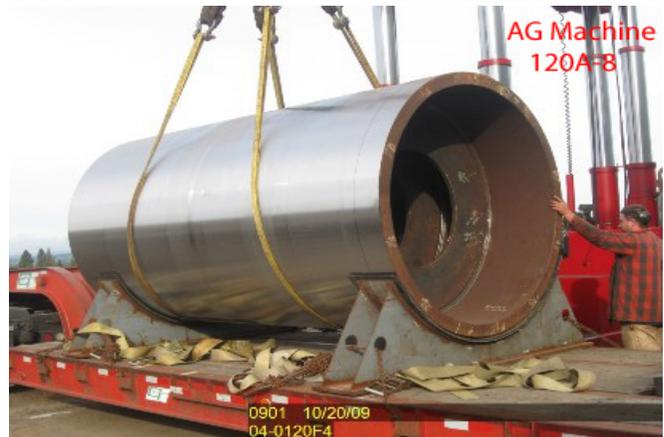
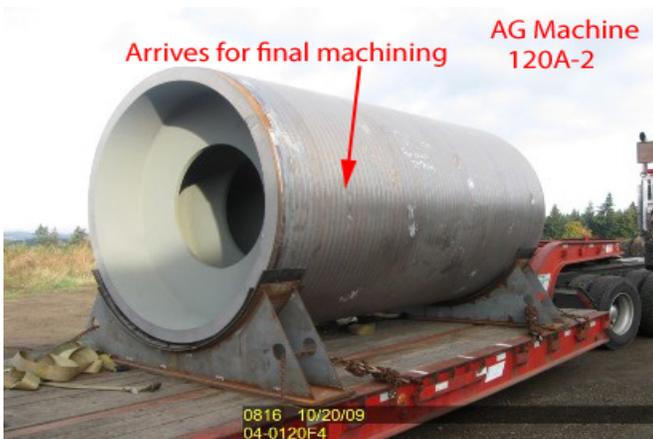
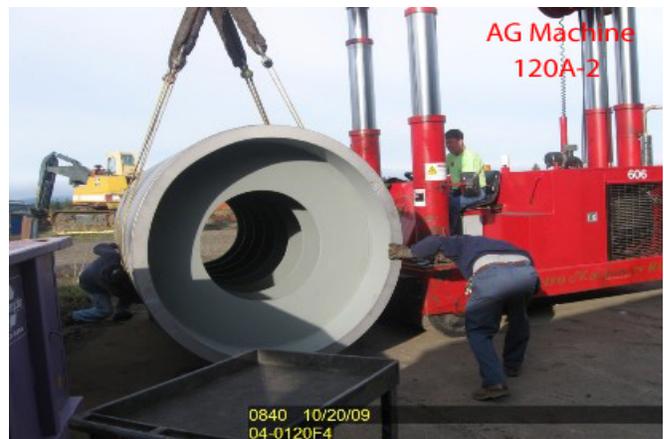
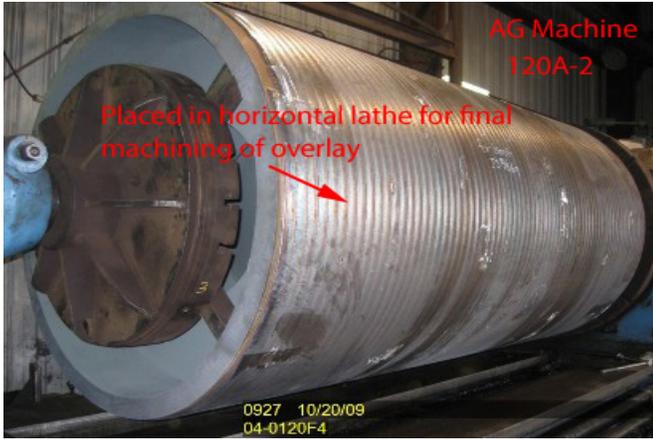
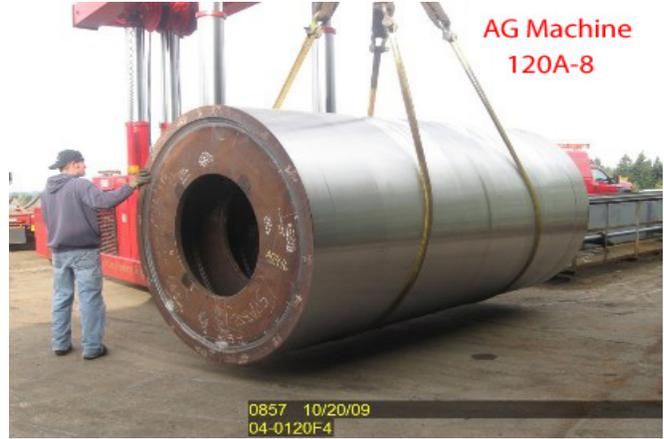
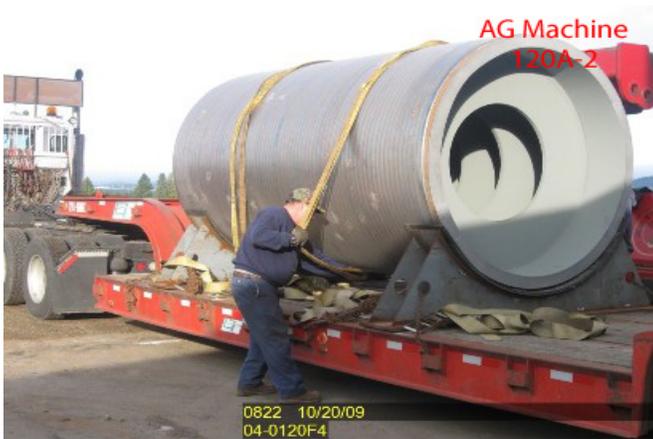
QA Inspector arrived at AG Machine shop, on this date and witnessed OIW removing fuse assembly 120A-8, from the horizontal shop lathe and placing fuse assembly 120A-2 in the lathe, in preparation for final machining, on the exterior overlay. QA Inspector noted that the above mentioned fuse assembly 120A-2, had arrived from OIW Vancouver, WA painting facility and the interior ring stiffeners and base material had been previously blasted and inorganic zinc had been applied. QA Inspector spoke with AG Machine and AG explained that the final machining will begin after initial setup/measurements in the lathe are performed and OIW is present to verify these and release to AG, to begin the final machining process, possibly on 10/21/09 or 10/22/09. See attached pictures below.
