**DEPARTMENT OF TRANSPORTATION**

Contract #: 04-0120F4Cty: SF/ALA Rte: 80 PM: 13.2/13.9File #: 69.28**WELDING INSPECTION REPORT****Resident Engineer:** Pursell, Gary**Address:** 333 Burma Road**City:** Oakland, CA 94607**Report No:** WIR-009723**Date Inspected:** 09-Oct-2009**Project Name:** SAS Superstructure**OSM Arrival Time:** 645**Prime Contractor:** American Bridge/Fluor Enterprises, a JV**OSM Departure Time:** 1845**Contractor:** Zhenhua Port Machinery Company, Ltd (ZPMC), Changxing Island **Location:** Shanghai, China**CWI Name:** Li zhi jiang**CWI Present:** Yes No**Inspected CWI report:** Yes No N/A**Rod Oven in Use:** Yes No N/A**Electrode to specification:** Yes No N/A**Weld Procedures Followed:** Yes No N/A**Qualified Welders:** Yes No N/A**Verified Joint Fit-up:** Yes No N/A**Approved Drawings:** Yes No N/A**Approved WPS:** Yes No N/A**Delayed / Cancelled:** Yes No N/A**Bridge No:** 34-0006**Component:** OBG**Summary of Items Observed:**

## WELDING INSPECTION REPORT

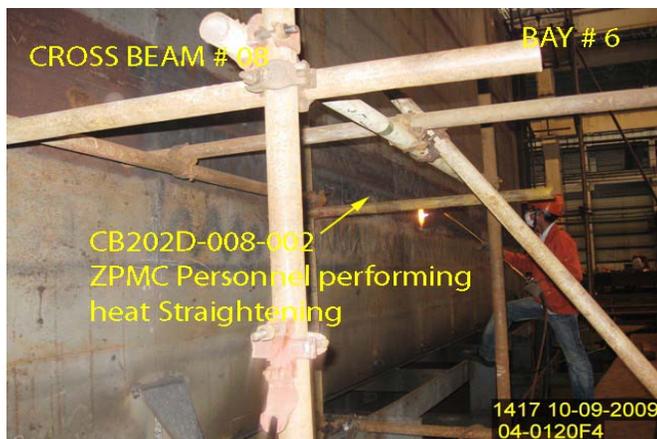
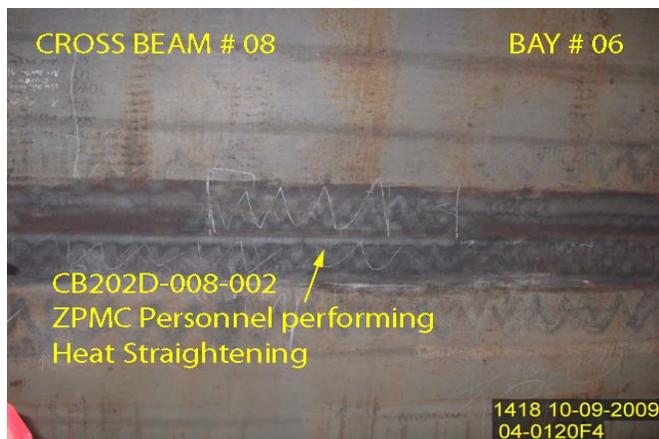
OBG # Cross Beam 08 (BAY 06)

During random in process inspection Cross Beam 08 in bay 06, this QA inspector observed ZPMC Personnel performing heat straightening the FCW CB202D-008-002 weld joint. See attached photos.
