Contract #: 04-0120F4Cty: SF/ALA Rte: 80 PM: 13.2/13.9File #: 13.28**WELDING INSPECTION REPORT****Resident Engineer:** Pursell, Gary**Address:** 333 Burma Road**City:** Oakland, CA 94607**Report No:** WIR-009881**Date Inspected:** 27-Oct-2009**Project Name:** SAS Superstructure**OSM Arrival Time:** 1500**Prime Contractor:** American Bridge/Fluor Enterprises, a JV**OSM Departure Time:** 2330**Contractor:** Oregon Iron Works Clackamas, Or.**Location:** Clackamas, OR**CWI Name:** Steve Barnett**CWI Present:** Yes No**Inspected CWI report:** Yes No N/A**Rod Oven in Use:** Yes No N/A**Electrode to specification:** Yes No N/A**Weld Procedures Followed:** Yes No N/A**Qualified Welders:** Yes No N/A**Verified Joint Fit-up:** Yes No N/A**Approved Drawings:** Yes No N/A**Approved WPS:** Yes No N/A**Delayed / Cancelled:** Yes No N/A**Bridge No:** 34-0006**Component:** Hinge-K Components**Summary of Items Observed:**

Hinge-K Pipe Beam Base Assembly 102A-3:

WELDING INSPECTION REPORT

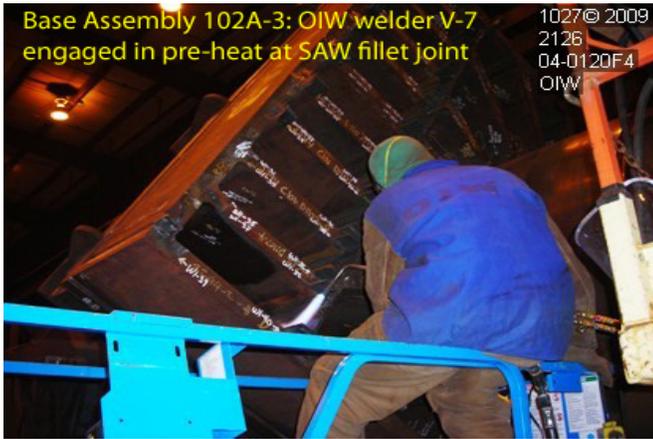
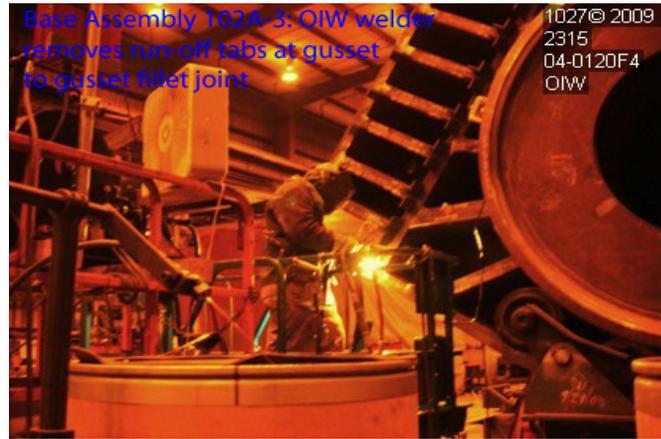
The QA Inspector intermittently monitored OIW welders Vincent Vu (WID V7) and Bounhoun Savahn (WID S74) during in progress Submerged Arc Welding (SAW) at weld joints W1-03, W1-07, W1-11, W1-15 & W1-40 and W1-52, W1-56, W1-79, W1-71 & W1-75 respectively. The referenced connections are fillet welds joining c106 stiffeners to a107 and b106 gussets. The QA Inspector intermittently observed as OIW QC Inspector Steve Barnett performed Magnetic particle Testing (MT) and Visual Inspection (VT) of completed root pass at weld joints referenced above. The testing performed was informational MT at root pass of these fillet joints at the behest of OIW QC management. Mr. Barnett stated that he had located no rejectable indications. The QA Inspector randomly observed as welders V7 & S74 deposited SAW passes in the horizontal (2F) position in accordance with approved welding procedure 4020. The QA Inspector noted the OIW welders were maintaining continuous preheat utilizing a torch. The QA Inspector observed OIW QC Inspector Steve Barnett regularly monitoring and recording the in process SAW parameters. The QA Inspector also intermittently observed in process welding parameters and determined that the SAW parameters and minimum preheat/interpass temperature appeared to be in general compliance with the contract requirements -- (W1-75: 35 volts, 563 amperes,

432mm/min travel speed).
