Contract #: 04-0120F4Cty: SF/ALA Rte: 80 PM: 13.2/13.9File #: 13.28**WELDING INSPECTION REPORT****Resident Engineer:** Pursell, Gary**Address:** 333 Burma Road**City:** Oakland, CA 94607**Report No:** WIR-009883**Date Inspected:** 29-Oct-2009**Project Name:** SAS Superstructure**OSM Arrival Time:** 1500**Prime Contractor:** American Bridge/Fluor Enterprises, a JV**OSM Departure Time:** 2330**Contractor:** Oregon Iron Works Clackamas, Or.**Location:** Clackamas, OR**CWI Name:** Steve Barnett**CWI Present:** Yes No**Inspected CWI report:** Yes No N/A**Rod Oven in Use:** Yes No N/A**Electrode to specification:** Yes No N/A**Weld Procedures Followed:** Yes No N/A**Qualified Welders:** Yes No N/A**Verified Joint Fit-up:** Yes No N/A**Approved Drawings:** Yes No N/A**Approved WPS:** Yes No N/A**Delayed / Cancelled:** Yes No N/A**Bridge No:** 34-0006**Component:** Hinge-K Components**Summary of Items Observed:**

Hinge-K Pipe Beam Base Assembly 102A-3:

WELDING INSPECTION REPORT

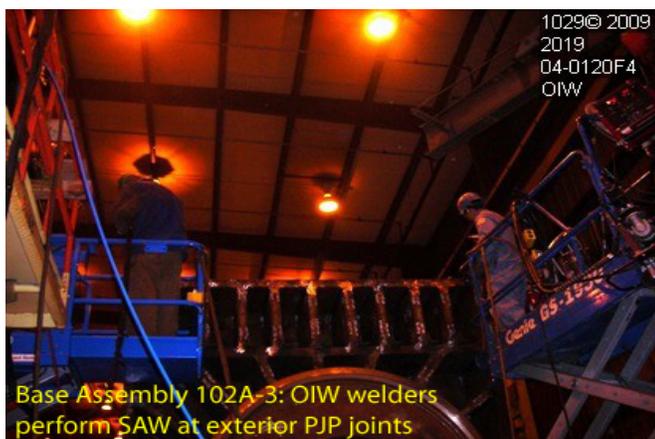
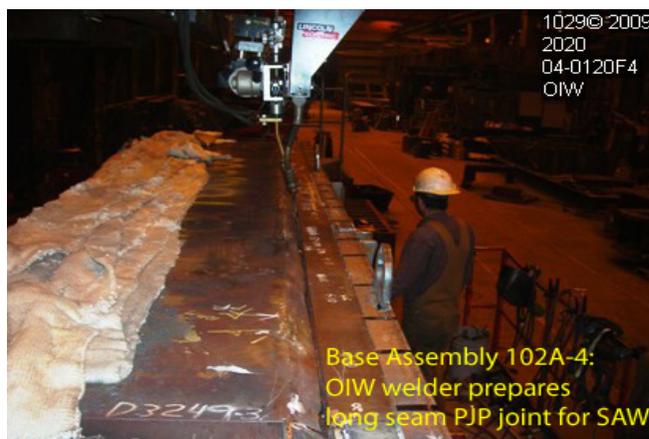
The QA Inspector intermittently monitored OIW welders Vincent Vu (WID V7) and Bounhoun Savahn (WID S74) during in progress Submerged Arc Welding (SAW) at weld joints W1-165 & W1-166 and W1-164 & W1-167 respectively. The referenced connections are Partial Joint Penetration (PJP) welds joining b106 gussets to b106 and ab106 gussets. The QA Inspector intermittently observed as OIW QC Inspector Steve Barnett performed Magnetic particle Testing (MT) and Visual Inspection (VT) of completed root pass at weld joints referenced above. Mr. Barnett stated that he had located no rejectable indications. The QA Inspector subsequently performed 100% VT & 50% MT verification at weld joints W1-165 & W1-166 finding the root passes to be in general compliance with contract documents. Please reference TL-6028 report for this date for detailed information. The QA Inspector randomly observed as welders V7 & S74 deposited SAW root and fill passes in the horizontal (2F) position in accordance with approved welding procedure 4020. The QA Inspector noted the OIW welders were maintaining continuous preheat utilizing a torch. The QA Inspector observed OIW QC Inspector Steve Barnett regularly monitoring and recording the in process SAW parameters. The QA Inspector also intermittently observed in process welding parameters and determined that the SAW parameters and minimum preheat/interpass

temperature appeared to be in general compliance with the contract requirements -- (W1-165: 35 volts, 565 amperes, 432mm/min travel speed).

The QA Inspector intermittently monitored OIW welder Bui Liem (WID B10) during in progress Submerged Arc Welding (SAW) at weld joints W2-24 & W2-23 joining ab106 gusset to a109 cap plate and a110 base plate respectively. The QA Inspector observed as OIW QC Inspector Steve Barnett performed Magnetic particle Testing (MT) and Visual Inspection (VT) of completed root passes at joint W2-23 referenced above. Mr. Barnett stated that he had located no rejectable indications. The QA Inspector subsequently performed 100% VT & 50% MT verification at the noted location finding the root pass to be in general compliance with contract documents. Please reference TL-6028 report for this date for details. The QA Inspector intermittently observed as welder B10 deposited SAW root and fill passes in the flat (1F) position in accordance with approved welding procedure 4020. The QA Inspector noted the OIW welder was maintaining continuous preheat utilizing electric resistance cords and a torch. The QA Inspector observed OIW QC Inspector Steve Barnett regularly monitoring and recording the in process SAW parameters. The QA Inspector also intermittently observed in process welding parameters and determined that the SAW parameters and minimum preheat/interpass temperature appeared to be in general compliance with the contract requirements -- (W2-23: 35 volts, 565 amperes, 432mm/min travel speed).
