Contract #: 04-0120F4Cty: SF/ALA Rte: 80 PM: 13.2/13.9File #: 69.28**WELDING INSPECTION REPORT****Resident Engineer:** Pursell, Gary**Address:** 333 Burma Road**City:** Oakland, CA 94607**Report No:** WIR-010132**Date Inspected:** 30-Oct-2009**Project Name:** SAS Superstructure**OSM Arrival Time:** 700**Prime Contractor:** American Bridge/Fluor Enterprises, a JV**OSM Departure Time:** 1900**Contractor:** Zhenhua Port Machinery Company, Ltd (ZPMC), Changxing Island **Location:** Shanghai, China

WELDING INSPECTION REPORT

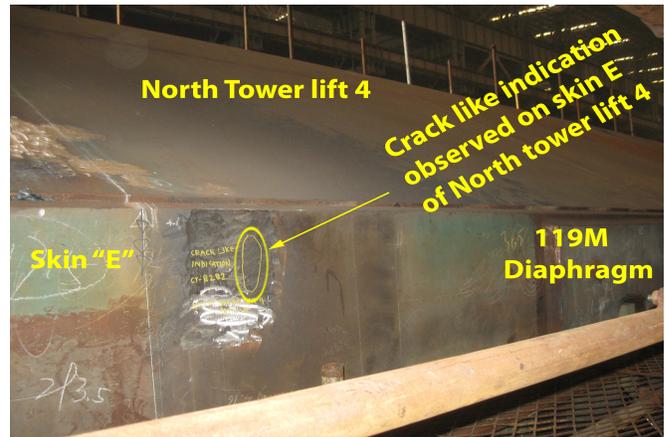
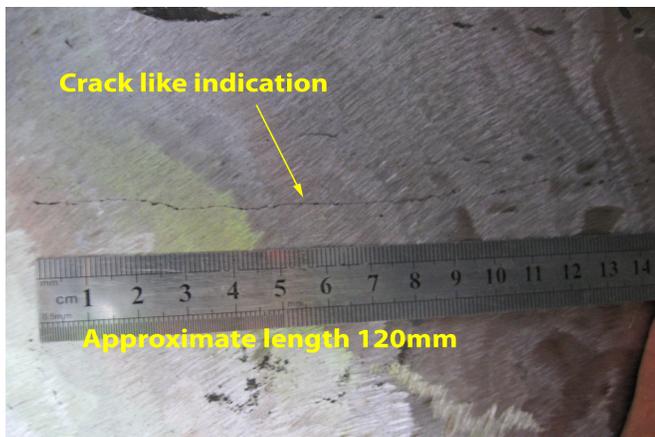
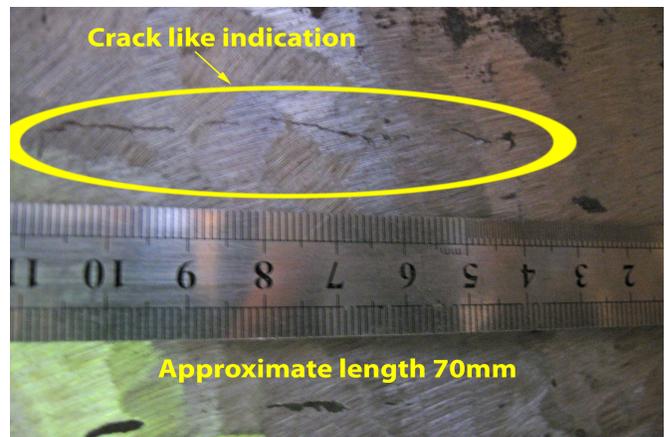
During random verification Visual Testing (VT), Caltrans Quality Assurance (QA) Inspector observed crack like indications on temporary attachment weld removed area of skin E of North tower lift 4. The attached photographs provide additional detail.

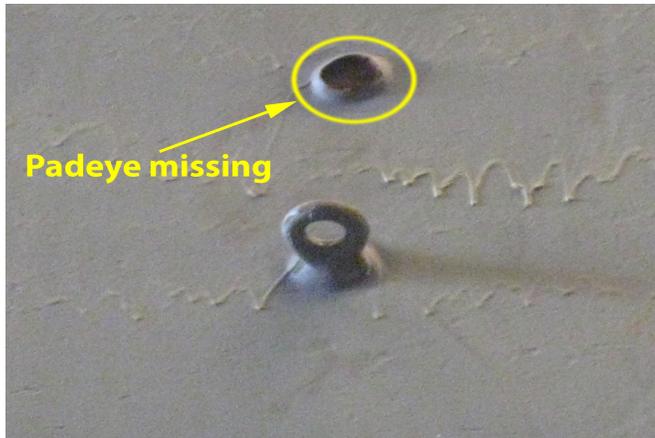
During random verification Visual Testing (VT), Caltrans Quality Assurance (QA) Inspector observed a padeye was missing on skin E of North tower lift 1 in between 43M and 47.6M double diaphragm. The attached photographs provide additional detail.
