DEPARTMENT OF TRANSPORTATION

Quality Assurance and Source Inspection

Contract #: 04-0120F4Cty: SF/ALA Rte: 80 PM: 13.2/13.9File #: 13.28**WELDING INSPECTION REPORT****Resident Engineer:** Pursell, Gary**Address:** 333 Burma Road**City:** Oakland, CA 94607**Report No:** WIR-010150**Date Inspected:** 17-Nov-2009**Project Name:** SAS Superstructure**OSM Arrival Time:** 700**Prime Contractor:** American Bridge/Fluor Enterprises, a JV**OSM Departure Time:** 1530**Contractor:** Oregon Iron Works Clackamas, Or.**Location:** Clackamas, OR**CWI Name:** Mike Gregson, Jose Salazar**CWI Present:** Yes No**Inspected CWI report:** Yes No N/A**Rod Oven in Use:** Yes No N/A**Electrode to specification:** Yes No N/A**Weld Procedures Followed:** Yes No N/A**Qualified Welders:** Yes No N/A**Verified Joint Fit-up:** Yes No N/A**Approved Drawings:** Yes No N/A**Approved WPS:** Yes No N/A**Delayed / Cancelled:** Yes No N/A**Bridge No:** 34-0006**Component:** Hinge K Pipe Beams**Summary of Items Observed:**

Hinge-K Pipe Beam Assembly 102A-3: 11/17/09

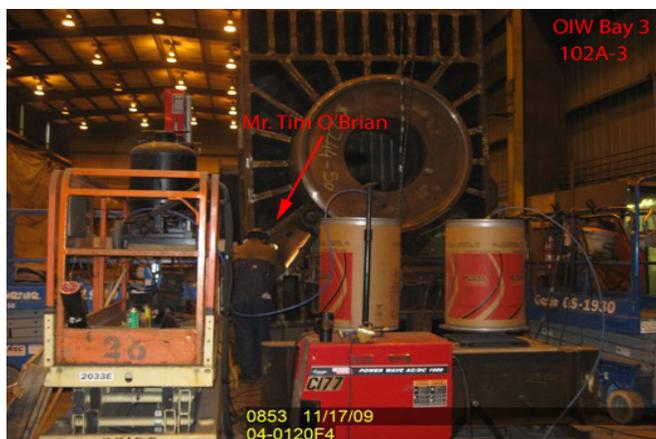
QA Inspector noticed that the partial joint penetration and fillet welds were previously completed, on the HPS 485W stiffeners and OIW production personell were in-process of performing weld clean-up and occasional FCAW on the weld joints, identified as WJ#'s W1-01 thru W1-163. QA Inspector spoke with QC Inspector Jose Salazar and Mr. Salazar explained that OIW welder #06, Mr. Tim O'Brian and #T23, Mr. John Tellone were continuing to grind the weld start/stops, removing weld spatter and grinding all areas, which were previously marked by OIW QC Inspectors, per AWS D1.5 visual criteria and contract requirements. Mr. Salazar explained that minor underfill and undercut had been previously measured on weld joints # W1-123 (piece mark e108/a107), #W1-127 (e108/a110), #W1-129 (d108/a110) and #W1-115 (f108/a107), exceeded the limits of AWS D1.5 visual testing requirements and required a FCAW fill pass. QA Inspector noted that Mr. Salazar was present during the FCAW repair and had recorded average, in-process welding parameters of 262 amps/26.2 volts, 10 i.p.m. travel speed, with a pre-heat temperature of approximately 400 degrees Fahrenheit (204 C). QA Inspector noted that the welding procedure specifications (WPS 3049 and WPS 3050) were utilized for the repairs and welding parameters/pre-heat temperatures appeared to in compliance with the above mentioned WPS's. Mr. Salazar also explained that a total of 4 base metal arc strikes, on the forging (a111-3), were noted during the in-process visual

inspection and Mr. O'Brian had previously performed the repairs (shallow grinding), per AWS D1.5, sect. 3.10. Mr. Salazar explained that the arc strikes had been ground out to sound base metal and 100% magnetic particle testing was then performed, with no rejectable indications present and that the Brinell hardness values were acceptable. Mr. Salazar explained that the clean-up/grinding and welding, performed by Mr. O'Brian and Mr. Tellone, was periodically monitored and the welds visually re-inspected, in accordance with AWS D1.5 and an applicable visual testing report was then completed. See attached picture below.
