DEPARTMENT OF TRANSPORTATION

Quality Assurance and Source Inspection

Contract #: 04-0120F4Cty: SF/ALA Rte: 80 PM: 13.2/13.9File #: 69.28**WELDING INSPECTION REPORT****Resident Engineer:** Pursell, Gary**Address:** 333 Burma Road**City:** Oakland, CA 94607**Report No:** WIR-010313**Date Inspected:** 03-Oct-2009**Project Name:** SAS Superstructure**OSM Arrival Time:** 645**Prime Contractor:** American Bridge/Fluor Enterprises, a JV**OSM Departure Time:** 1900**Contractor:** Zhenhua Port Machinery Company, Ltd (ZPMC), Changxing Island **Location:** Shanghai, China**CWI Name:** Chen fu you**CWI Present:** Yes No**Inspected CWI report:** Yes No N/A**Rod Oven in Use:** Yes No N/A**Electrode to specification:** Yes No N/A**Weld Procedures Followed:** Yes No N/A**Qualified Welders:** Yes No N/A**Verified Joint Fit-up:** Yes No N/A**Approved Drawings:** Yes No N/A**Approved WPS:** Yes No N/A**Delayed / Cancelled:** Yes No N/A**Bridge No:** 34-0006**Component:** OBG Components**Summary of Items Observed:**

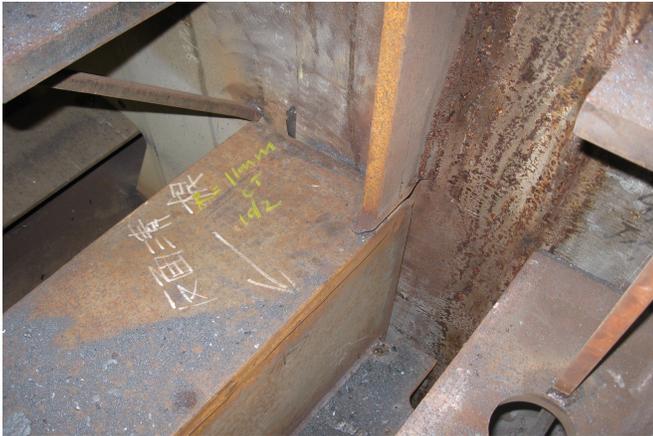
During Visual inspection it is found that the following weld joints fit up root gap was not as per WPS-B-T-2231-Tc-U4b-F. Root gap is 10mm, the weld joints are SEG051B-003 , SEG051B-005. of 9BW. SEG055B-003 of 9DW. This is informed to ZPMC QC Mr.Xu tao.
