DEPARTMENT OF TRANSPORTATION

Quality Assurance and Source Inspection

Contract #: 04-0120F4Cty: SF/ALA Rte: 80 PM: 13.2/13.9File #: 69.28**WELDING INSPECTION REPORT****Resident Engineer:** Pursell, Gary**Address:** 333 Burma Road**City:** Oakland, CA 94607**Report No:** WIR-010380**Date Inspected:** 21-Oct-2009**Project Name:** SAS Superstructure**OSM Arrival Time:** 700**Prime Contractor:** American Bridge/Fluor Enterprises, a JV**OSM Departure Time:** 1900**Contractor:** Zhenhua Port Machinery Company, Ltd (ZPMC), Changxing Island **Location:** Shanghai, China**CWI Name:** Li Yang**CWI Present:** Yes No**Inspected CWI report:** Yes No N/A**Rod Oven in Use:** Yes No N/A**Electrode to specification:** Yes No N/A**Weld Procedures Followed:** Yes No N/A**Qualified Welders:** Yes No N/A**Verified Joint Fit-up:** Yes No N/A**Approved Drawings:** Yes No N/A**Approved WPS:** Yes No N/A**Delayed / Cancelled:** Yes No N/A**Bridge No:** 34-0006**Component:** OBG Crossbeams**Summary of Items Observed:**

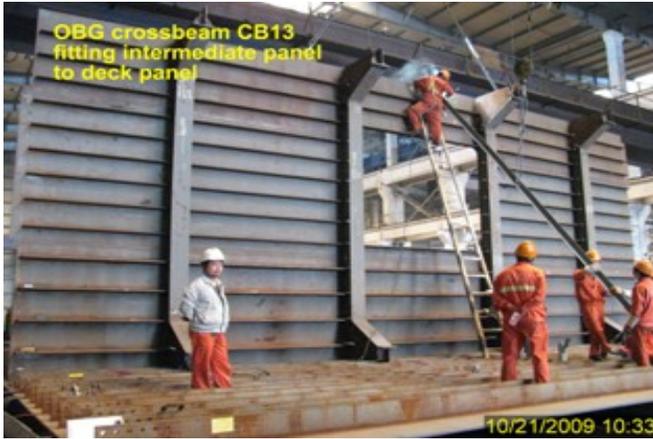
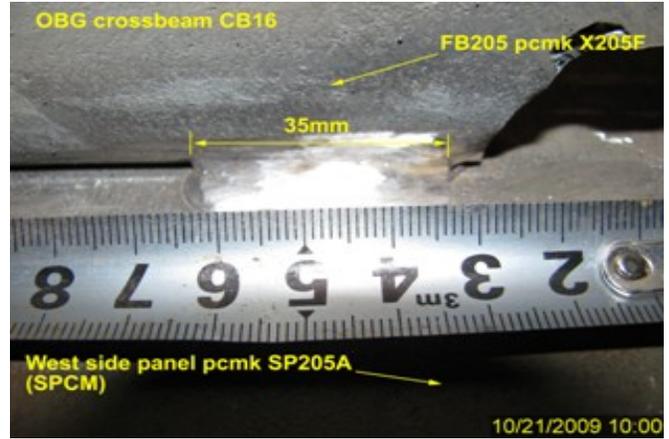
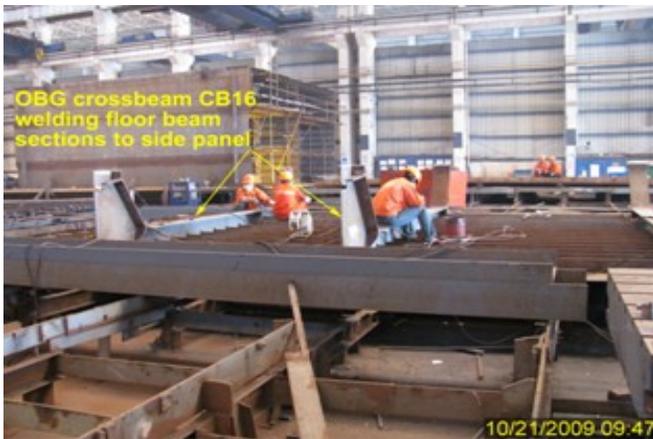
During random in process visual inspection of above mentioned crossbeam, this QA observed twelve Fracture Critical Weld (FCW) tack welds that do not appear to comply with the contract documents. The tack welds in question are joining two of the FB diaphragms to the SPCM area of the west side panel. The members are identified as FB205 and SP205A weld joints identified as CB202F-050-180 and CB202F-051-180. This condition exists in 6 locations on both of the above mentioned welds. AWS D1.5 2002 section 12, table 12.2 requires FCW tack welds not covered by Submerged Arc Welding (SAW) to be a minimum of 75mm in length. The length of these tack welds measure 35mm to 60mm. This QA notified ZPMC QC CWI identified as Mr. Li Yang and ABF QA inspector identified as Mr. Yu Kum Ming of this issue and that an incident report would be generated. See attached photo for details.
