Contract #: 04-0120F4Cty: SF/ALA Rte: 80 PM: 13.2/13.9File #: 13.28**WELDING INSPECTION REPORT****Resident Engineer:** Pursell, Gary**Address:** 333 Burma Road**City:** Oakland, CA 94607**Report No:** WIR-010467**Date Inspected:** 25-Nov-2009**Project Name:** SAS Superstructure**OSM Arrival Time:** 600**Prime Contractor:** American Bridge/Fluor Enterprises, a JV**OSM Departure Time:** 1830**Contractor:** Oregon Iron Works Clackamas, Or.**Location:** Clackamas, OR**CWI Name:** Mike Gregson, Jose Salazar**CWI Present:** Yes No**Inspected CWI report:** Yes No N/A**Rod Oven in Use:** Yes No N/A**Electrode to specification:** Yes No N/A**Weld Procedures Followed:** Yes No N/A**Qualified Welders:** Yes No N/A**Verified Joint Fit-up:** Yes No N/A**Approved Drawings:** Yes No N/A**Approved WPS:** Yes No N/A**Delayed / Cancelled:** Yes No N/A**Bridge No:** 34-0006**Component:** Hinge K Pipe Beams**Summary of Items Observed:**

Hinge-K Pipe Beam Assembly 102A-3: 11/25/09

Hinge-K Pipe Beam Fuse Assembly 120A-1: 11/25/09

a124-6 Half Fuse to a124-7 Half Fuse

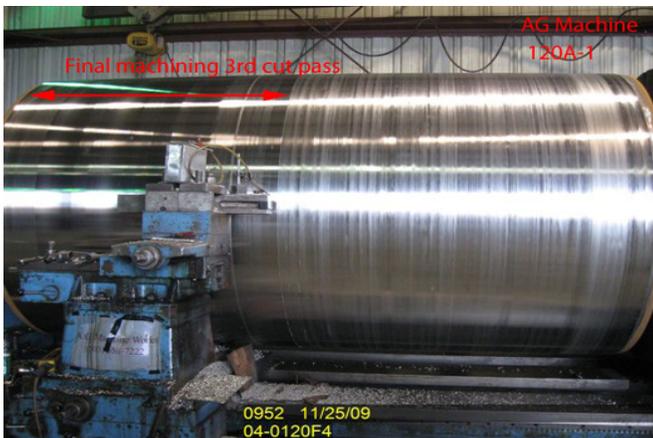
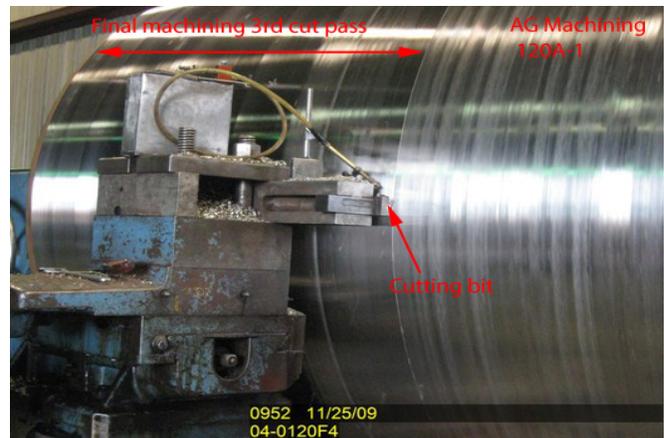
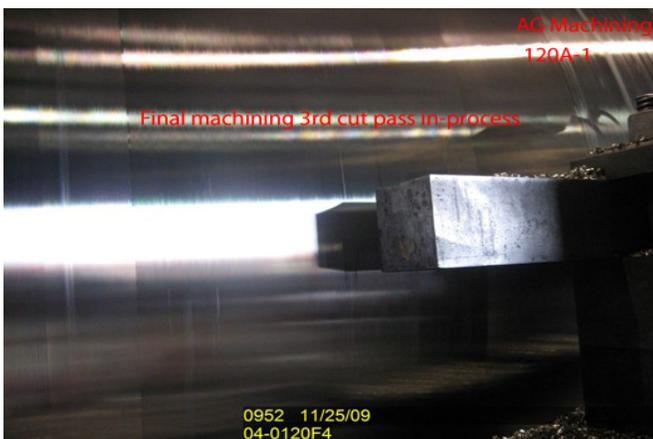
the third and final machining cut pass, approximately 40% complete. QA Inspector spoke with AG machinist and AG explained that this final cut pass will machine the outer diameter to the upper end (1921mm), measured tolerance. AG explained that approximately 30+ visual indications were present, at this time, on the exterior overlay, that will require weld repairs or machining out. AG explained that this 3rd cut pass should be completed by Mon. (11/30) morning and that OIW was previously notified of the visual indications that were present and AG explained that OIW management is meeting today, to discuss this and decide how to proceed. See attached pictures below.

Note: QA Inspector noted that these visible surface indications were similar in length/depths as the previous indications that were discovered at AG, during the final machining of fuse assembly 120A-2. The indications on 120A-2, previously appeared during the second machining cut pass (as in this case) and OIW performed the TIG weld repairs at AG.
