DEPARTMENT OF TRANSPORTATION

Quality Assurance and Source Inspection

Contract #: 04-0120F4Cty: SF/ALA Rte: 80 PM: 13.2/13.9File #: 69.28**WELDING INSPECTION REPORT****Resident Engineer:** Pursell, Gary**Address:** 333 Burma Road**City:** Oakland, CA 94607**Report No:** WIR-010584**Date Inspected:** 04-Dec-2009**Project Name:** SAS Superstructure**OSM Arrival Time:** 645**Prime Contractor:** American Bridge/Fluor Enterprises, a JV**OSM Departure Time:** 1845**Contractor:** Zhenhua Port Machinery Company, Ltd (ZPMC), Changxing Island **Location:** Shanghai, China**CWI Name:** Lu Li Qing**CWI Present:** Yes No**Inspected CWI report:** Yes No N/A**Rod Oven in Use:** Yes No N/A**Electrode to specification:** Yes No N/A**Weld Procedures Followed:** Yes No N/A**Qualified Welders:** Yes No N/A**Verified Joint Fit-up:** Yes No N/A**Approved Drawings:** Yes No N/A**Approved WPS:** Yes No N/A**Delayed / Cancelled:** Yes No N/A**Bridge No:** 34-0006**Component:** OBG Components**Summary of Items Observed:**

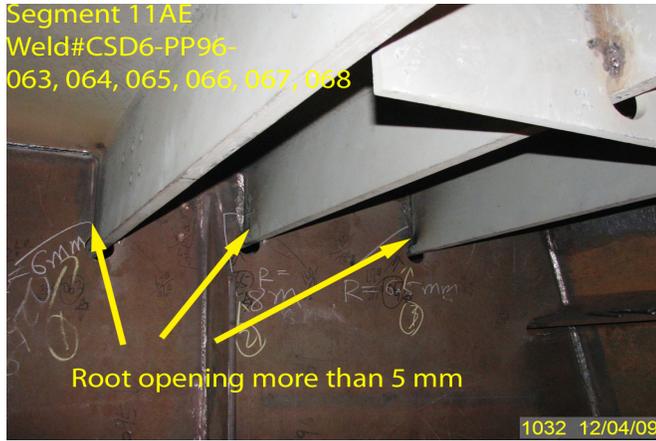
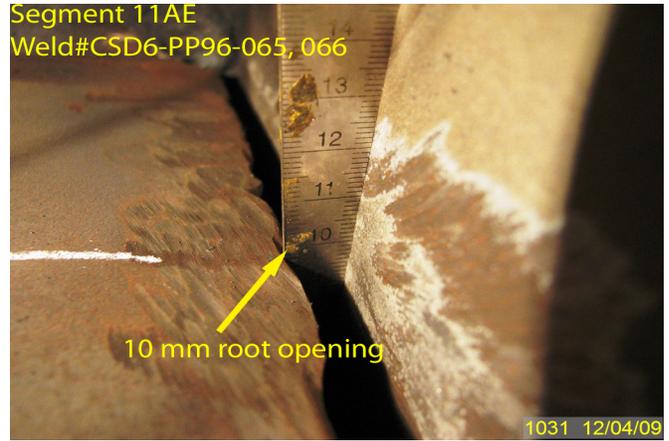
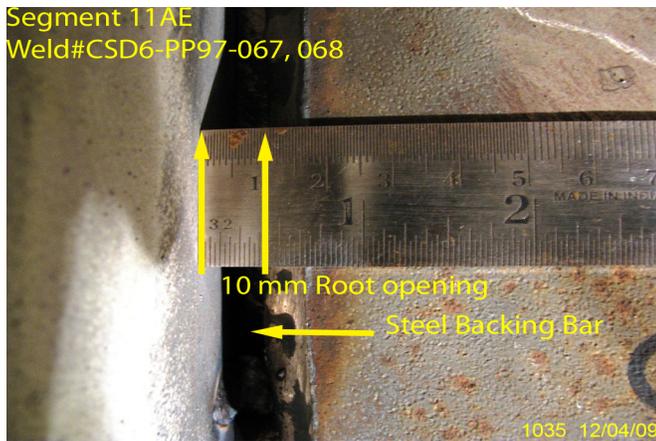
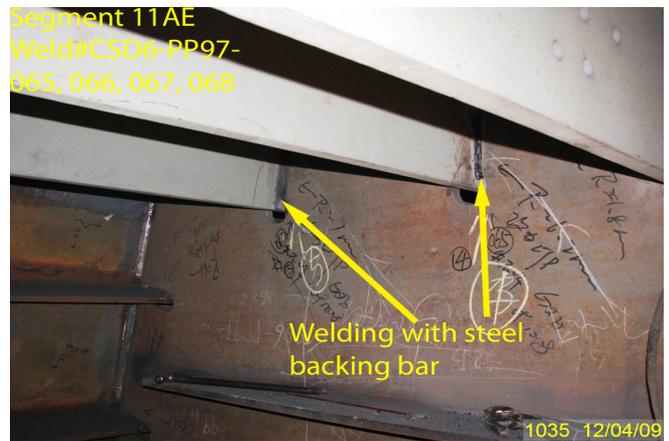
During random visual inspection of OBG Segment 11AE, this QA inspector observed that ZPMC has deviated from the joint design and used steel backing where it is not specified. The steel backing bar used to rectify excessive root opening in Corner Assembly to Deck Plate open ribs. For further information, see attached pictures below.

Weld# having root opening more than 5mm are as below.

-CSD6-PP96-063, 064, 065, 066, 067, 068.

-CSD6-PP97-065, 066, 067, 068.
