Contract #: 04-0120F4Cty: SF/ALA Rte: 80 PM: 13.2/13.9File #: 69.28**WELDING INSPECTION REPORT****Resident Engineer:** Pursell, Gary**Address:** 333 Burma Road**City:** Oakland, CA 94607**Report No:** WIR-010603**Date Inspected:** 28-Nov-2009**Project Name:** SAS Superstructure**OSM Arrival Time:** 700**Prime Contractor:** American Bridge/Fluor Enterprises, a JV**OSM Departure Time:** 1900**Contractor:** Zhenhua Port Machinery Company, Ltd (ZPMC), Changxing Island **Location:** Shanghai**CWI Name:** ZPMC and ABF**CWI Present:** Yes No**Inspected CWI report:** Yes No N/A**Rod Oven in Use:** Yes No N/A**Electrode to specification:** Yes No N/A**Weld Procedures Followed:** Yes No N/A**Qualified Welders:** Yes No N/A**Verified Joint Fit-up:** Yes No N/A**Approved Drawings:** Yes No N/A**Approved WPS:** Yes No N/A**Delayed / Cancelled:** Yes No N/A**Bridge No:** 34-0006**Component:** OBG Components**Summary of Items Observed:**

WELDING INSPECTION REPORT

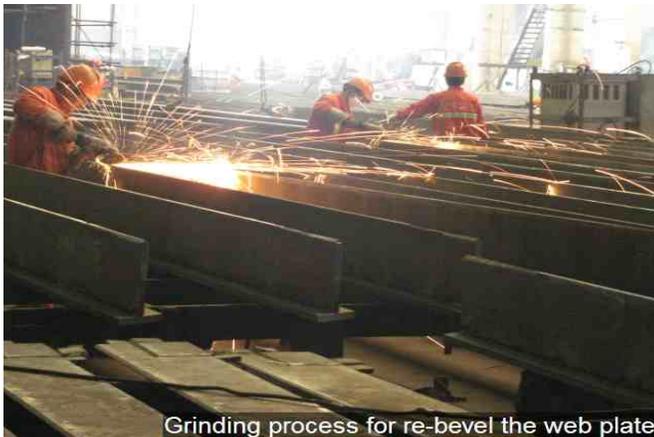
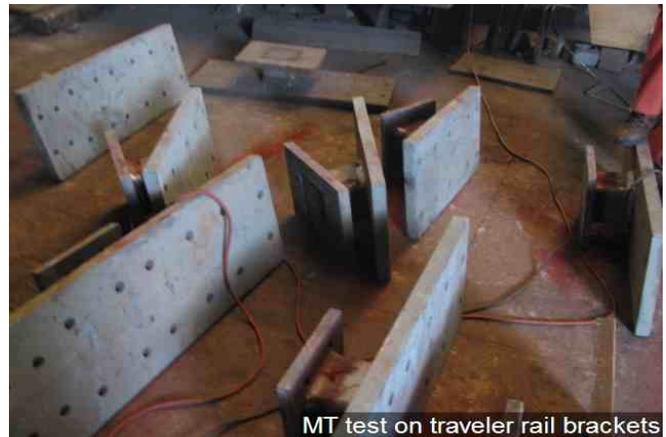
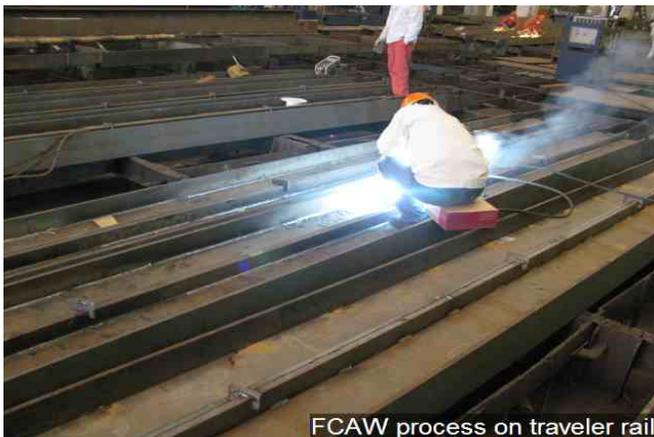
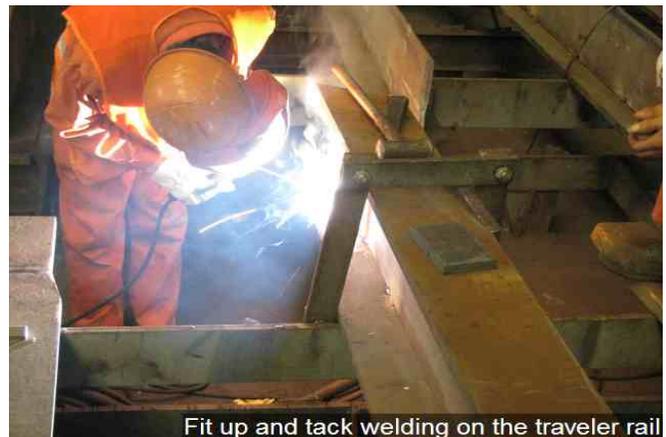
Traveler rail: - Caltrans QA inspector observed eight ZPMC welders performed FCAW process on the flange to web plate of traveler rail #11TR2-005, 11TR2-006, 11TR3-015, 10TR1-003, 11TR3-026, 11TR1-013, 11TR1-023, 11TR1-018, 11TR1-010, 11TR1-011, 11TR3-026, 11TR2-017 11TR3-016 and 11TR2-013. This type component designed has CJP and PJP weld along on one side of full weld length and other side has CJP only. All the welding areas have been pre heating prior FCAW welding. The FCAW process were monitored and recorded by ZPMC and ABF QC inspector. Based on Caltrans QA Inspector observations, no discrepancies were noted.

Traveler rail: - Caltrans QA inspector observed three fit up groups performed fit up and SMAW and FCAW tack weld process on the flange to web plate of seven 10TR and 11TR type traveler rails. Each group has two workers and one tack weld welder. During observation, the traveler rails have not been identified by ZPMC at this time. A numerous temporary tack welds have been welded attach to the web after adjusted and secured by template. The fit up and SMAW and FCAW tack welding process were monitored and recorded by ZPMC and ABF QC inspector. Base on Caltrans QAI observation, no discrepancies were noted.

Traveler rail: - Caltrans QA inspector observed two ZPMC workers performed grinding process on one side edge of web for traveler rail. The purpose of the grinding is getting a suitable bevel for the web prior fit up to the flange. A total eight webs of travel rail have been completed re-bevel. The grinding process was monitored and recorded

Traveler rail: - Caltrans QA inspector observed two welders performed carbon arc back gouging process on the flange to web plate of traveler rail. A back gouging is on one side of flange to web of three traveler rails. Approximately 8mm sound wall thick has been gouged out. The back gouging area has been re-bevel to request design joint by grinding and the beveled surface is entirely free of the scale, traces of oxide films and other contaminants prior welding. Base on Caltrans observation, no discrepancies were noted.

Traveler rail bracket: - Caltrans QA inspector performed final MT inspection on the fillet welds of eighteen traveler rail bracket. The fillet welds are attached to square tube. The traveler rail brackets weld ID are tr1d-pp033-007/008, tr5c-pp031-005/006, tr5c-pp035-005/006, tr5b-pp035-003/004, tr5d-pp032-007/008, tr5c-pp029-005/006, tr5b-pp033-003/004, tr5b-pp031-003/004, tr5b-pp029-003/004, tr6c-pp032-005/006, tr6e-pp030-001/002, tr6b-pp030-003/004, tr6b-pp036-003/004, tr6c-pp034-005/006, tr6e-pp036-001/002, tr6a-pp034-001/002, tr6e-pp032-001/002 and tr1a-pp021-001/002 All the welds have been tested and accepted by ZPMC prior Caltrans testing. Base on Caltrans inspection, the fillet welds appeared to be in compliance with requirements of AWS D1.5 2002 and Caltrans contract documents.
