**DEPARTMENT OF TRANSPORTATION**

Contract #: 04-0120F4Cty: SF/ALA Rte: 80 PM: 13.2/13.9File #: 13.28**WELDING INSPECTION REPORT****Resident Engineer:** Pursell, Gary**Address:** 333 Burma Road**City:** Oakland, CA 94607**Report No:** WIR-010722**Date Inspected:** 08-Dec-2009**Project Name:** SAS Superstructure**OSM Arrival Time:** 1000**Prime Contractor:** American Bridge/Fluor Enterprises, a JV**OSM Departure Time:** 1830**Contractor:** Oregon Iron Works Clackamas, Or.**Location:** Clackamas, OR**CWI Name:** M. Gregson, J. Salazar**CWI Present:** Yes No**Inspected CWI report:** Yes No N/A**Rod Oven in Use:** Yes No N/A**Electrode to specification:** Yes No N/A**Weld Procedures Followed:** Yes No N/A**Qualified Welders:** Yes No N/A**Verified Joint Fit-up:** Yes No N/A**Approved Drawings:** Yes No N/A**Approved WPS:** Yes No N/A**Delayed / Cancelled:** Yes No N/A**Bridge No:** 34-0006**Component:** Hinge K Pipe Beams**Summary of Items Observed:**

Hinge-K Pipe Beam Assembly 102A-3: 12/8/09

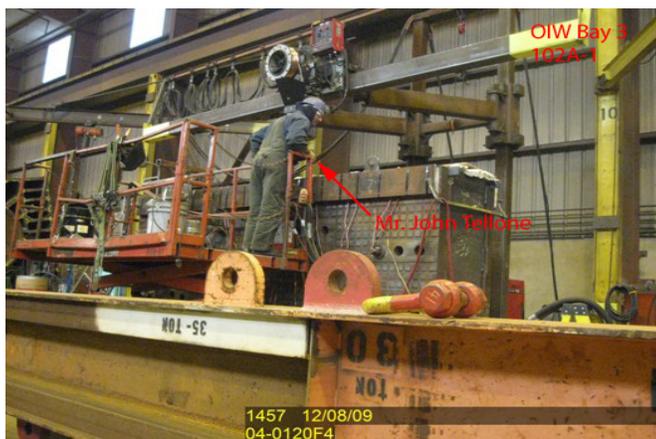
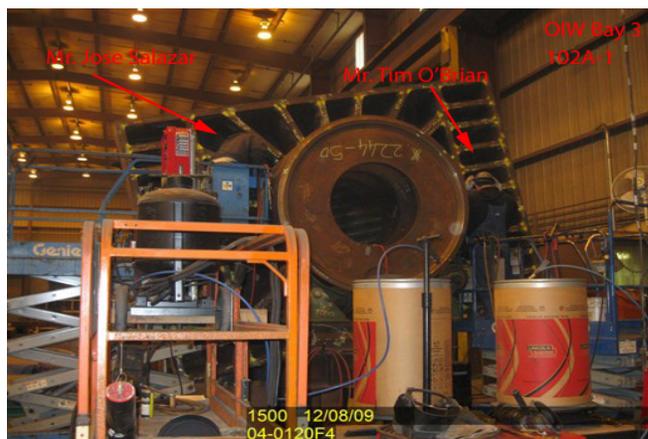
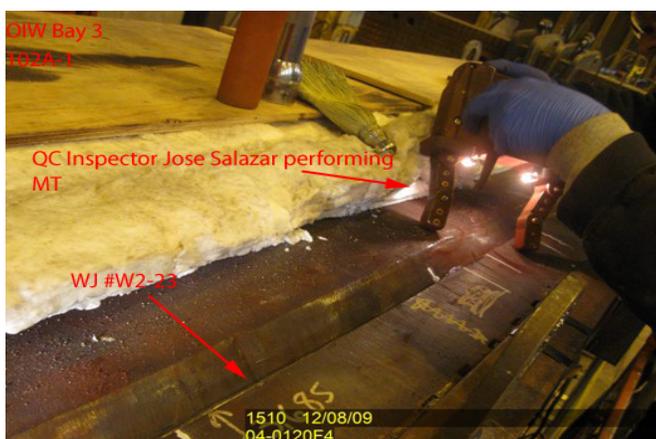
QA Inspector noticed that the partial joint penetration and fillet welds, designated as weld joints #W1-01 thru W1-163, were previously completed and OIW production personell were in-process of performing weld clean-up, on the above mentioned stiffeners. QA Inspector spoke with QC Inspector Jose Salazar and Mr. Salazar explained that OIW welder # O6, Mr. Tim O'Brian was continuing to blend the weld start/stops, removing weld spatter and grinding all areas, which were previously marked by OIW QC Inspectors. Mr. Salazar explained that the visual clean-up that was being performed by Mr. O'Brian, was intermittently monitored by Mr. Salazar and areas that were previously marked up and completed, were then visually re-inspected, per AWS D1.5 and contract requirements. QA Inspector noted that the in-process visual testing by OIW QC Inspector Jose Salazar, appeared to be in compliance with AWS D1.5 and contract requirements.

QA Inspector noted that welder #T23 Mr. John Tellone, had previously completed the submerged arc welding root pass, designated as weld joint #W2-23, in the flat (1G) position, utilizing OIW approved welding procedure

specification (WPS 4020). QA Inspector spoke with QC Inspector Jose Salazar and Mr. Salazar explained that the above mentioned weld joint had previously cooled to ambient temperature and 100% visual and magnetic particle testing was to be performed on the root pass. QA Inspector witnessed Mr. Salazar performing the magnetic particle testing and noted that no rejectable indications were found. QA Inspector noted that Mr. Salazar signed off next to the weld joint as VT/MT ok, on this AWS D1.5 TC-P4-S, root pass. QA Inspector then performed approximately 25% magnetic particle testing and 100% visual testing on this SAW root pass and found no rejectable indications, per AWS D1.5 and contract requirements. See attached pictures below and completed TL 6028, for additional details.
